**Rehabilitation of the Portage Avenue
Twin Bridges over Sturgeon Creek**

Preliminary Engineering Study

Report No. 1 07 1234.AB

April 2013

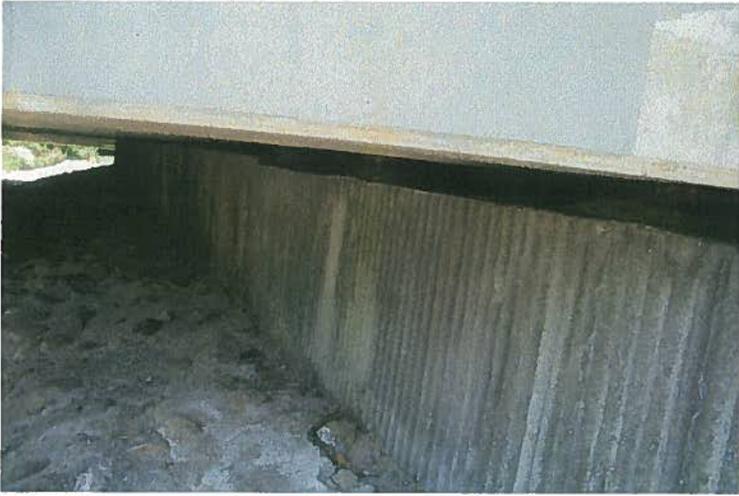
Photo 1 – west abutment

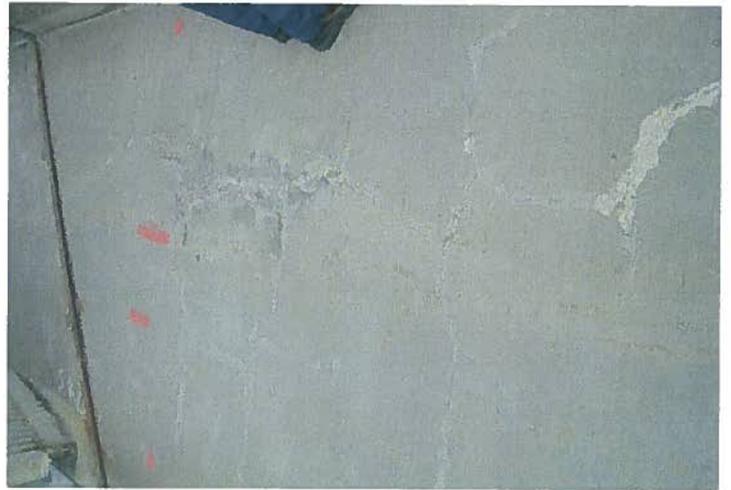
Photo 8 – south sidewalk west end

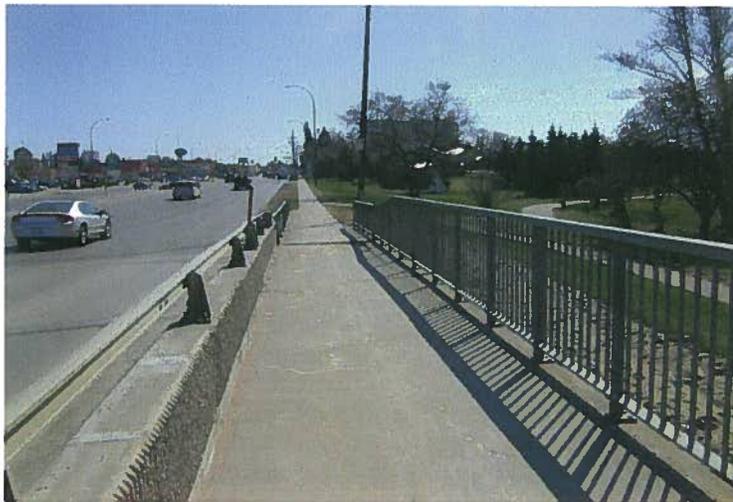
Photo 11 – south sidewalk looking east

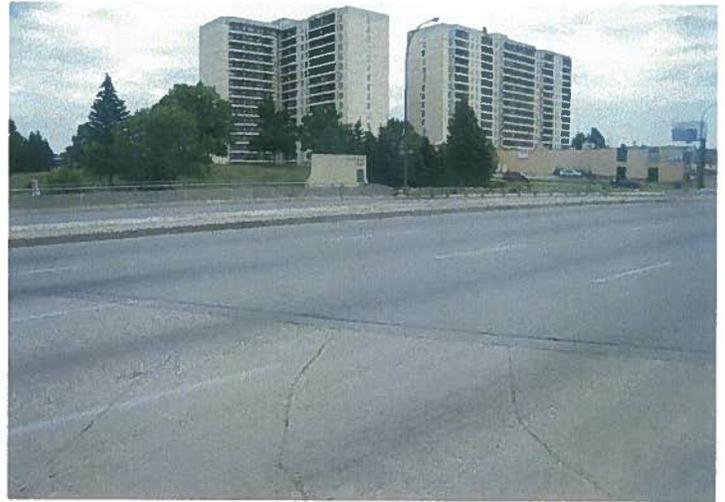
Photo 12- deck looking east

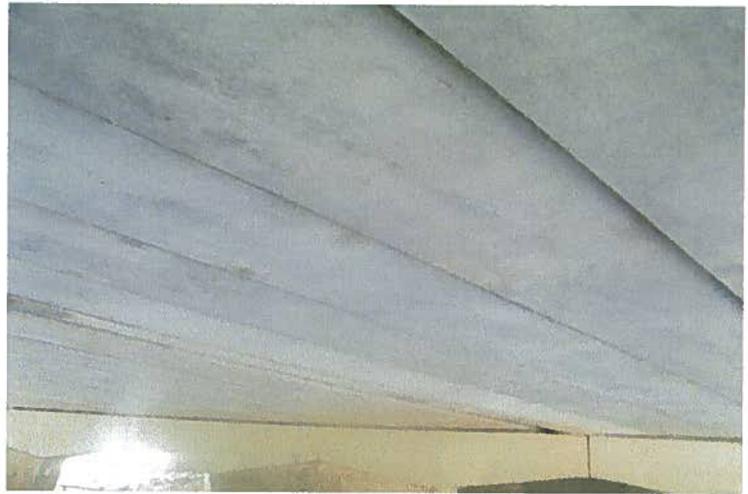
Photo 16 – middle span girders

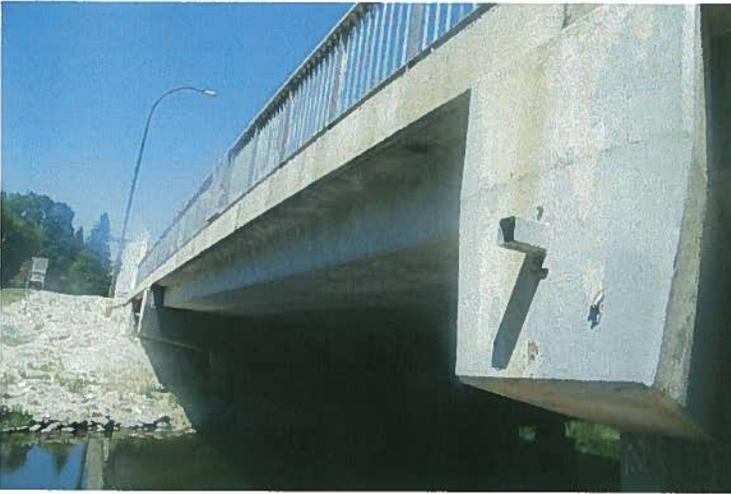
Photo 19 – middle span south extension soffit

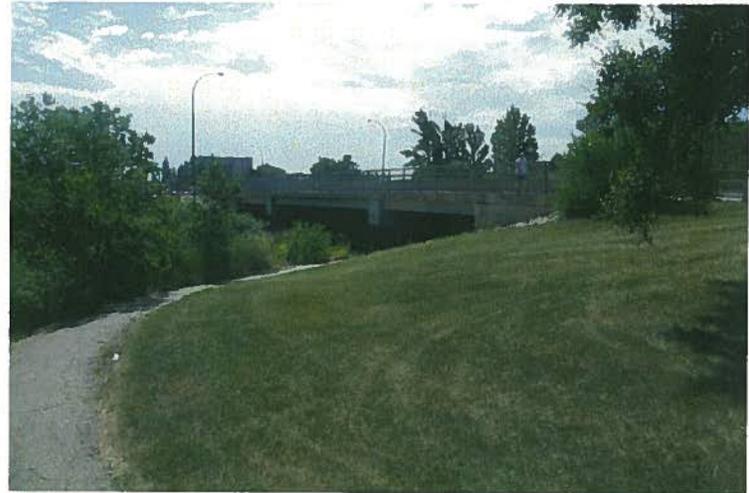
Photo 20 – north elevation from NW corner

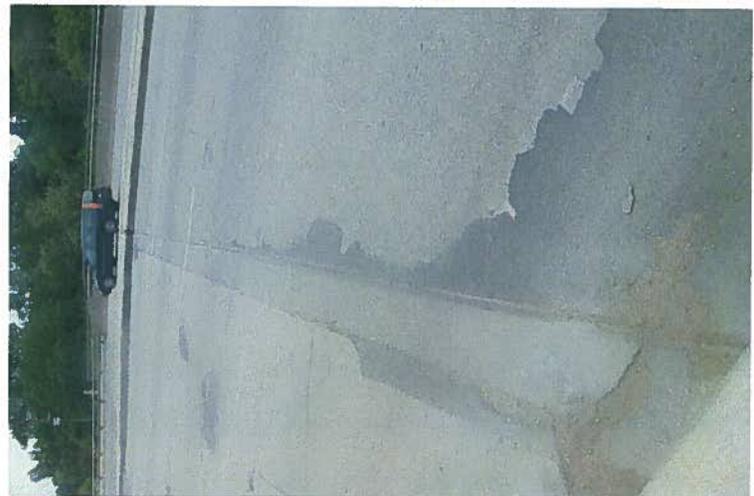
Photo 24 – east expansion joint looking south

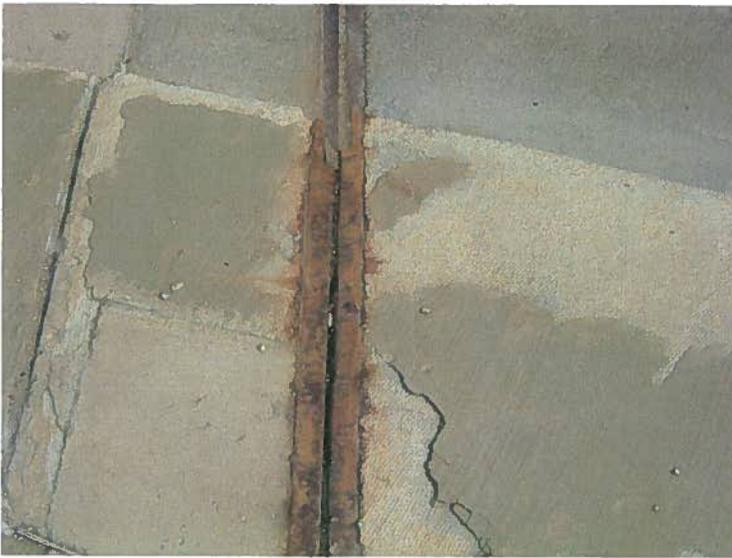
Photo 25 – median expansion joint

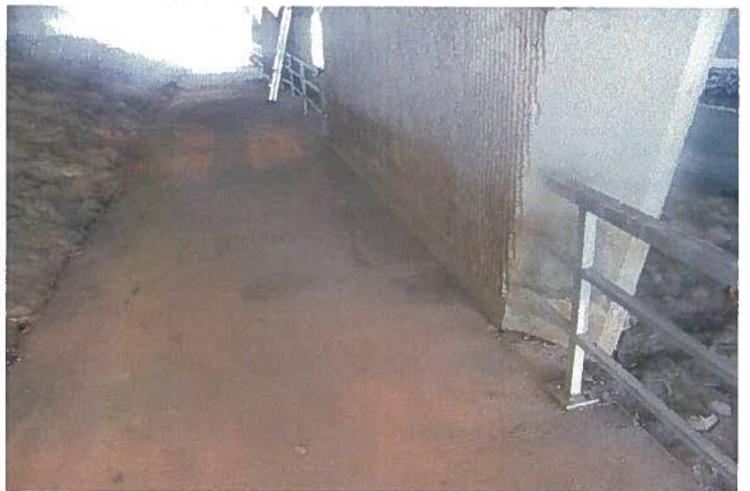
Photo 30 – under-bridge sidewalk

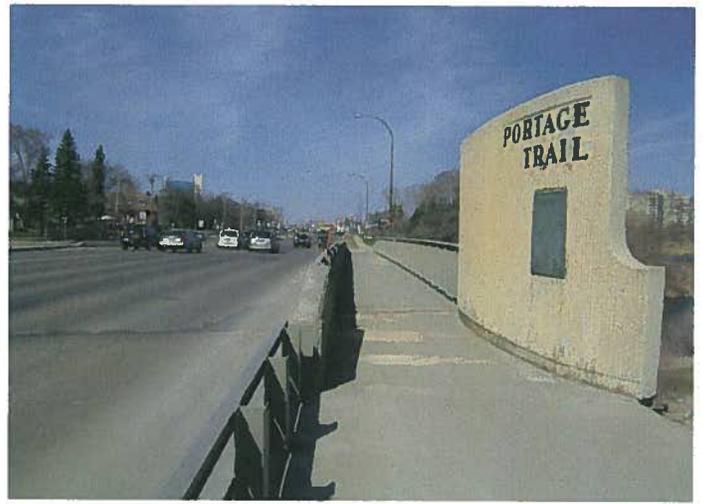
Photo 32 - endpost

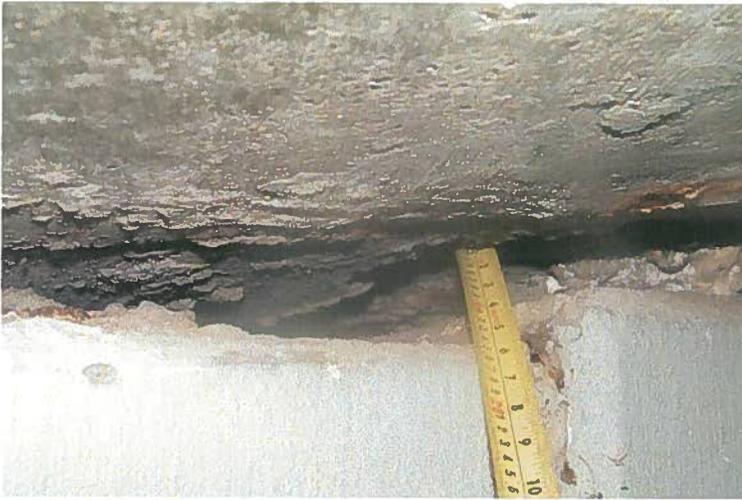
Photo 33 – middle soffit above west pier
