# Building Condition Assessment & Facility Feasibility Study

## St. Vital Library 6 Fermor Avenue

December 4, 2014

Project No. 2196

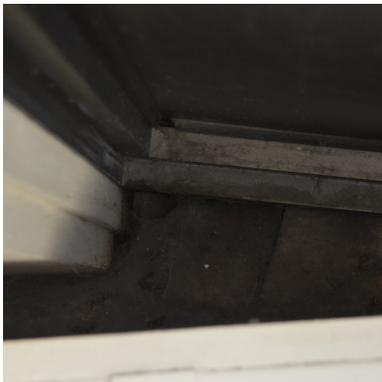
Carpet does not extend to window

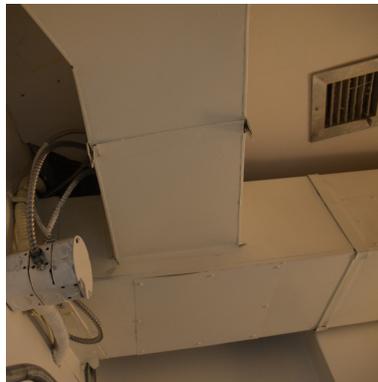
Ceiling mounted ductwork

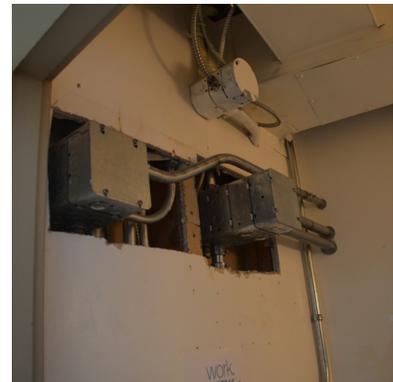
Exposed electrical devices on north wall

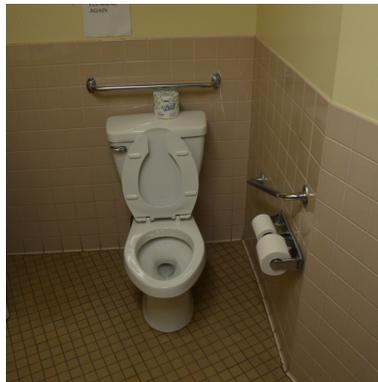
Non-code compliant grab bars

- Door hardware does not comply with current barrier free code requirements. Replacement required.
- Lavatory drain piping below counter is exposed. Piping in barrier free locations should be off-set to provide required clearances and covered to prevent potential burn hazard. Recommend modifications to offset drain piping.
- Grab bars around toilet have been provided. Location and orientation do not comply with current barrier free code requirements. Replacement recommended.

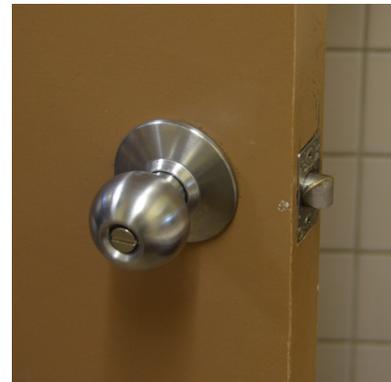
Non-barrier free door hardware

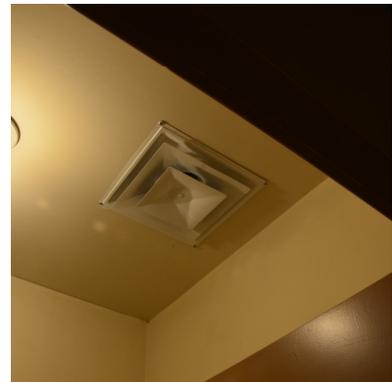
View of GWB ceiling finish

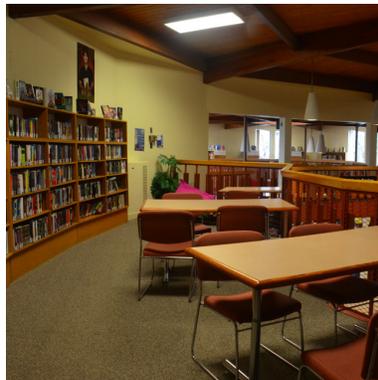
View of mezzanine

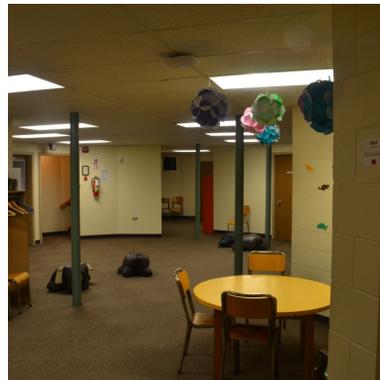
West view of common room

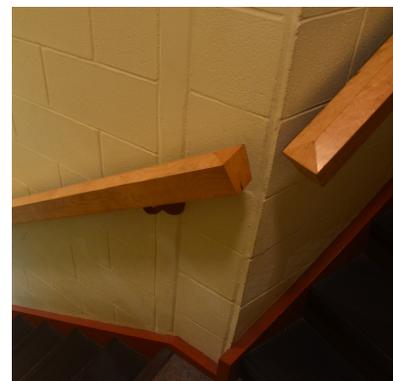
Non-code compliant handrails

- Contrasting nosing demarcating edge of all stair treads and landings are required. Recommend providing colour contrasting strips at all stair treads and landing levels.
- Handrail profiles do not comply with requirements of the current building code. Handrails are required to be continuous and installed on both side of stairs. Replacement and additional handrail recommended.
- Door and frame is required to be fire rated as it is providing the separation between main and basement floor levels. Replacement recommended with code compliant door release hardware as the doors serve as part of the basement floor level access to exit.

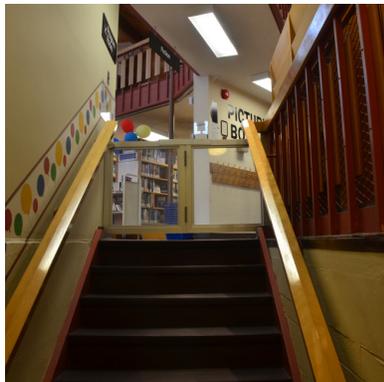
View from landing up to main floor

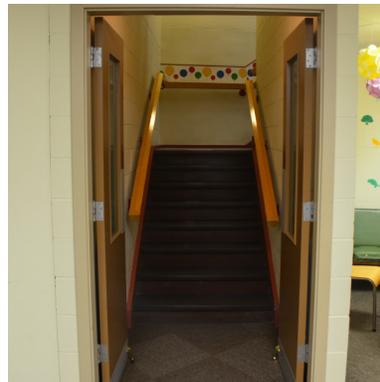
Non-fire rated doors into stairwell at basement level

- Contrasting nosing demarcating edge of all stair treads and landings are required. Recommend providing colour contrasting strips at all stair treads and landing levels.
- Handrail profiles do not comply with requirements of the current building code. Handrails are required to be continuous and installed on both side of stairs. Replacement and additional handrail recommended.
- Door and frame is required to be fire rated as it is providing the separation between main and basement floor levels. Replacement recommended with code compliant door release hardware as the doors serve as part of the basement floor level access to exit.

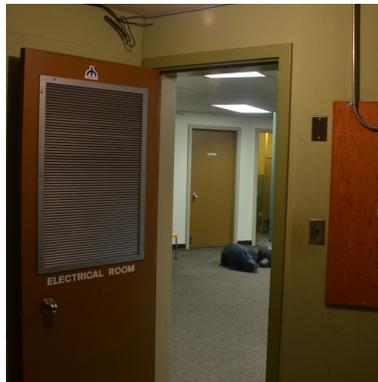
Door into electrical room c/w grille

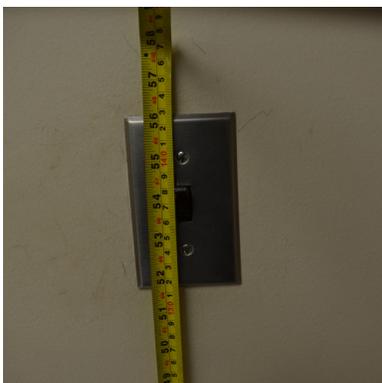
Light switch positioned too high, outside of barrier free acceptable range

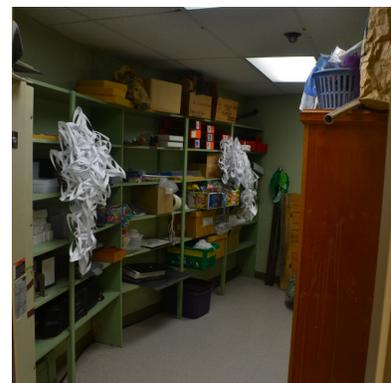
View of storage room

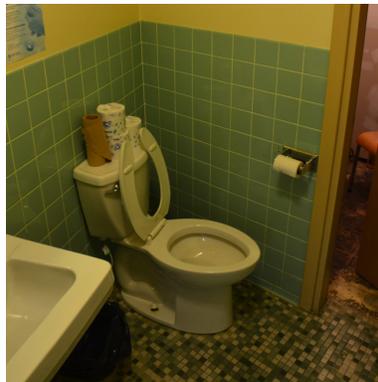
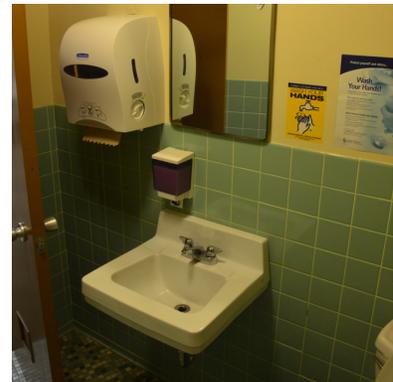
- Washroom does not comply with barrier free requirements of today's code. Recommend upgrading washroom to meet current code requirements.

View of mens watercloset

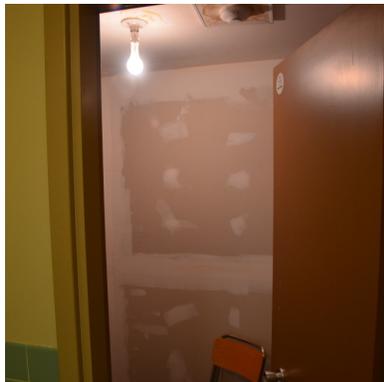
Exterior wall GWB unfinished

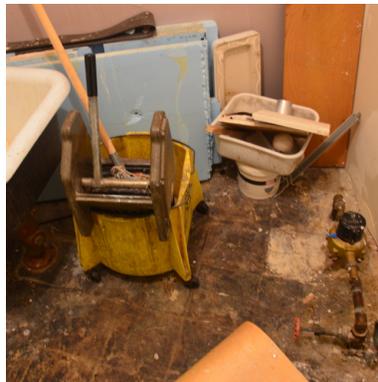
No floor finish within room

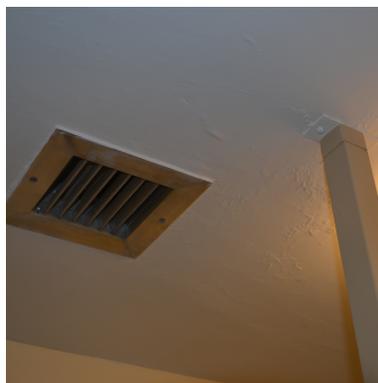
Previous patching on ceiling

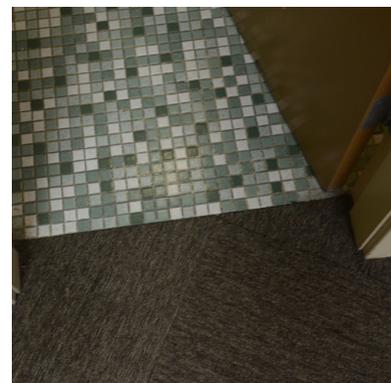
Ceramic tile floor finish

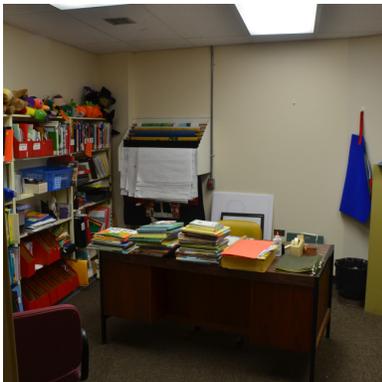
View of office

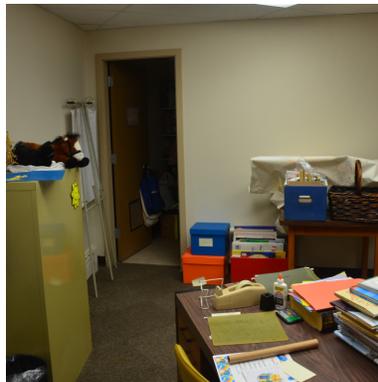
View towards storage room

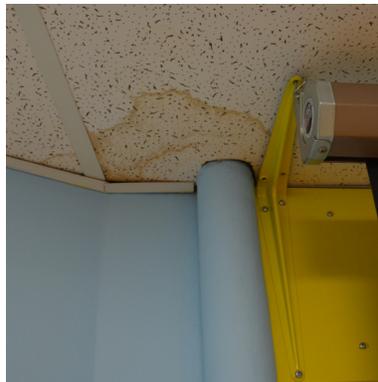
Water staining on acoustic ceiling

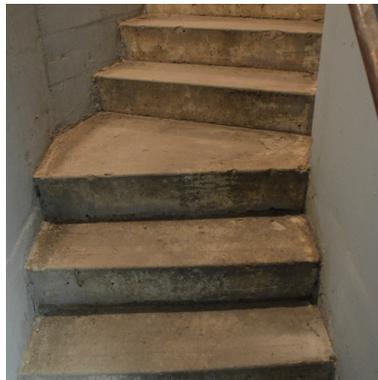
Concrete stairs

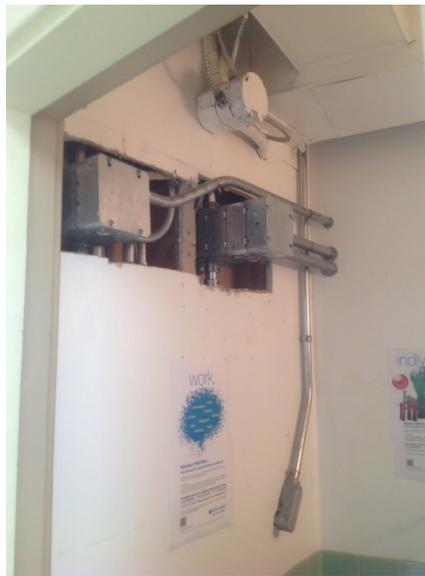
Junction boxes and extension rings have been cut into the wall and installed on the rear of Panels A & B to facilitate upgrades that have occurred over the years.

Figure 1: Junction Boxes & Extensions on Rear of Panelboards A & B

Panelboard space capacity will be insufficient to provide the additional circuits and devices requested for new computer workstations.

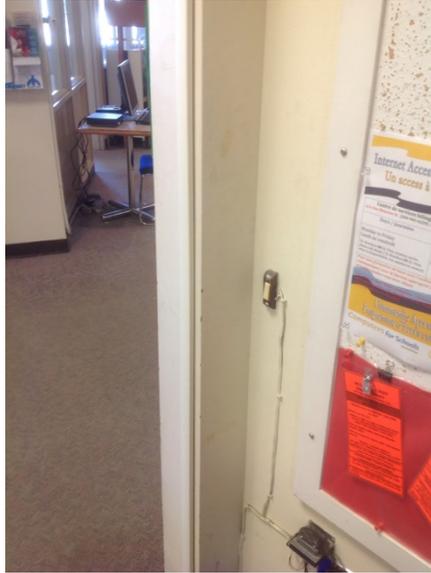
An existing buzzer system is installed with a buzzer located in the basement and call buttons at the main and mezzanine floors. The library staff reported that the system was not used.

Figure 2: Main Floor Buzzer Button Location

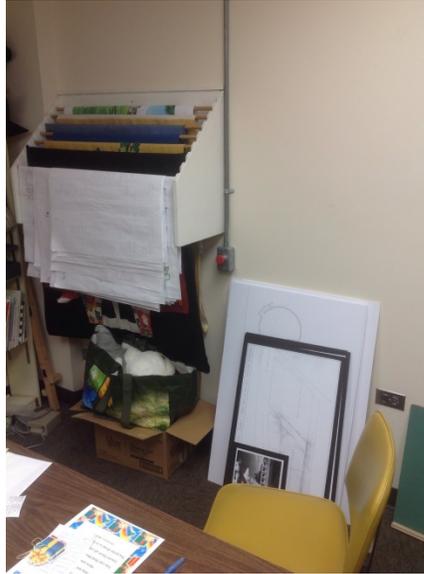
A panic alarm system is installed with red mushroom panic buttons in basement office spaces. Alarms are local only.

Figure 4: Panic Alarm Button

47. Maintain existing panic alarm system. Install additional panic buttons as required to suit new architectural layouts.
