Replacement of the FGSV Siphon

Geotechnical Data Report
FINAL – Rev. 1

City of Winnipeg

April 2025

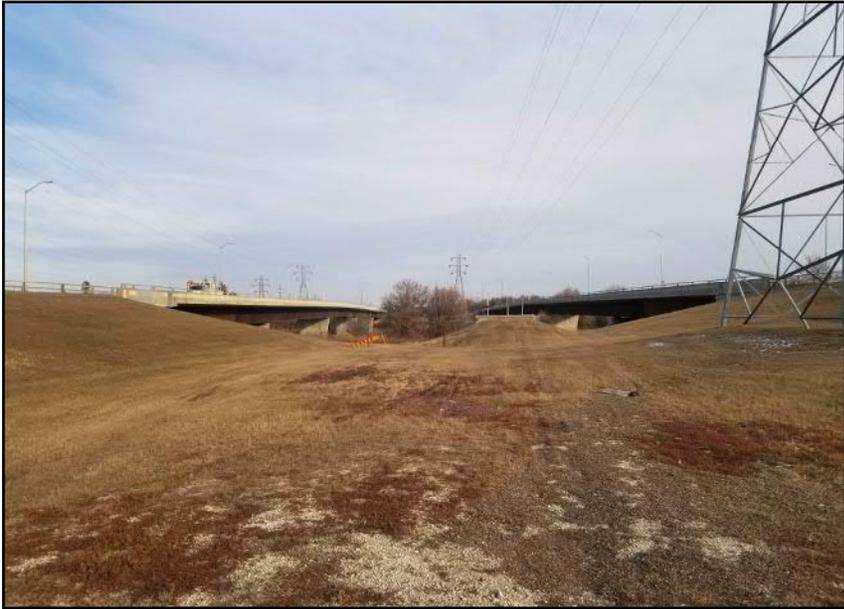
Site 4 - Western Riverbank | Ground between bridges gently sloping towards river (facing E)

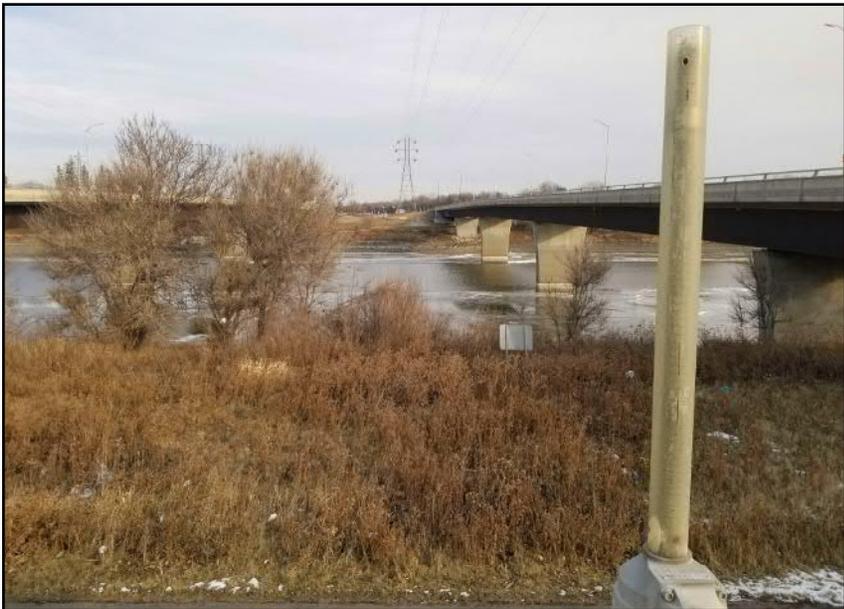
Site 4 - Western Riverbank | Gently sloping riverbank crest covered in brush, shrubs, and tree clusters (facing E)

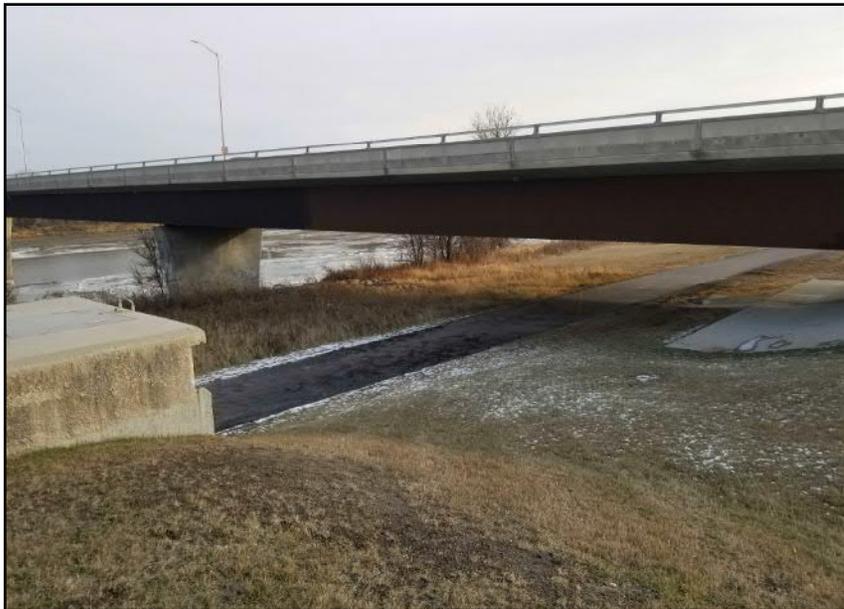
Site 4 - Western Riverbank | Gently sloping riverbank crest to the south of the crossing alignment(facing SE)

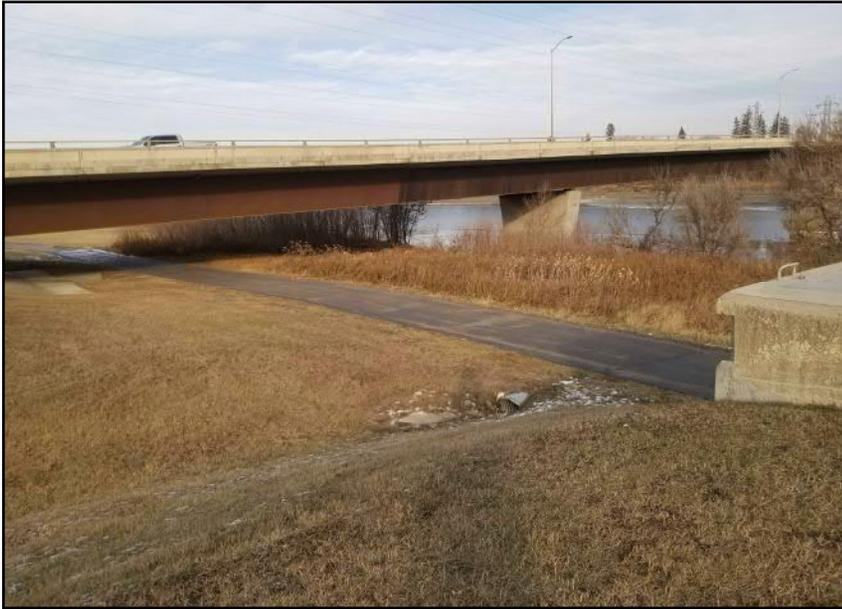
Site 4 - Western Riverbank	Gently sloping riverbank crest to the north of the crossing alignment (facing NE)
-----------------------------------	---

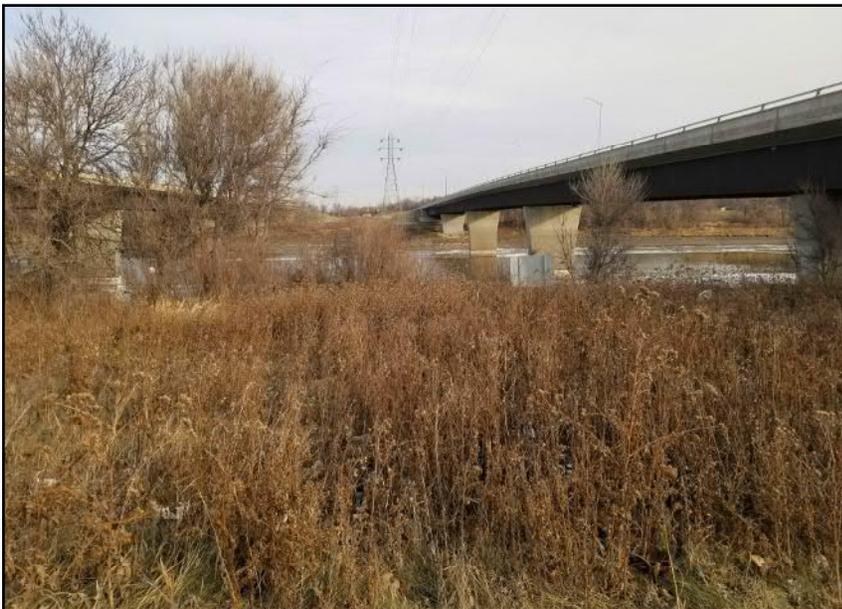
Site 4 - Western Riverbank	Densely vegetated riverbank crest to the east of the pedestrian pathway (facing E)
-----------------------------------	--

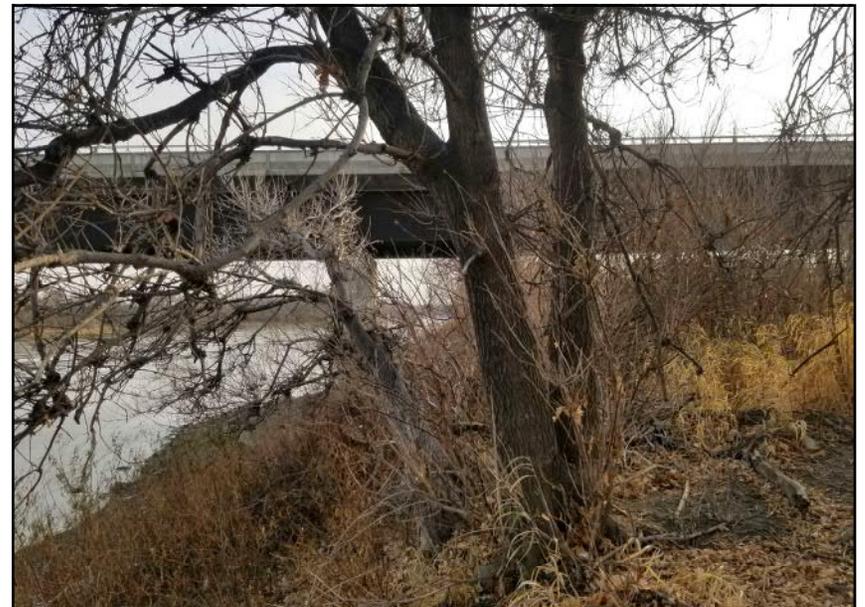
Site 4 - Western Riverbank | Generally vertical oriented trees near riverbank crest (facing S)

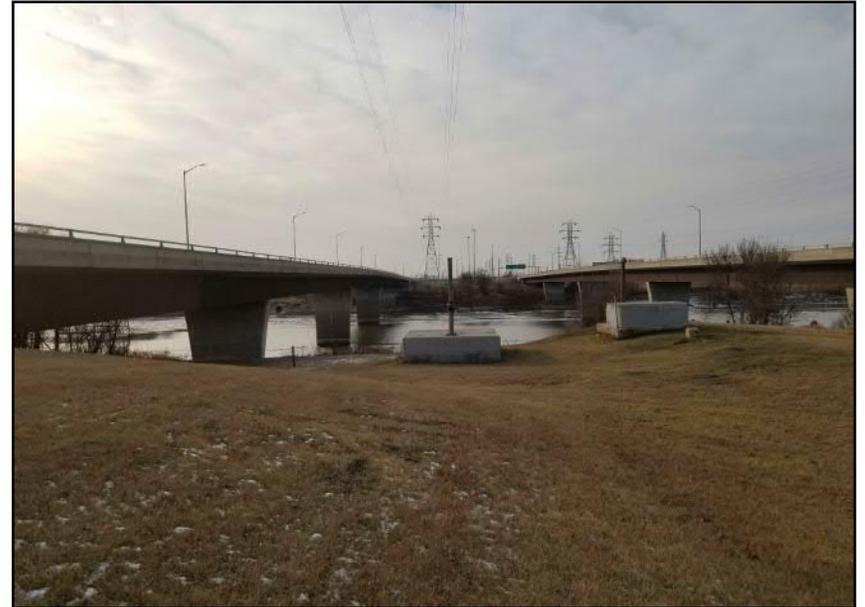
Site 4 - Eastern Riverbank	Ground between bridges gently sloping towards river (facing W)
-----------------------------------	--

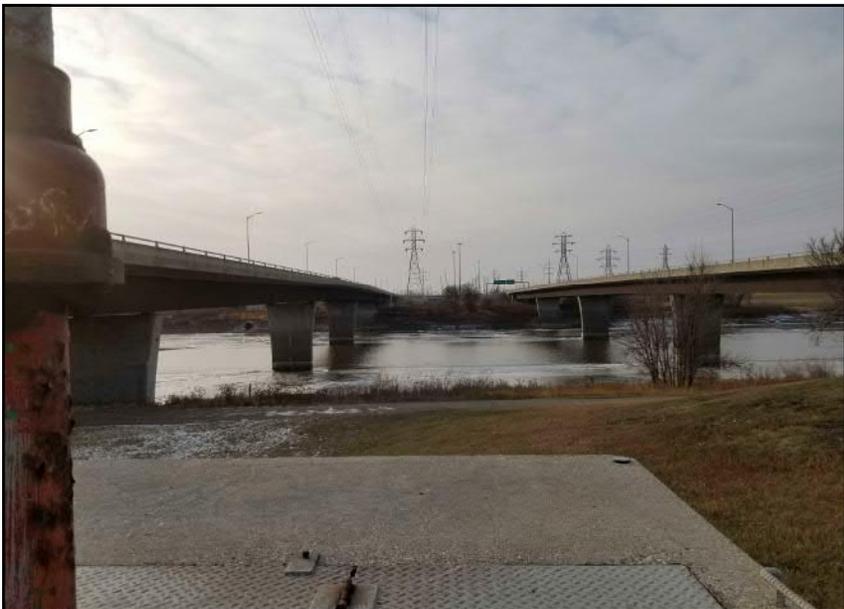
Site 4 - Eastern Riverbank	Gently sloping riverbank crest west of siphons inlet chamber structure (facing W)
-----------------------------------	---

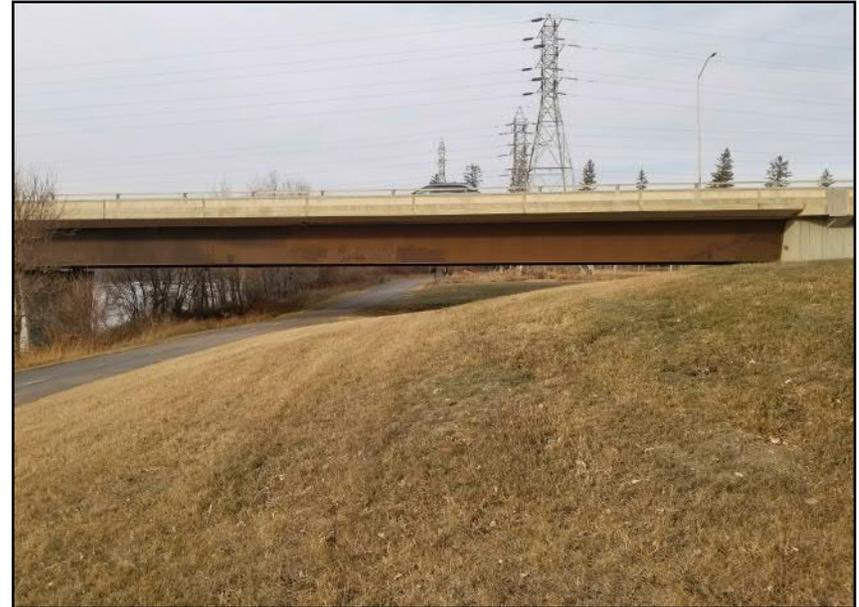
Site 4 - Eastern Riverbank Gradual riverbank crest slopes east of pedestrian pathway (facing N)

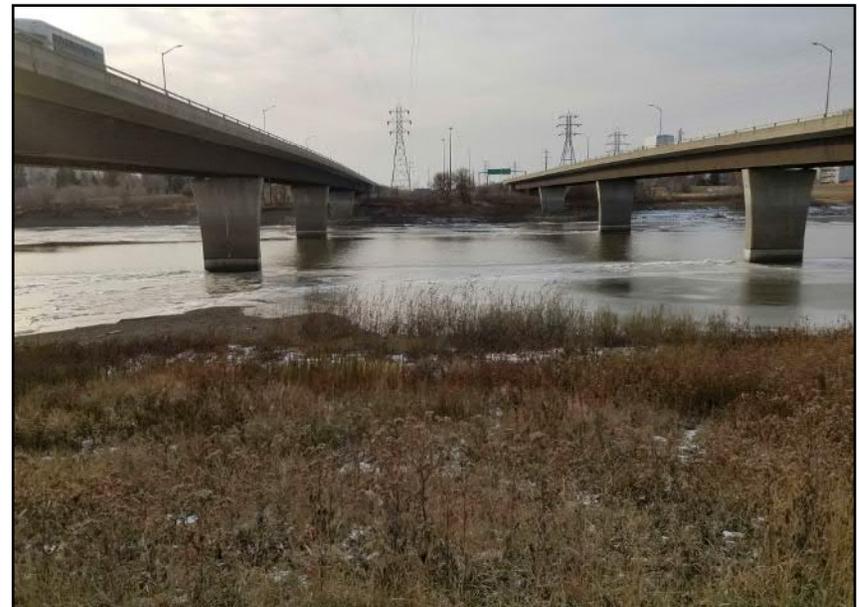
Site 4 - Eastern Riverbank Brush and shrubs observed along riverbank crest west of pedestrian pathway (facing W)

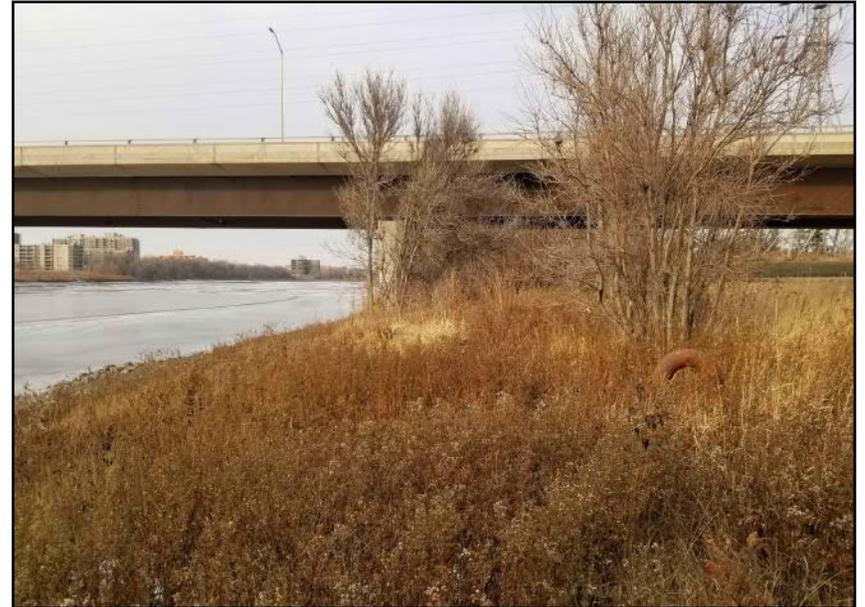
Site 4 - Eastern Riverbank Riverbank slightly steepening east of pedestrian pathway, tree clusters (facing N)

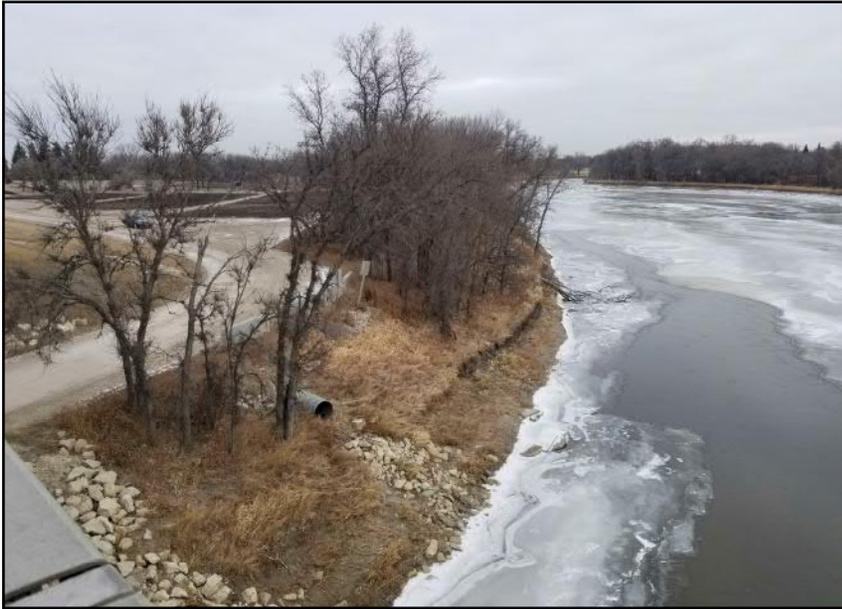
Site 5 - Northern Riverbank | View of northern bank from top of bridge (facing NE)

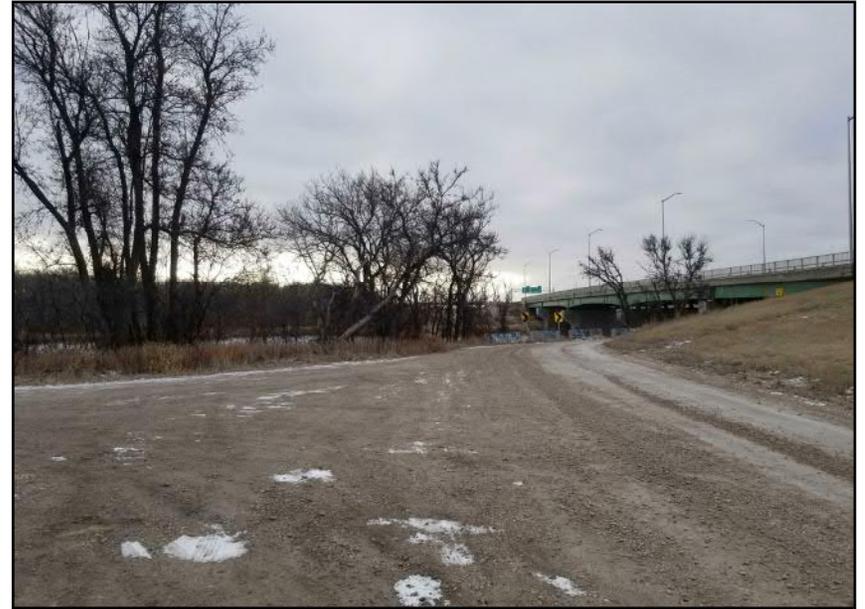
Site 5 - Northern Riverbank | Gradually sloping ground down Oxbow Bend Rd. towards river (facing S)

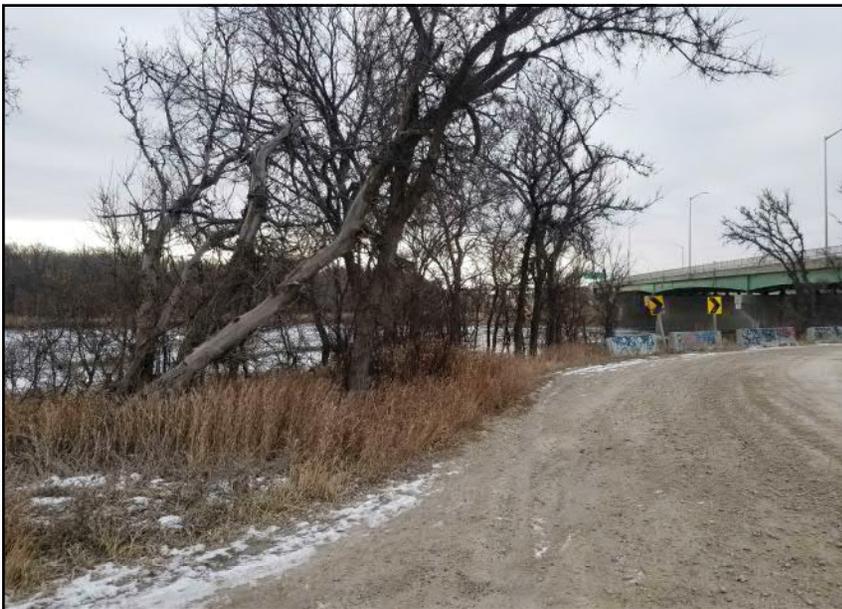
Site 5 - Northern Riverbank | View from riverbank crest along approximate crossing alignment (facing S)

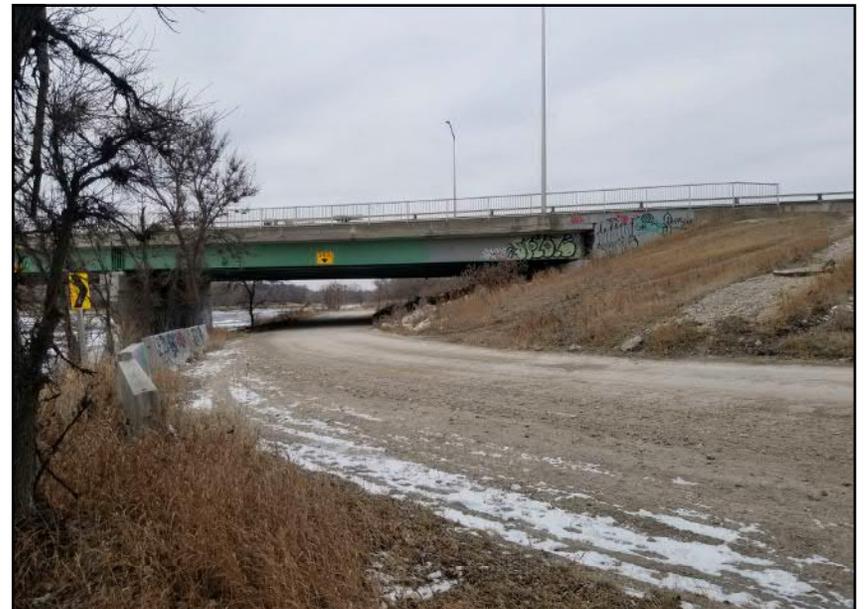
Site 5 - Northern Riverbank | Granular road along riverbank crest below bridge, jersey barriers, traffic signs (facing W)

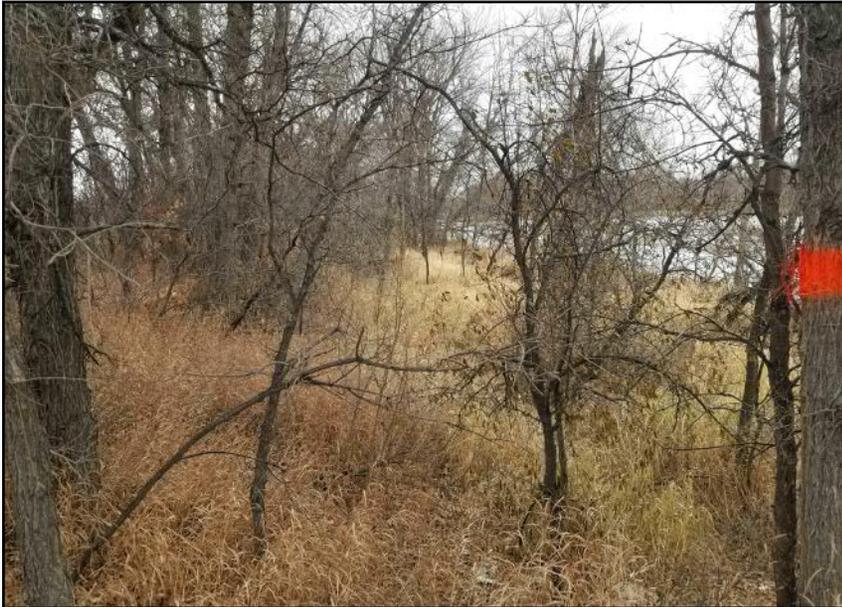
Site 5 - Northern Riverbank | Slightly steepening bank slope down towards river within eastern portion of study area (facing E)

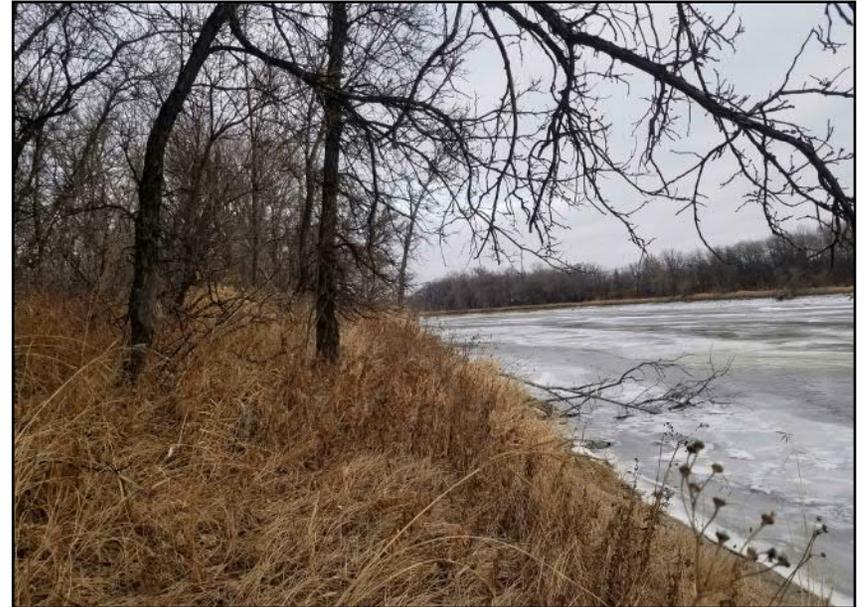
Site 5 - Northern Riverbank | Flattened bank slope near top of erosion scarp within eastern portion of study area (facing E)

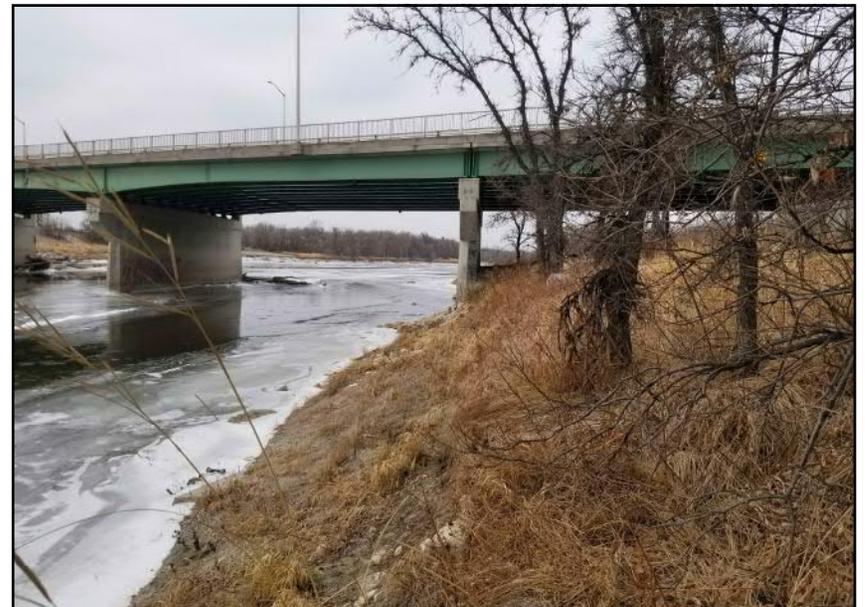
Site 5 - Northern Riverbank | Slightly steepened bank slope down towards river within western portion of study area (facing W)

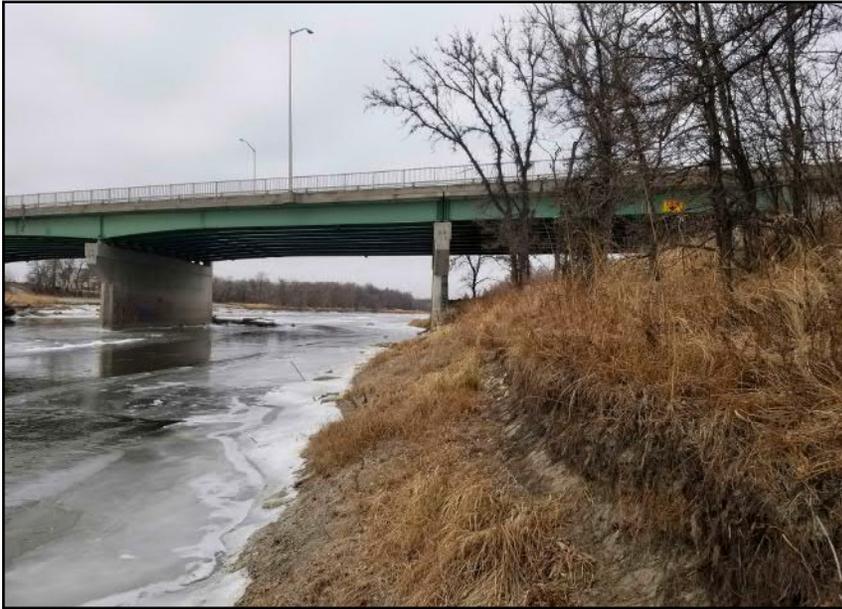
Site 5 - Northern Riverbank Erosion scarp observed near bank toe within western portion of study area (facing W)

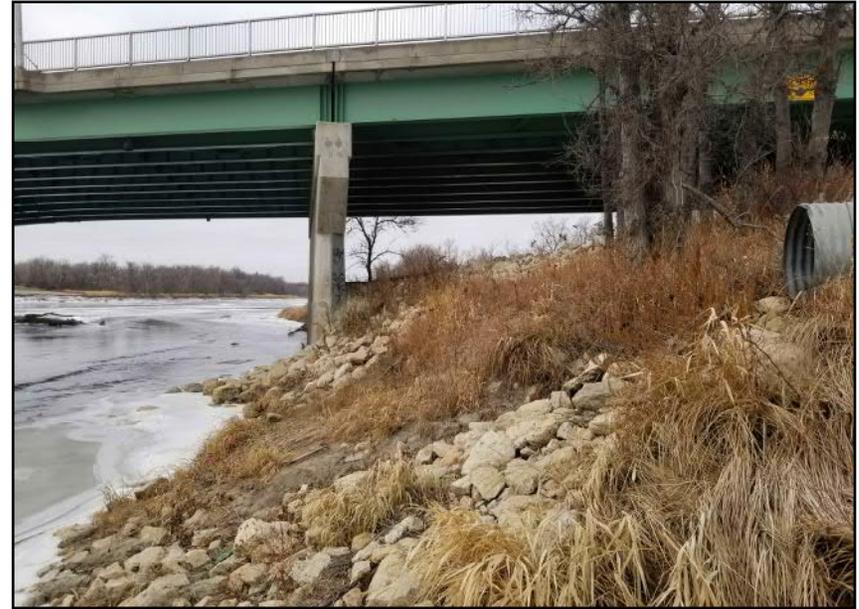
Site 5 - Northern Riverbank Rip-rap along slope within discharge path of CSP outfall in western portion of study area (facing W)

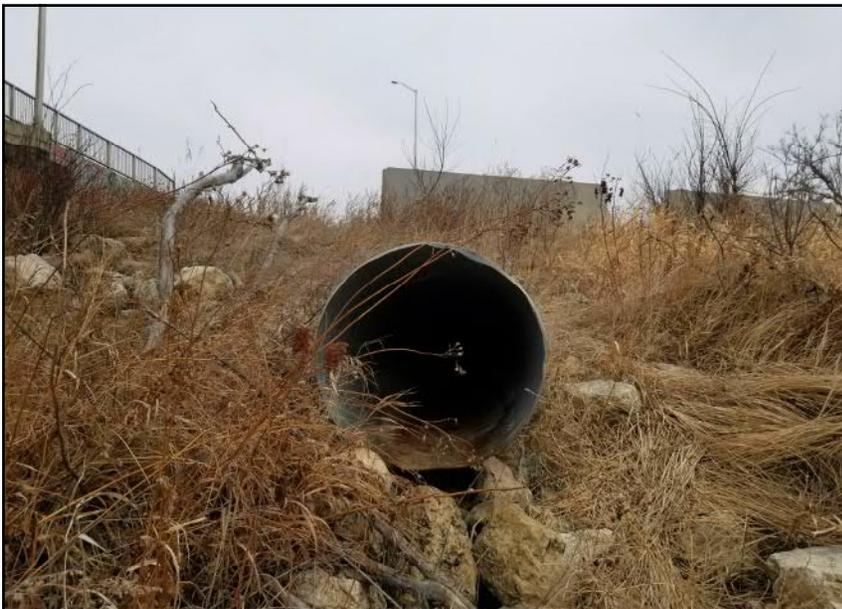
Site 5 - Northern Riverbank CSP outfall daylighting along bank slope, some erosion of bank material between rip-rap (facing N)

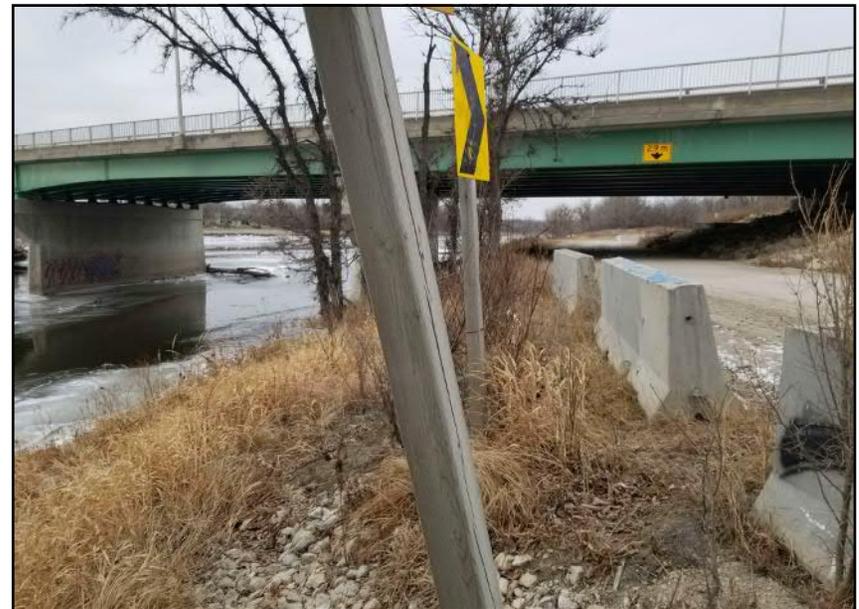
Site 5 - Northern Riverbank Traffic signs located along bank crest near crossing alignment. One leaning, one straight (facing W)

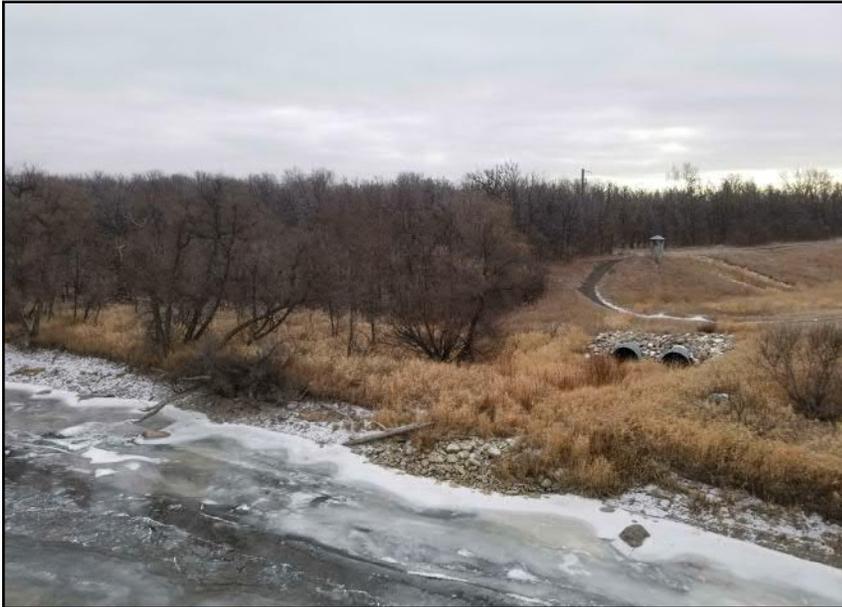
Site 5 - Southern Riverbank | View of southern bank from top of bridge (facing SE)

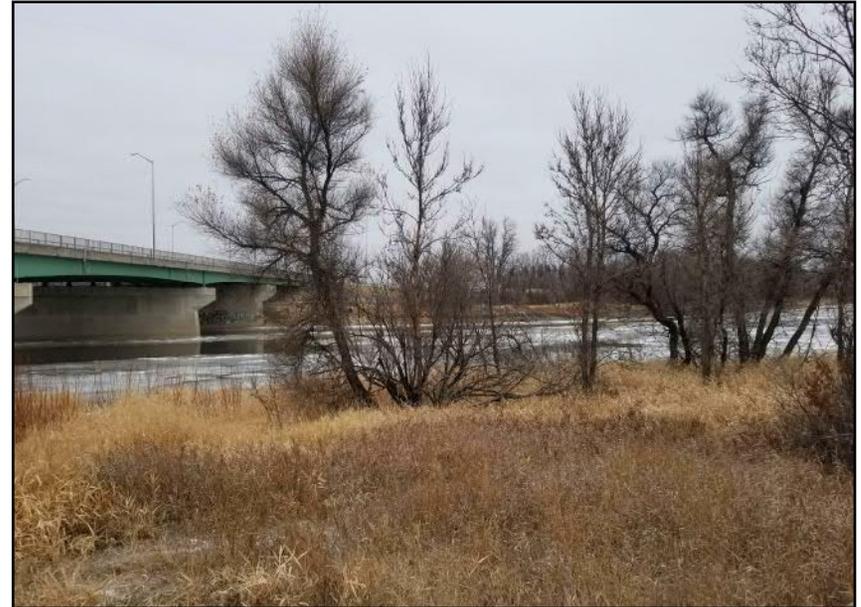
Site 5 - Southern Riverbank View from riverbank crest along approximate crossing alignment (facing N)

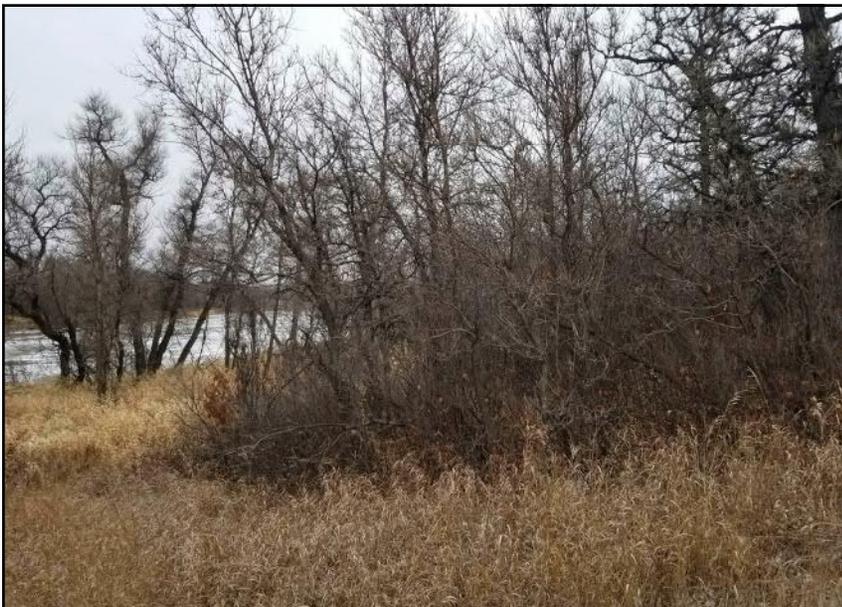
Site 5 - Southern Riverbank Gradual slopes, brush, shrubs, and trees observed along bank crest near crossing alignment (facing E)

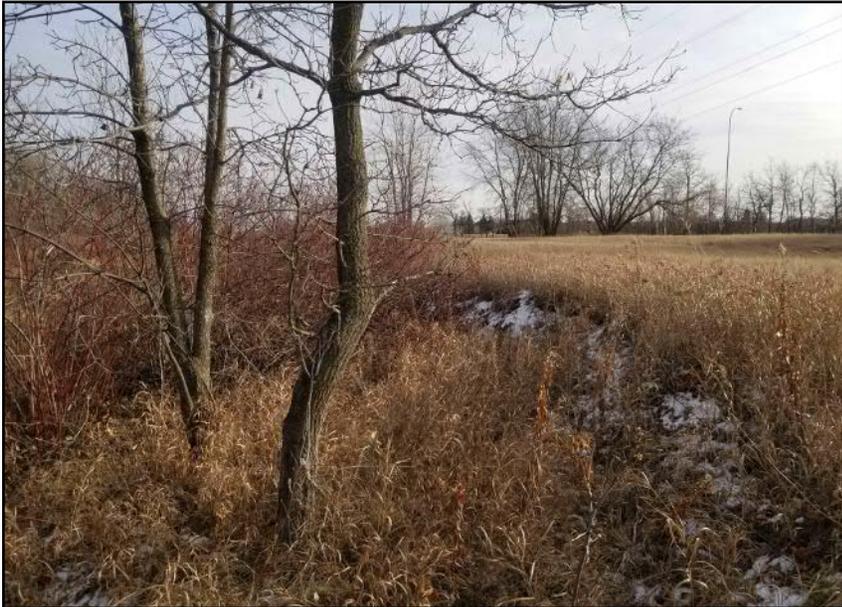
Site 6A - Southern Bank | Progressive slope instabilities have progressed towards the bank crest (facing W)

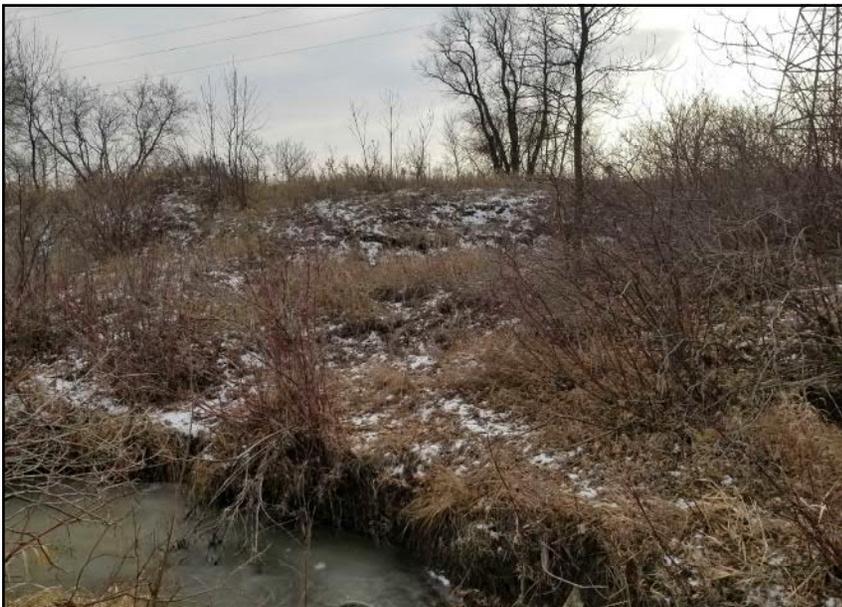
Site 6A - Southern Bank | Slope instability ridges observed near bank crest west of the crossing alignment (facing W)

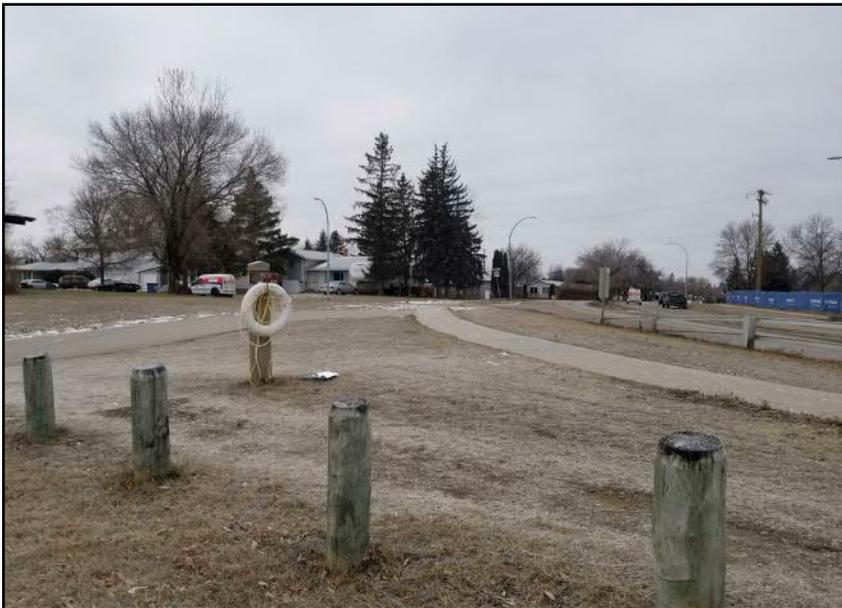
Site 7 - Western Bank | View from the west bank facing the east bank along the approximate crossing alignment (facing E)

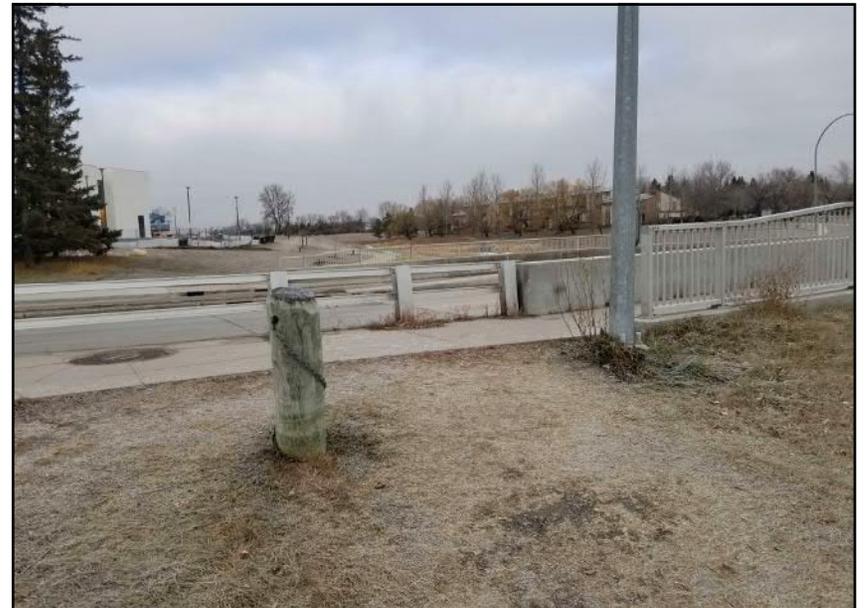
Site 7 - Western Bank | Gradual slope, manicured grass, wood posts along riverbank crest beside bridge abutment (facing W)

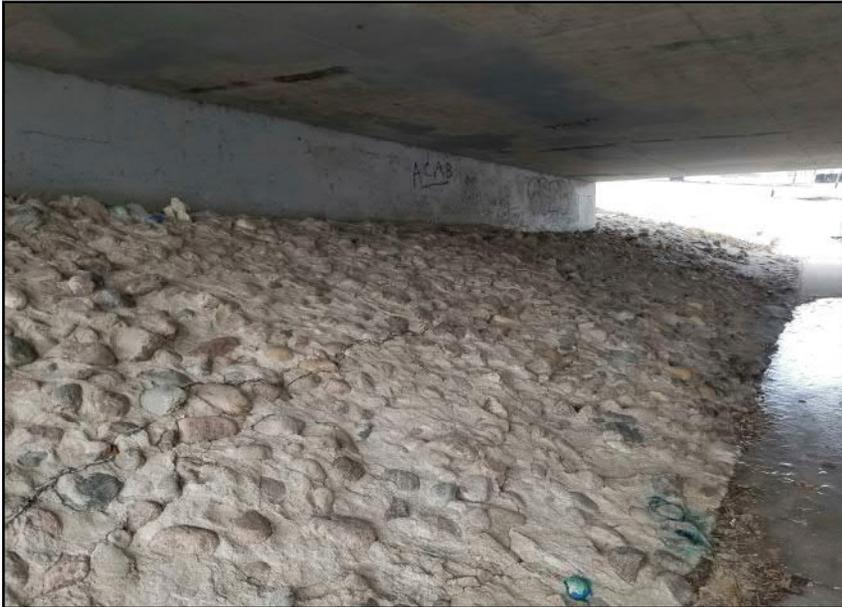
Site 7 - Western Bank Cracks observed within grouted rip-rap armorment at various orientations

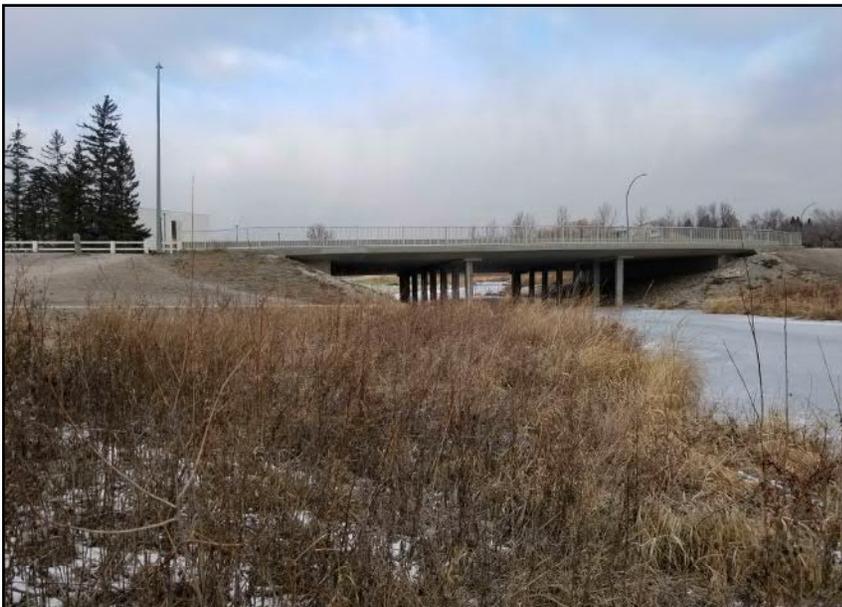
Site 7 - Western Bank Exposed grouted rip-rap and brush vegetation east of pathway near crossing alignment (facing S)

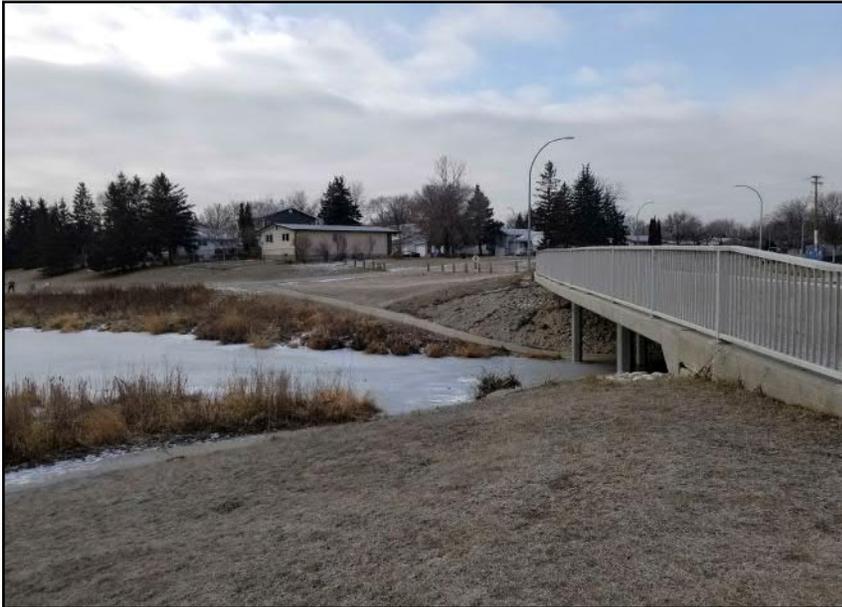
Site 7 - Eastern Bank | View from the east bank facing the west bank along the approximate crossing alignment (facing W)

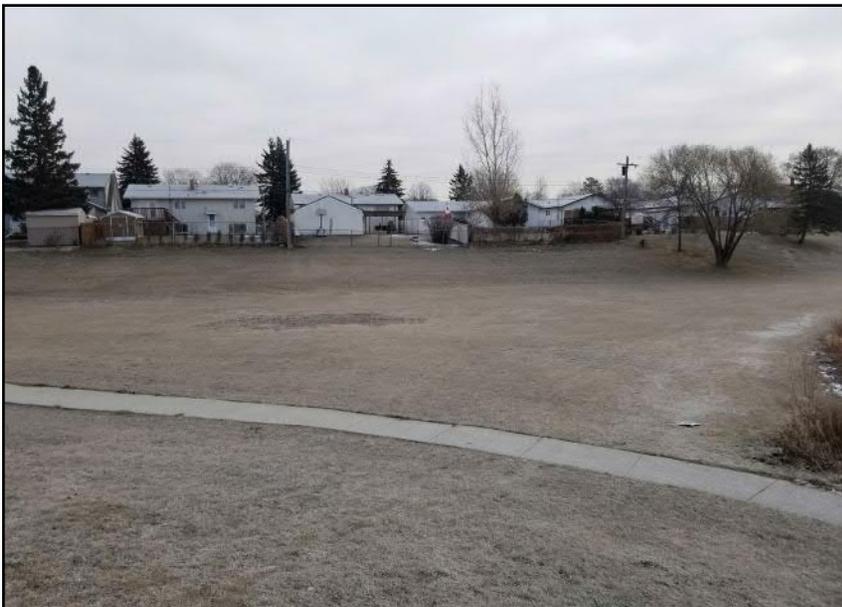
Site 7 - Eastern Bank | Near flat slopes and manicured grass within southern portion of study area (facing SE)

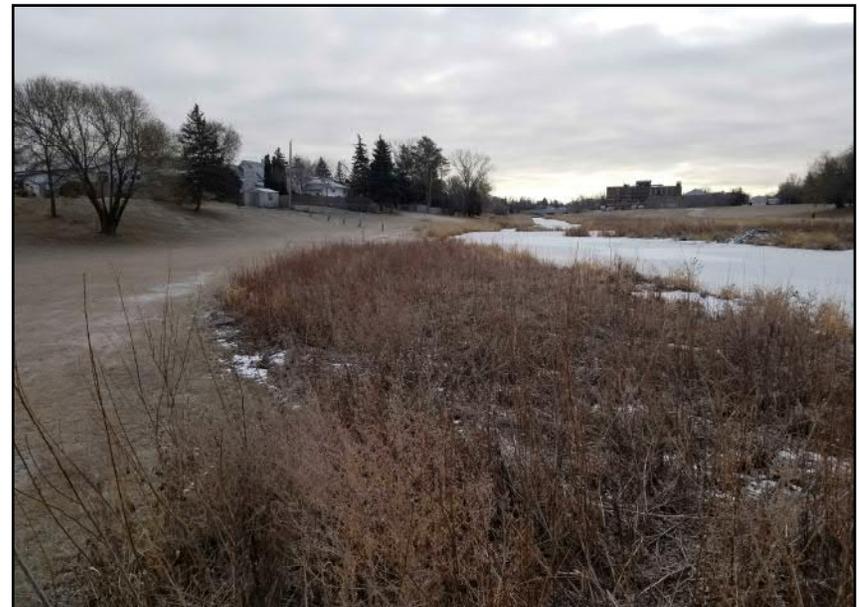
Site 7 - Eastern Bank | Brush and shrubs near bank edge within southern portion of study area (facing S)

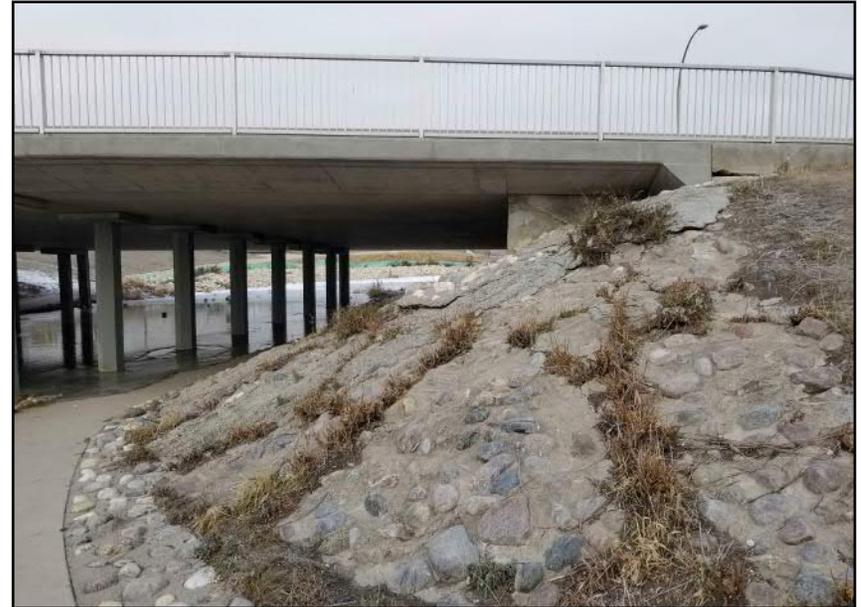
Site 7 - Eastern Bank Grouted rip-rap armouring along steeper banks in close proximity to bridge abutment (facing N)

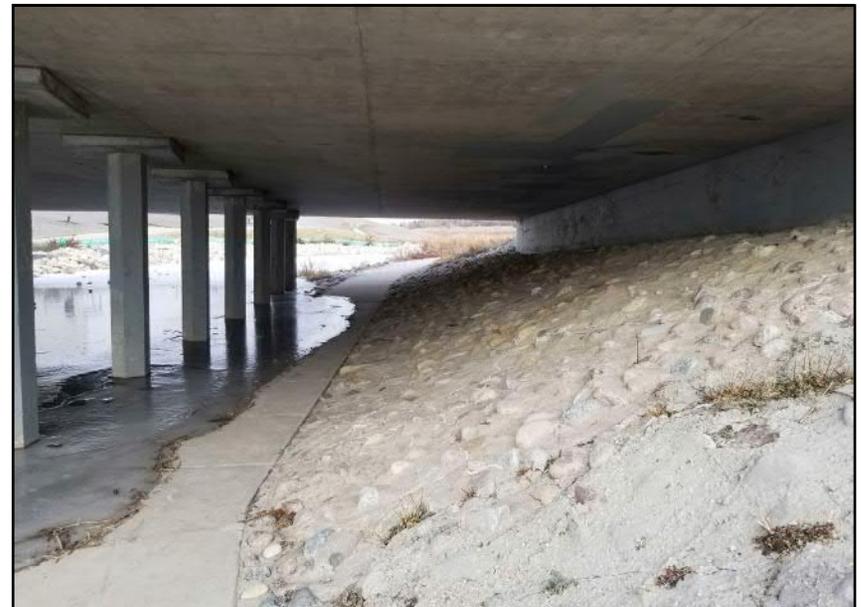
Site 7 - Eastern Bank Grouted rip-rap along abutment head slope below bridge structure (facing N)

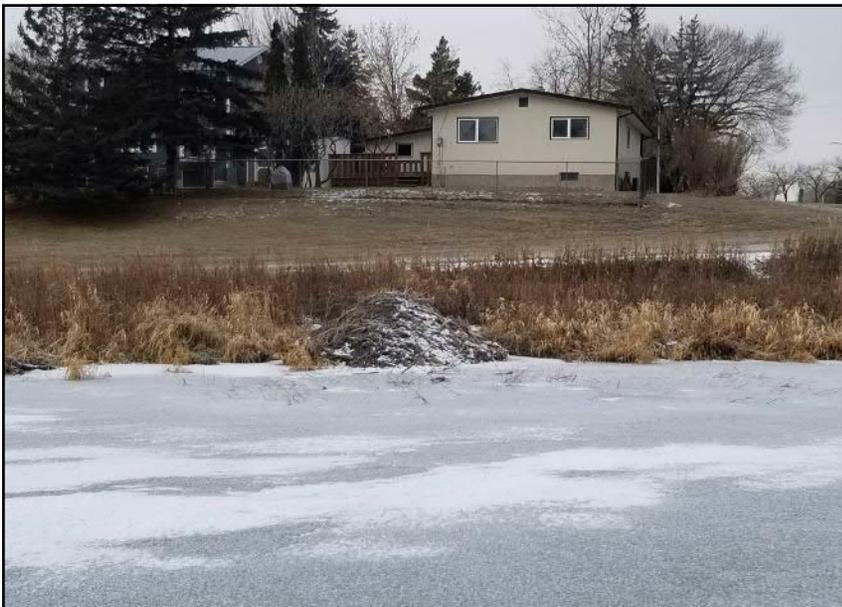
Site 7 - Eastern Bank	Beaver den observed across the creek near the bank edge (facing W)
------------------------------	--

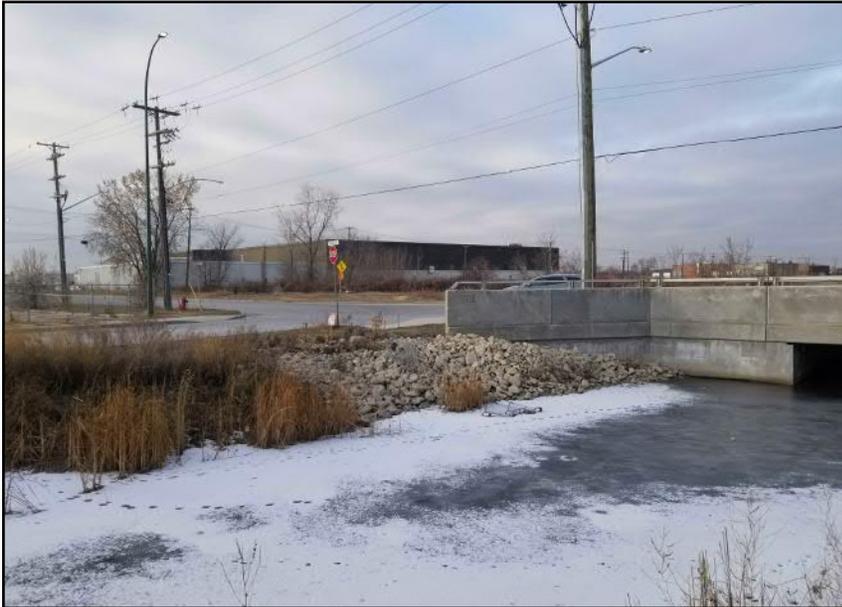
Site 8 - Western Bank View of western riverbank from eastern riverbank within study area (facing NW)

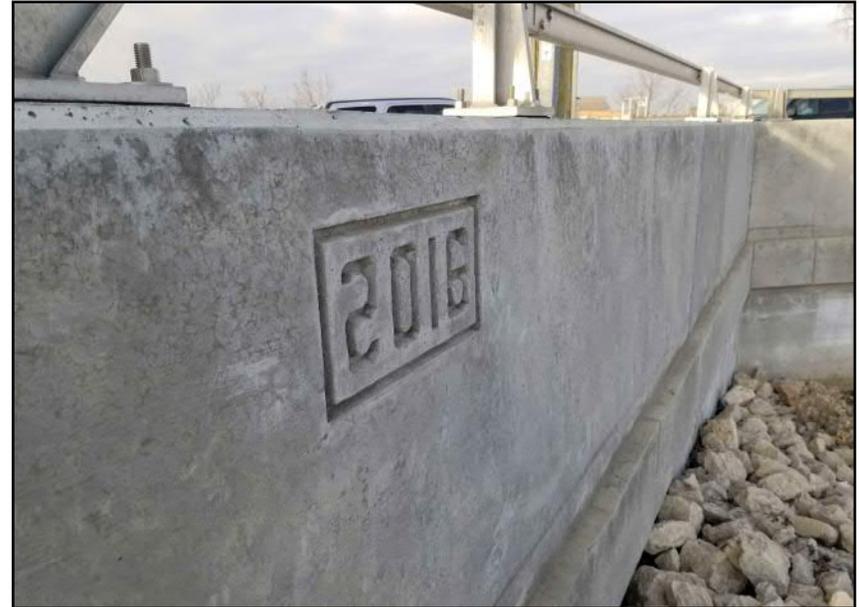
Site 8 - Western Bank Date of construction cast into Saskatchewan Ave. bridge wingwall (facing N)

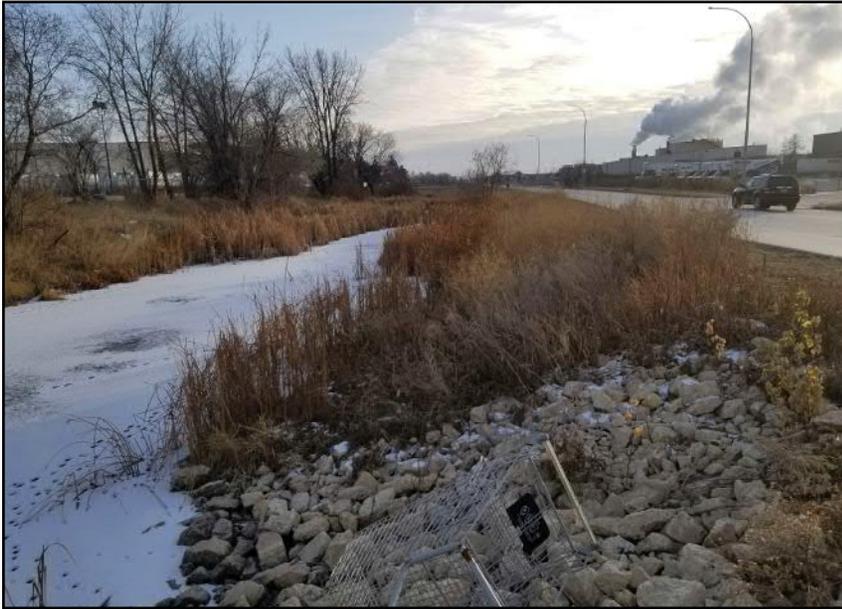
Site 8 - Western Bank	Gradual bank slopes and dense brush and shrub coverage observed south of rip-rap (facing S)
------------------------------	---

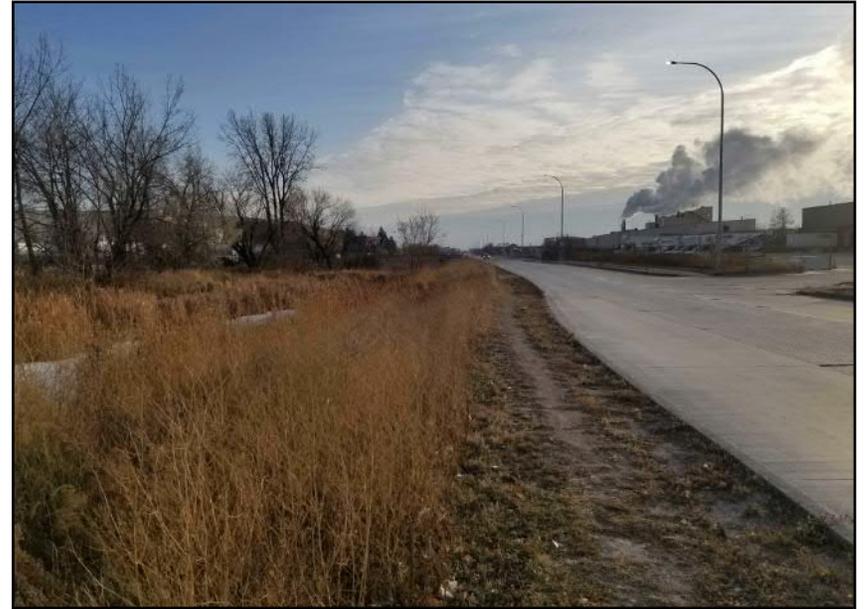
Site 8 - Western Bank	Partially grasses bank crest between Empress St. and the bank slope (facing S)
------------------------------	--

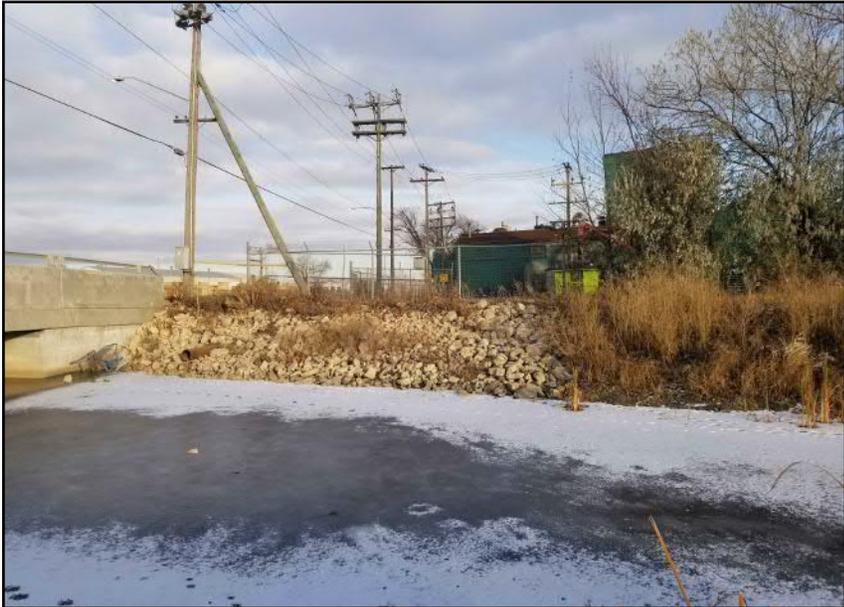
Site 8 - Eastern Bank | View of eastern riverbank from western riverbank within study area (facing NE)
