Replacement of the FGSV Siphon

Geotechnical Data Report
FINAL – Rev. 1

City of Winnipeg

April 2025

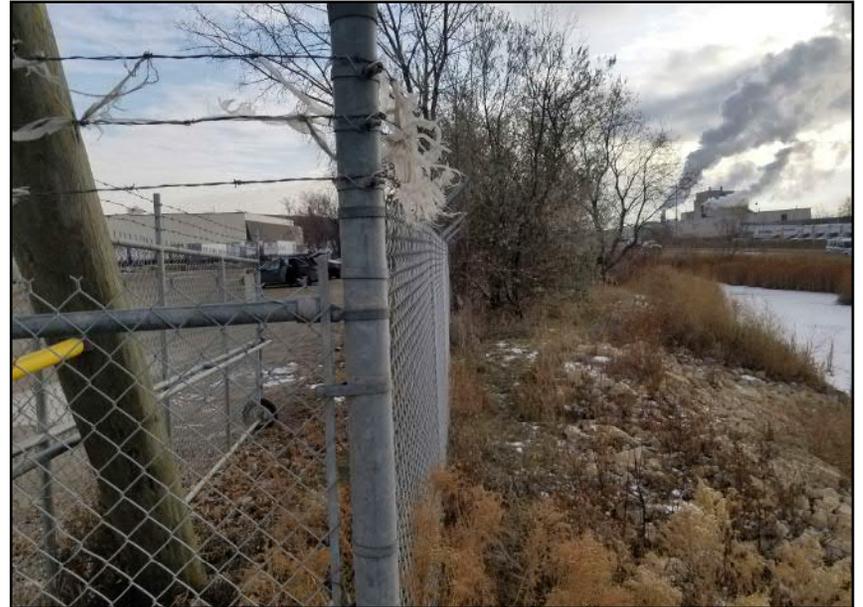
Site 8 - Eastern Bank | Approximately vertical fenceline along adjacent private property east of crossing (facing S)

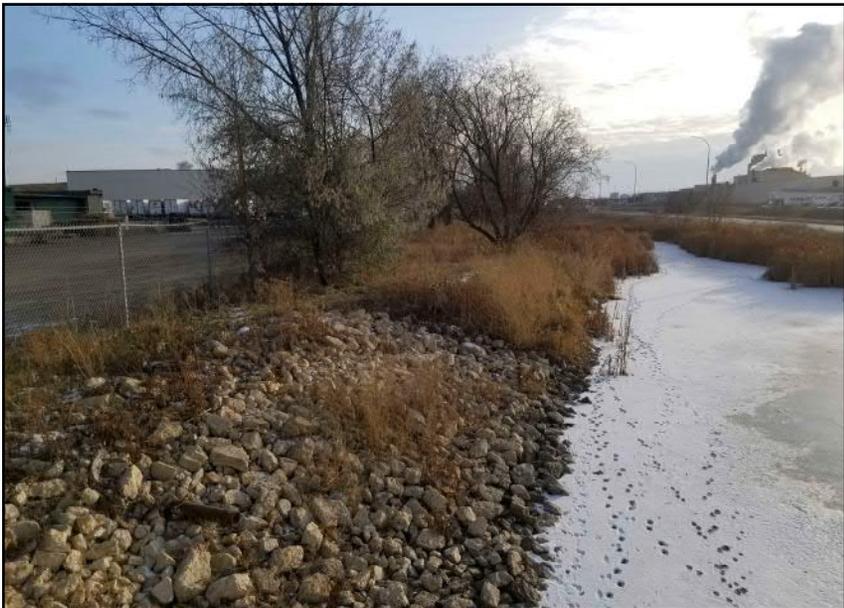
Site 8 - Eastern Bank | Regraded and rip-rap armored slope within crossing alignment (facing S)

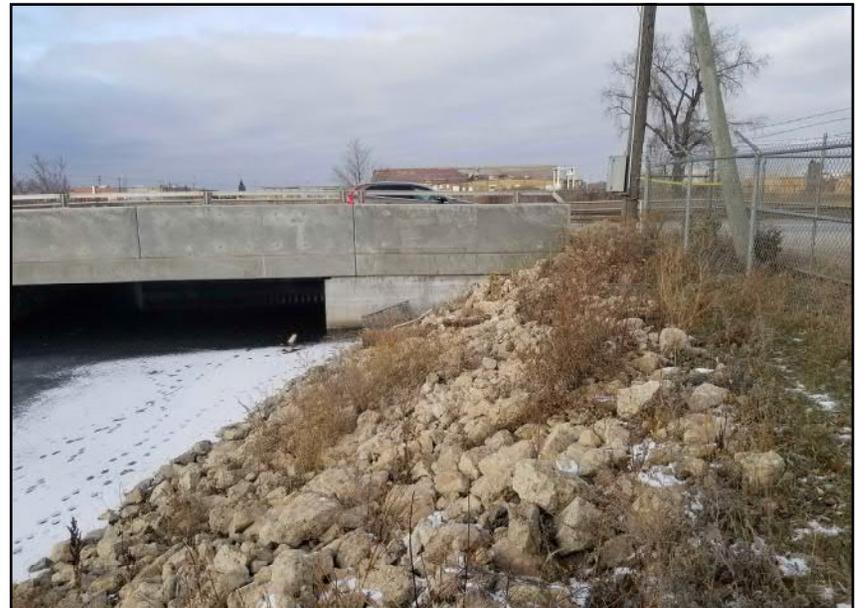
Site 8 - Eastern Bank | Regraded and rip-rap armored slope near bridge structure (facing N)

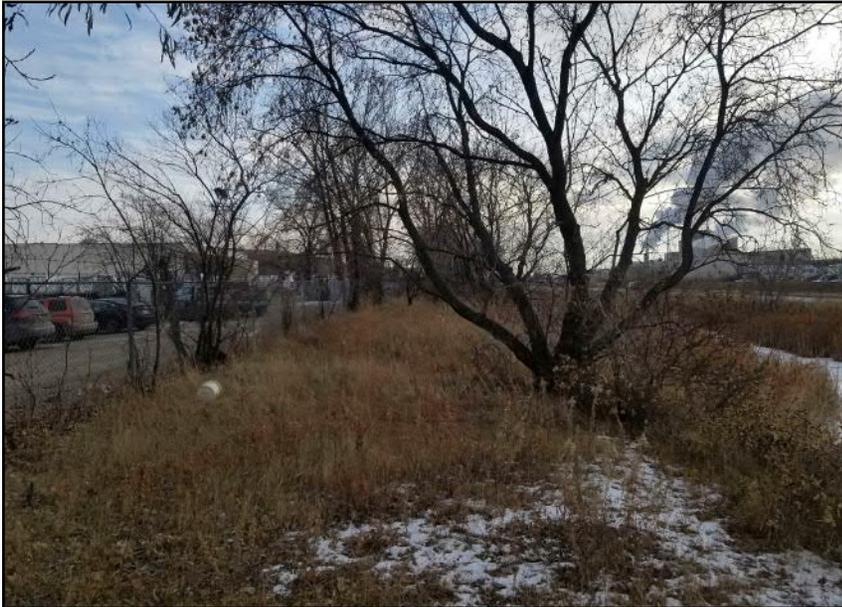
Site 8 - Eastern Bank	Brush and trees along riverbank crest within southern portion of study area (facing S)
------------------------------	--

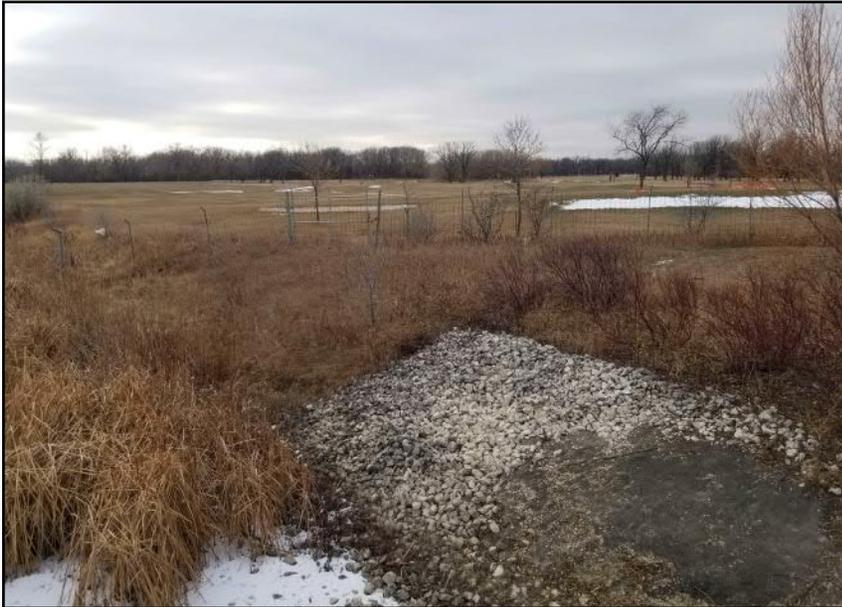
Site 9 - Western Bank	View of western riverbank from pedestrian bridge north of study area (facing W)
------------------------------	---

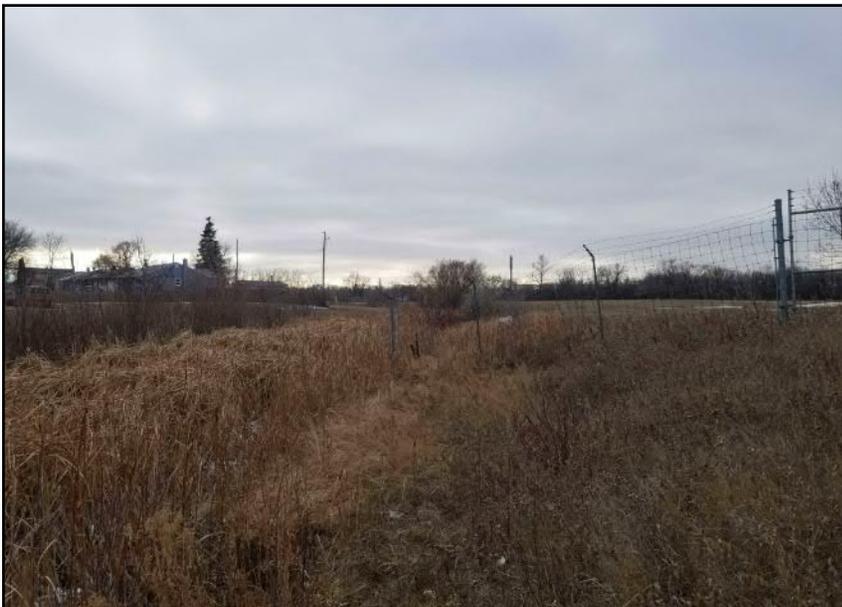
Site 9 - Western Bank	Gradual slopes down from bank crest to toe, heavily damaged fence (facing SW)
------------------------------	---

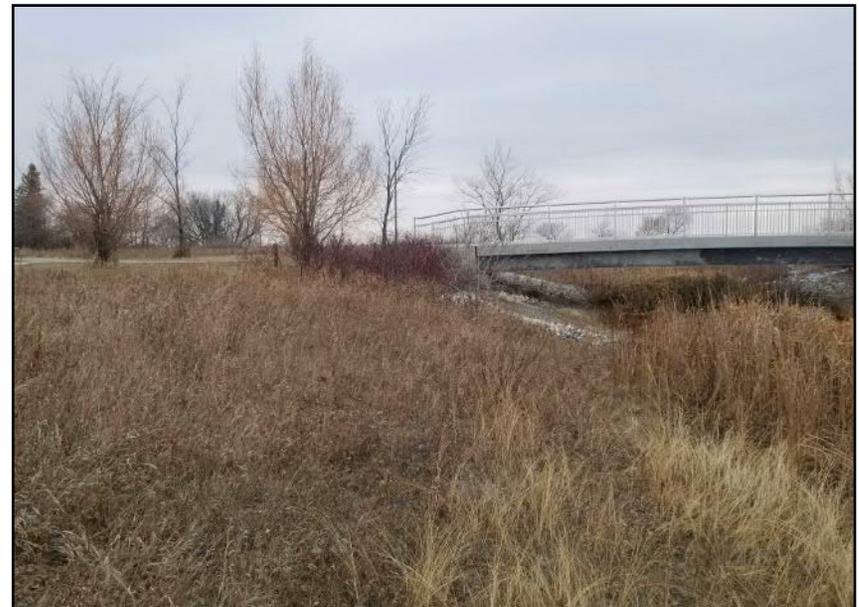
Site 9 - Western Bank	Moderate to dense brush vegetation along bank slope, groundwater well near bridge (facing N)
------------------------------	--

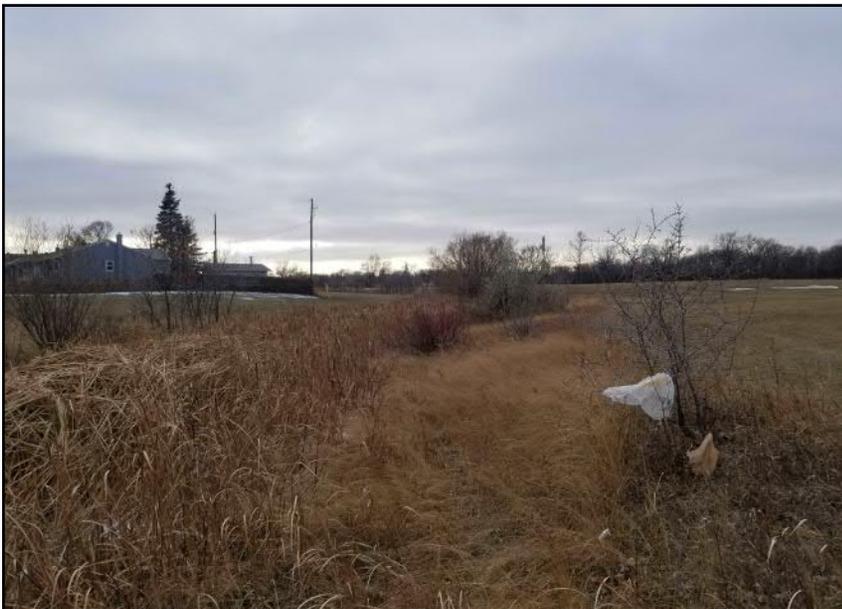
Site 9 - Western Bank	Relatively flat bank crest (Assiniboine Golf Course) becoming steeper towards creek (facing SW)
------------------------------	---

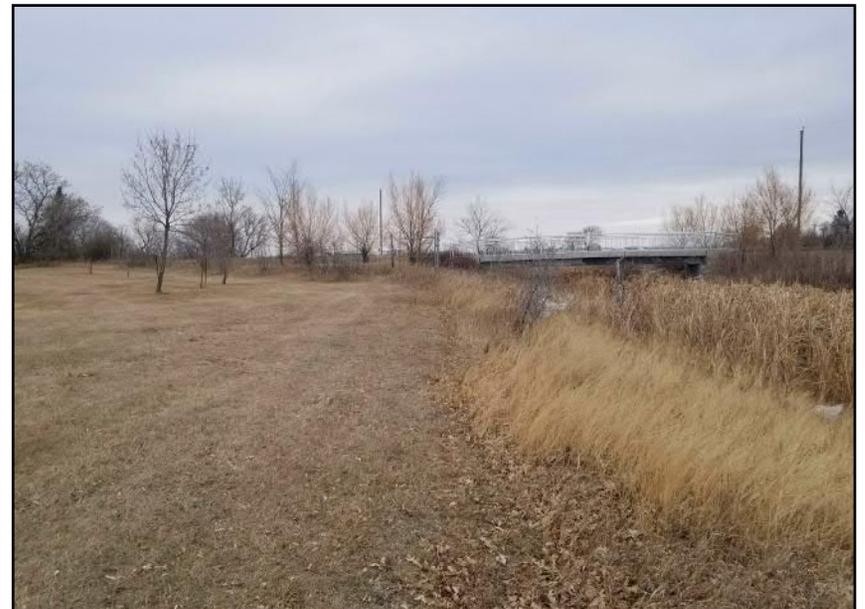
Site 9 - Western Bank	Relatively flat bank crest with manicured grass (Assiniboine Golf Course (facing N))
------------------------------	--

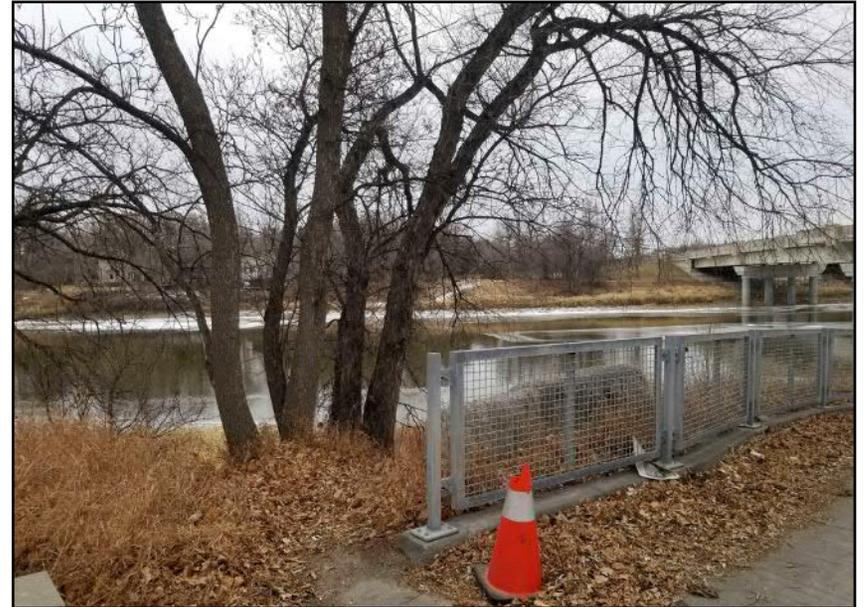
Site 10 - Northern Riverbank | Bank slope located near edge of pedestrian pathway within study area (facing S)
