### DETAILED BRIDGE CONDITION SURVEY

## Pembina Highway Bridge Over Abinojii Mikanah (Bishop Grandin)

(Site No. B-215)

November 22, 2024

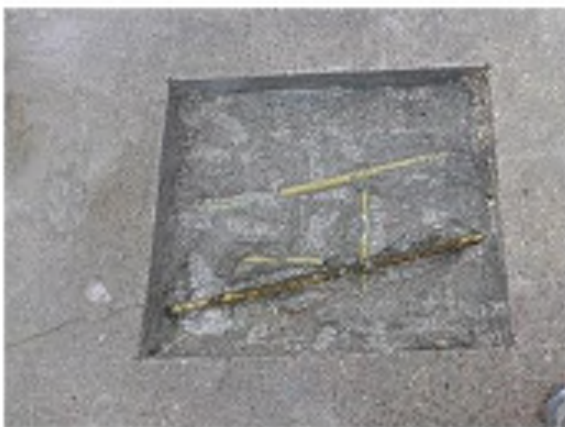
6. Light rebar corrosion noted during coring showed generally that corrosion may be beginning based on the measured chloride content test results and rebar condition in the extracted cores. The test pit photos from the 2017 assessment below cracked locations indicate that rebar corrosion may be occurring at deck crack locations. It is anticipated that epoxy coating failure and rebar corrosion are occurring at deck cracking locations, which are prevalent throughout the deck, based on the measured chloride contents and observations from the condition assessment.

**Photo 2.4 – Test Patch at Wide Crack with Failed Epoxy Coating and Corroded Reinforcing Directly Below Crack**

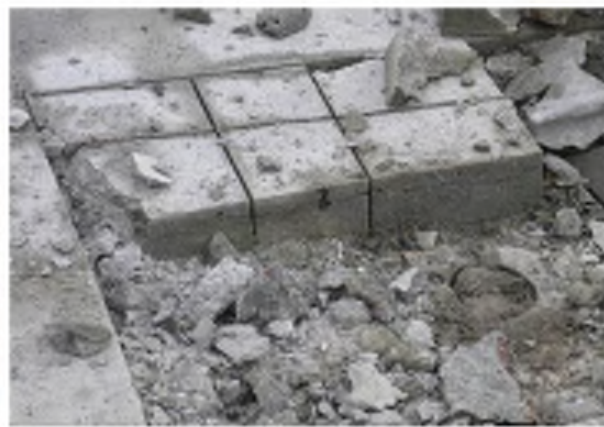
**Photo 2.5 – Test Patch with Shallow Delamination**

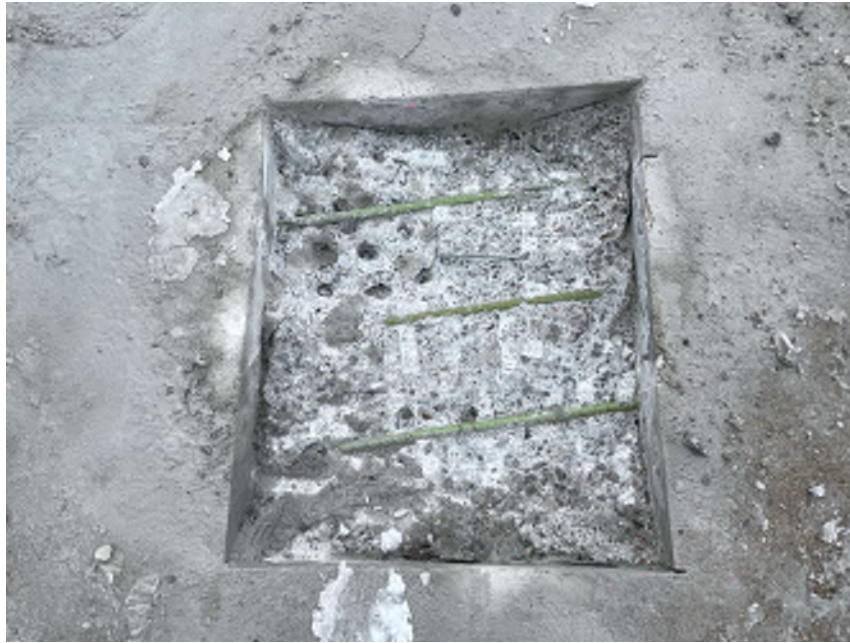
**Photo 3 - Median Test Pit 1 - median slab rebar exposed, good condition**

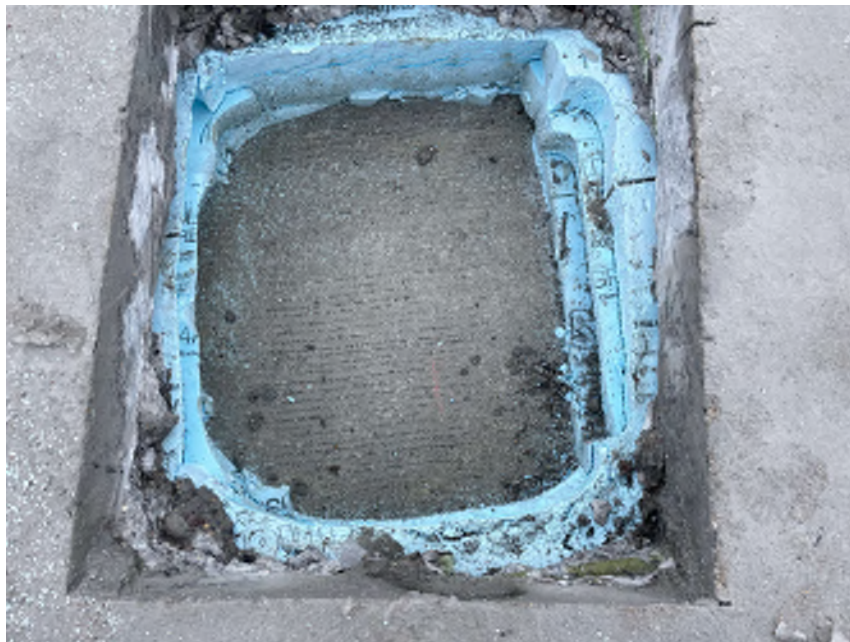
**Photo 4 - Median Test Pit 1 - median slab concrete and styrofoam removed, concrete noted to be dry and in good condition**

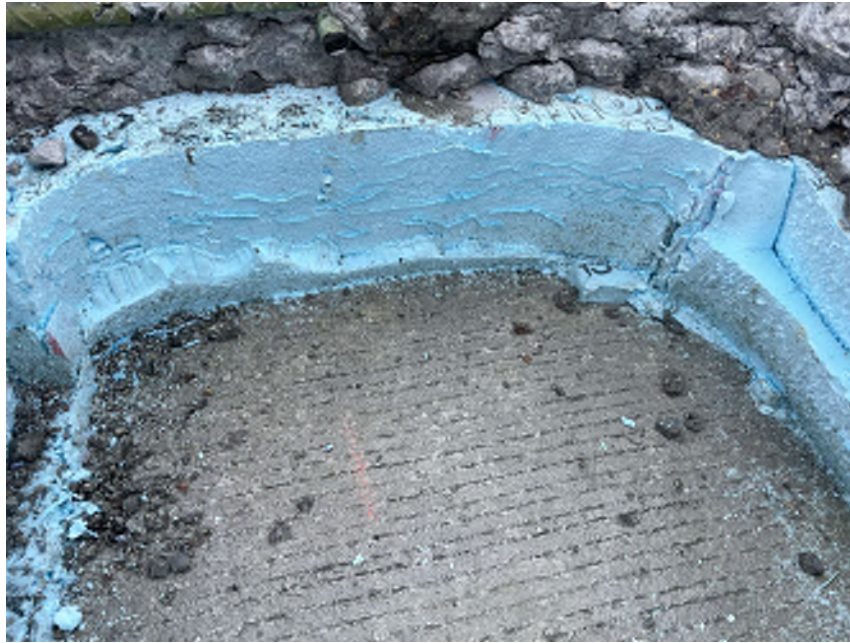
**Photo 5 - Median Test Pit 1 - median slab concrete and styrofoam removed, concrete noted to be dry and in good condition, closer view**

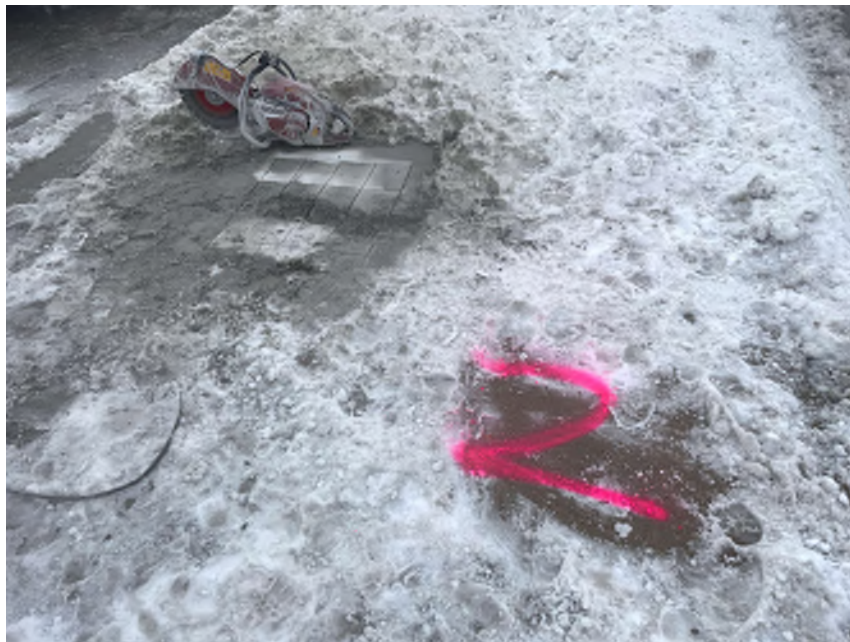
**Photo 6 - Median Test Pit 2 - at start of removals, note deterioration at joint location**

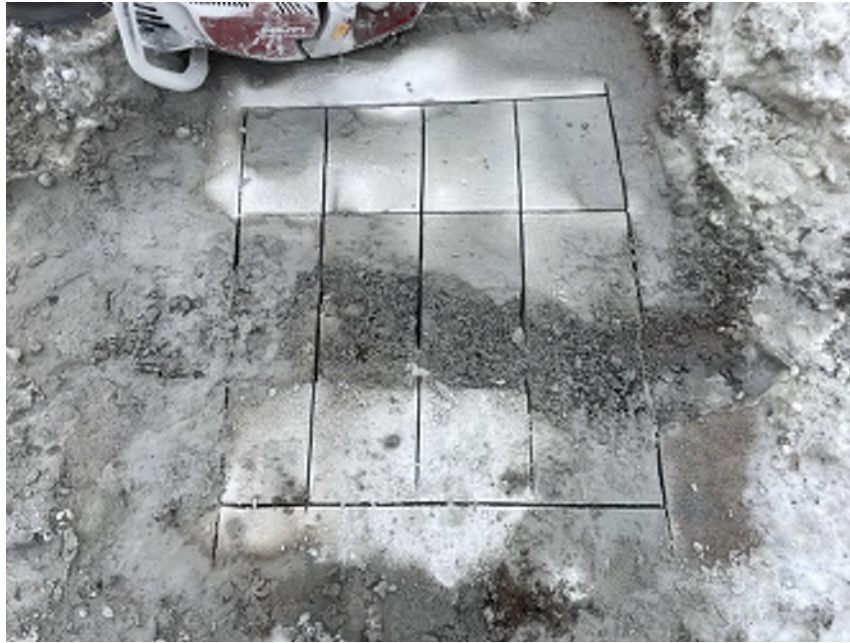
**Photo 7 - Median Test Pit 2 - at start of removals, note deterioration at joint location, closer view**

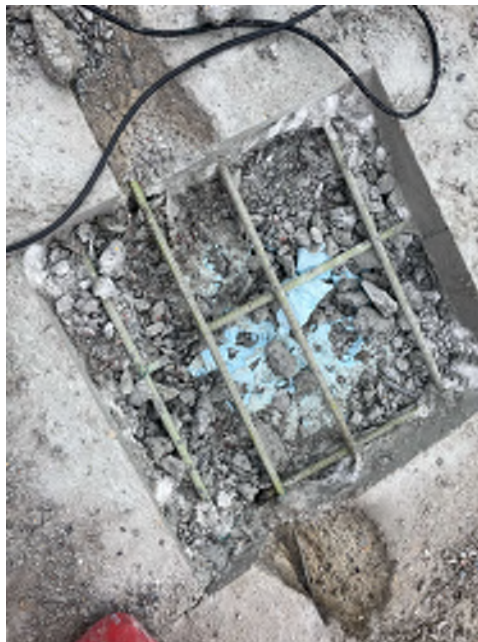
**Photo 8 - Median Test Pit 2 - median slab concrete removed, styrofoam partially exposed, longitudinal bar under transverse joint corroded through**

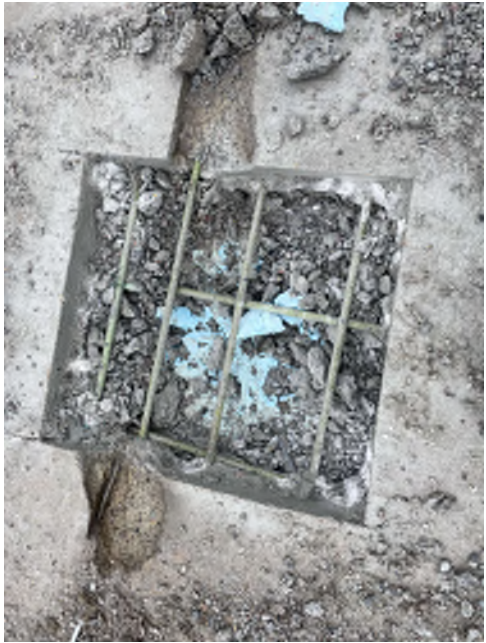
**Photo 9 - Median Test Pit 2 - median slab concrete removed, styrofoam partially exposed, longitudinal bar under transverse joint corroded through additional view**

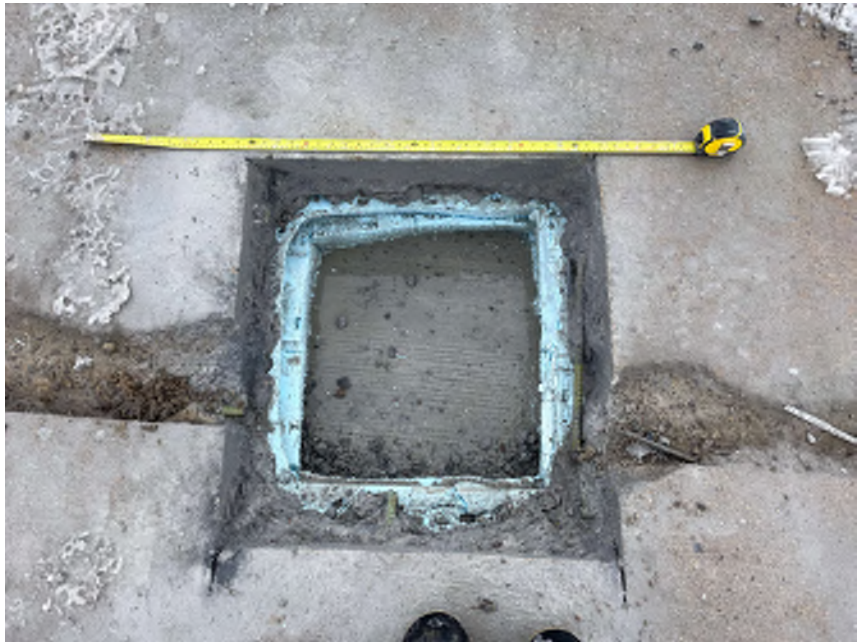
**Photo 10 - Median Test Pit 2 - median slab concrete and styrofoam removed, concrete noted to be slightly wet and in good condition**

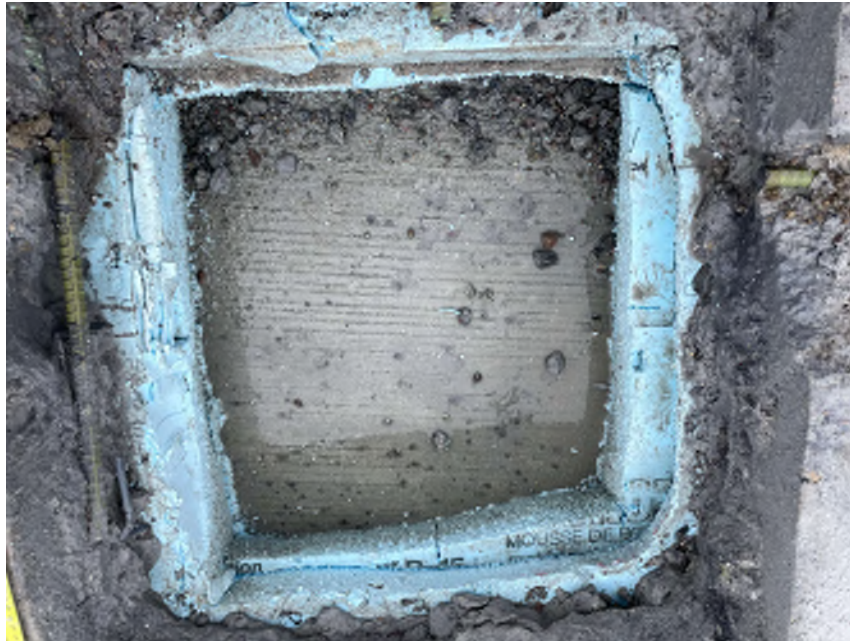
**Photo 11 - Median Test Pit 2 - median slab concrete and styrofoam removed, concrete noted to be slightly wet and in good condition, closer view**

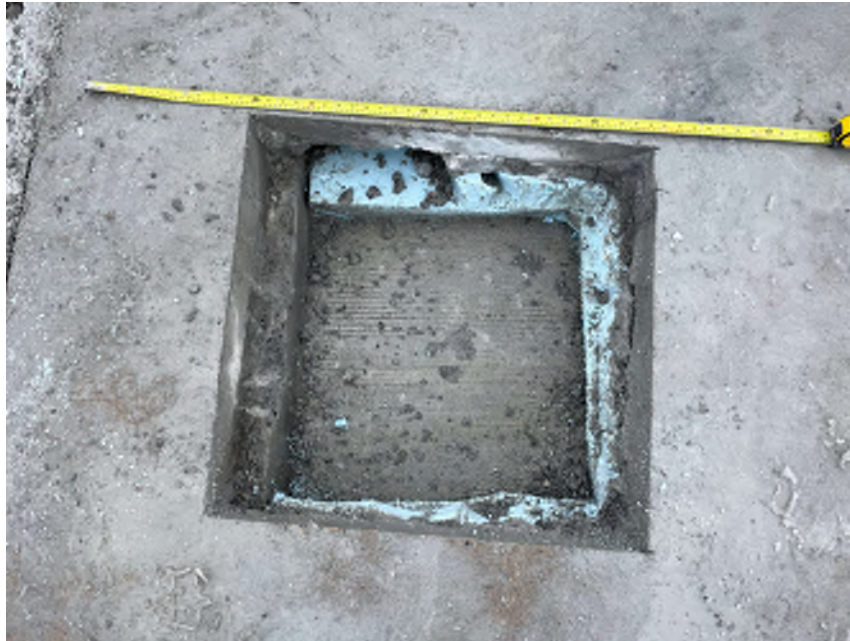
**Photo 15 - Median Test Pit 3 - median slab concrete and styrofoam removed, concrete noted to be dry and in good condition, light flaking surface chipping occurred during s**

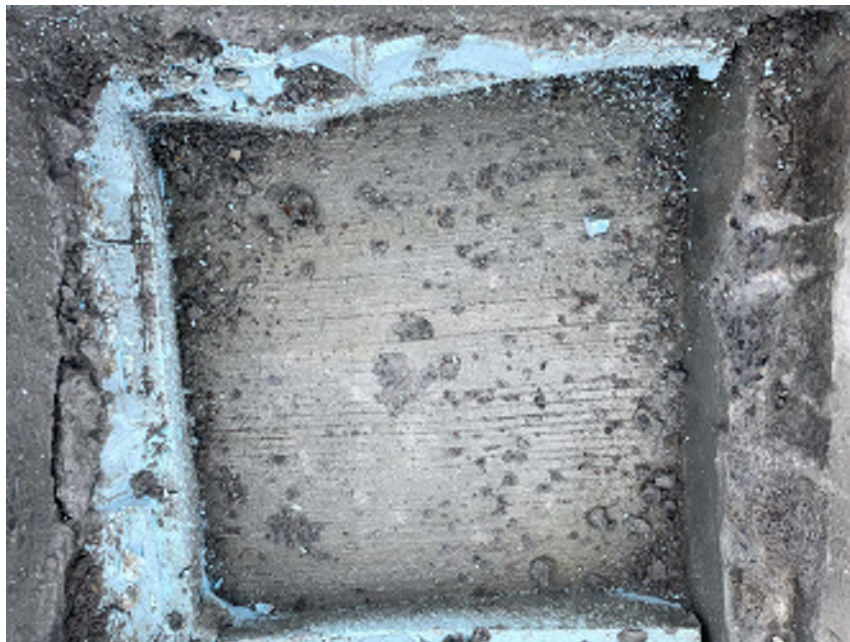
**Photo 16 - Median Test Pit 3 - median slab concrete and styrofoam removed, concrete noted to be dry and in good condition, light flaking surface chipping occurred during s**

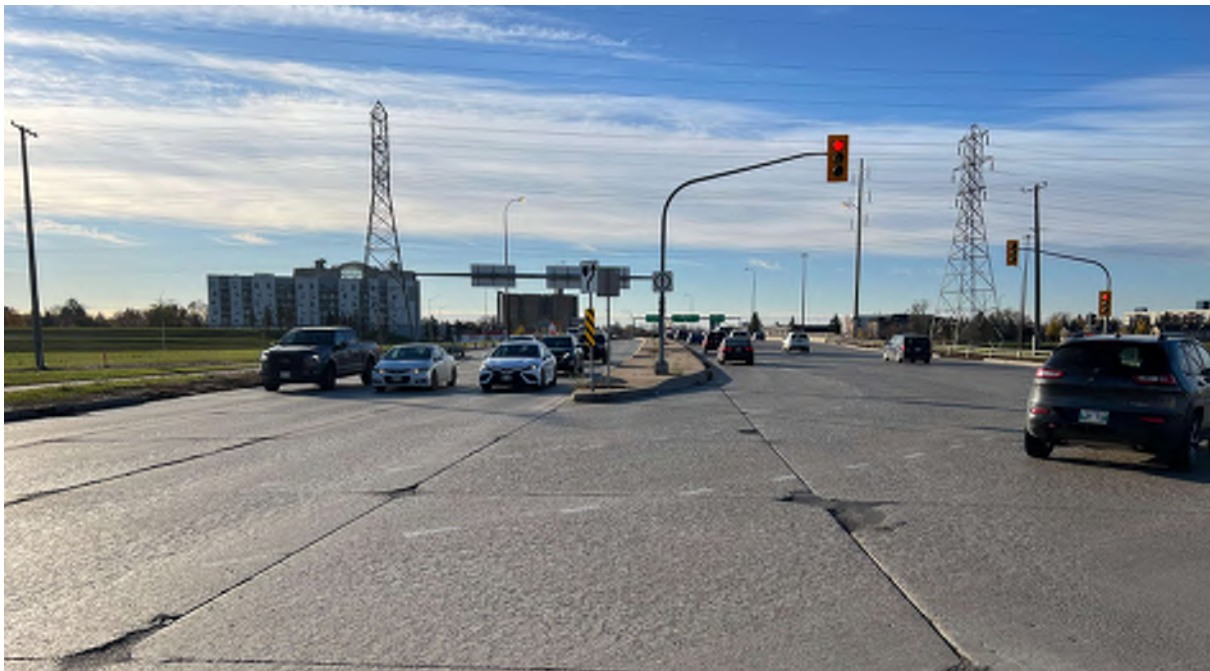
**Photo 6 - Roadway looking South**

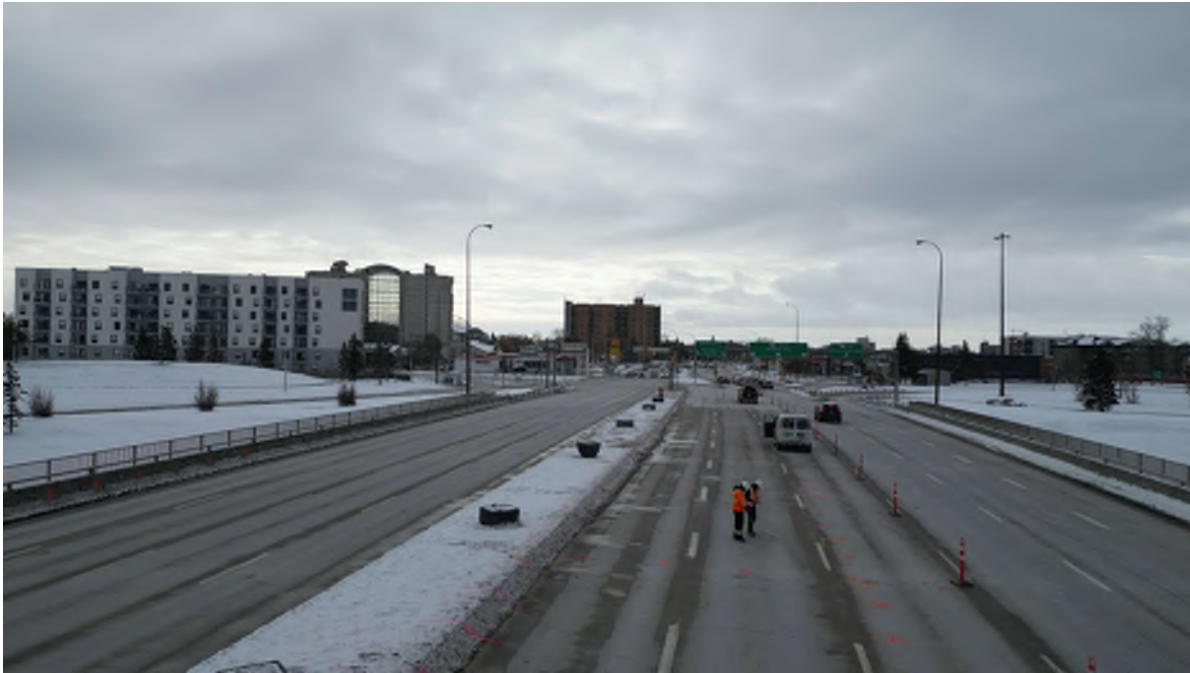
**Photo 7 - Bridge deck top looking South**

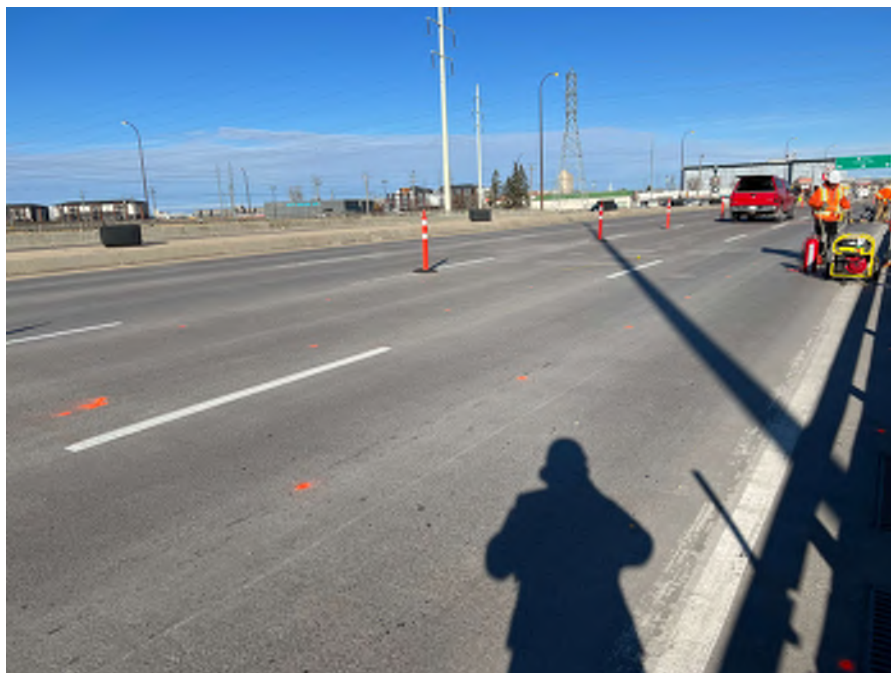
**Photo 8 - Bridge deck top looking North**

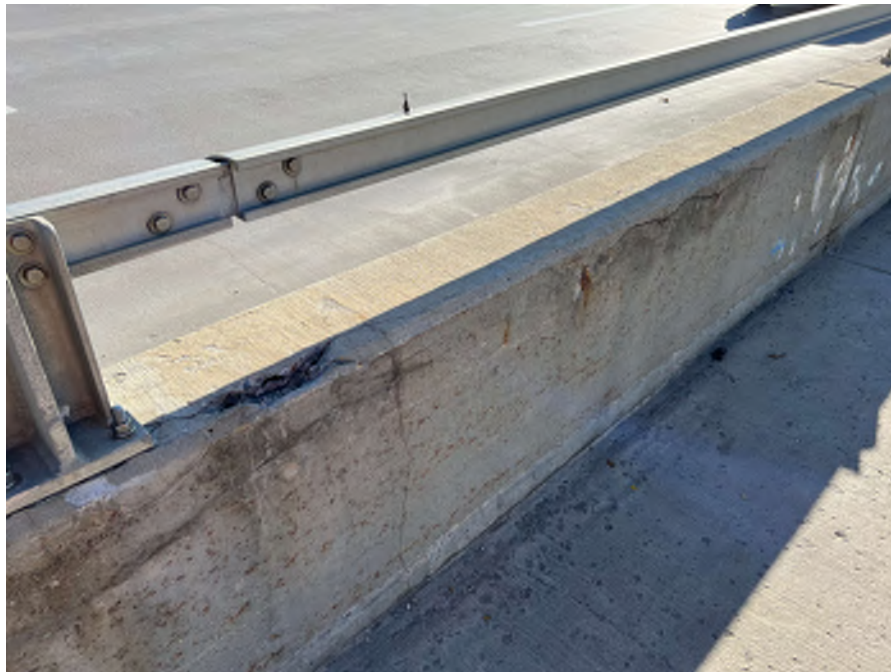
**Photo 9 - Typical traffic barrier - exterior face and traffic barrier rail**

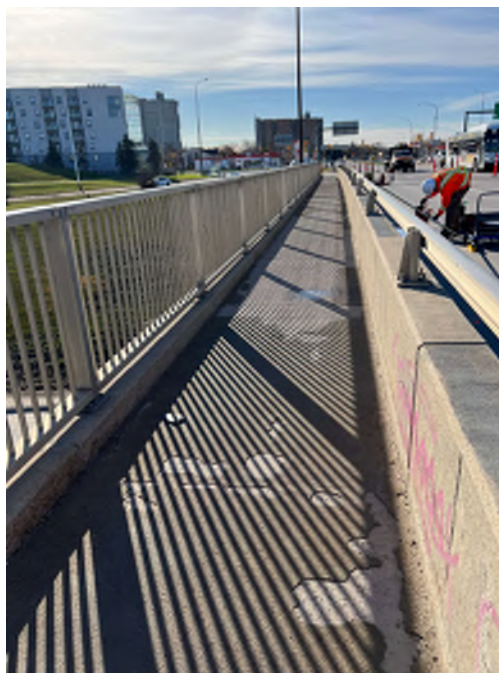
<b>Element Group:</b>	Sidewalks / Curbs					<b>Length:</b>	89.46
<b>Element Name:</b>	Sidewalks					<b>Width:</b>	1.53
<b>Location:</b>	East and West of Bridge					<b>Height:</b>	0.00
<b>Description:</b>	Pedestrian Sidewalk					<b>Count:</b>	2
<b>Material:</b>	Cast-in-Place Concrete					<b>Total Quantity:</b>	272.85
<b>Element type:</b>	Reinforced Concrete					<b>Limited Inspection:</b>	No
<b>Environment:</b>	Moderate					<b>Perform. Deficiencies</b>	<b>Maint. Needs</b>
<b>Condition Data:</b>	<b>Units</b>	<b>Exc.</b>	<b>Good</b>	<b>Fair</b>	<b>Poor</b>	None	None
	Sq.m.	0.0	272.6	0.2	0.2		
<b>Comments:</b> - Epoxy polymer surface is spalling off of ~50% of East and West sidewalks with light surface scaling on some of the exposed areas. - Hairline to medium transverse cracks noted on some exposed areas. - Pot hole / severe concrete spalling on East sidewalk (0.15 sq.m. rated poor).							
<b>Photo Ref.:</b>	Photo 10	Photo 61	Photo 62

**Photo 10 - Typical sidewalk and pedestrian handrail**

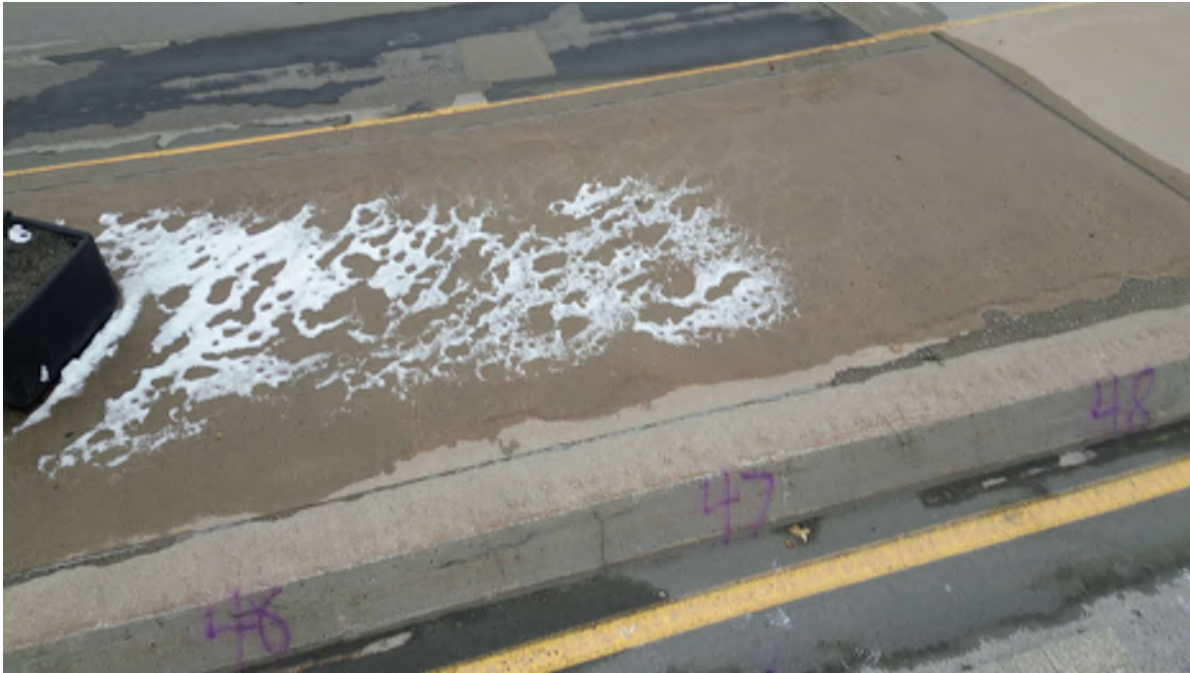
**Photo 11 - Typical center median**

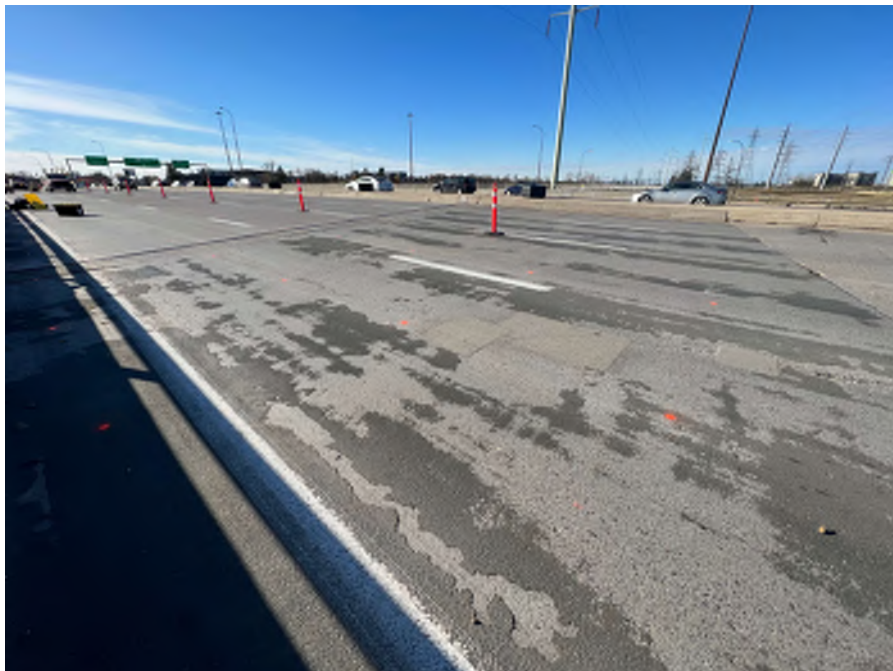
**Photo 12 - North approach slab, NB lanes**

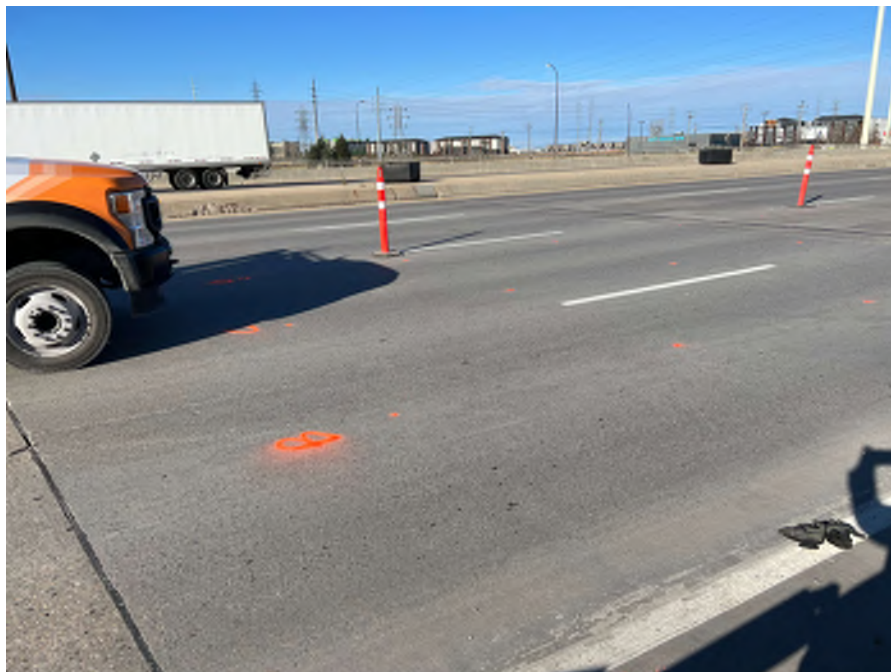
**Photo 13 - South approach slab, NB lanes**

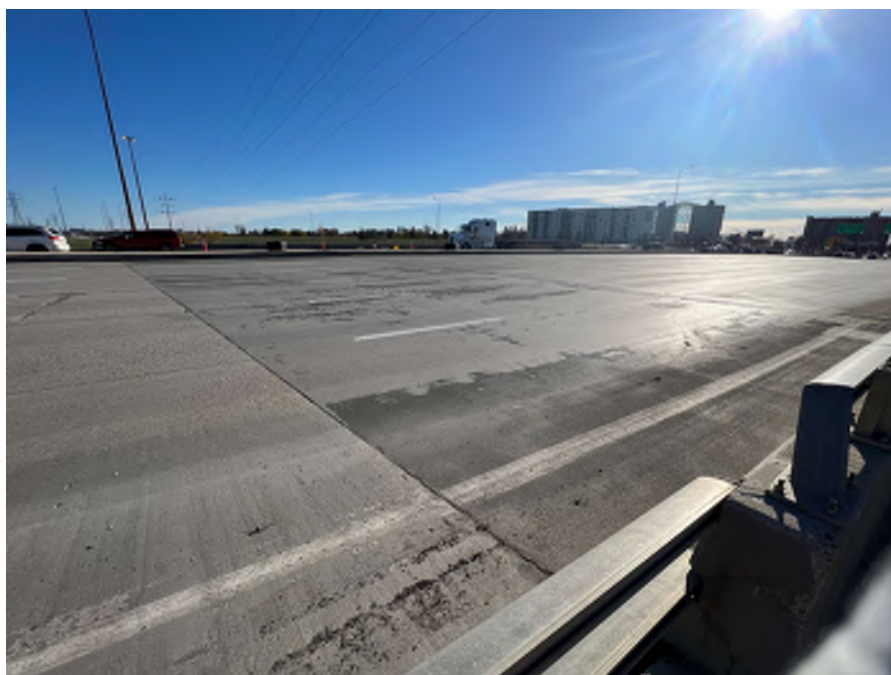
**Photo 14 - North approach slab, SB lanes**

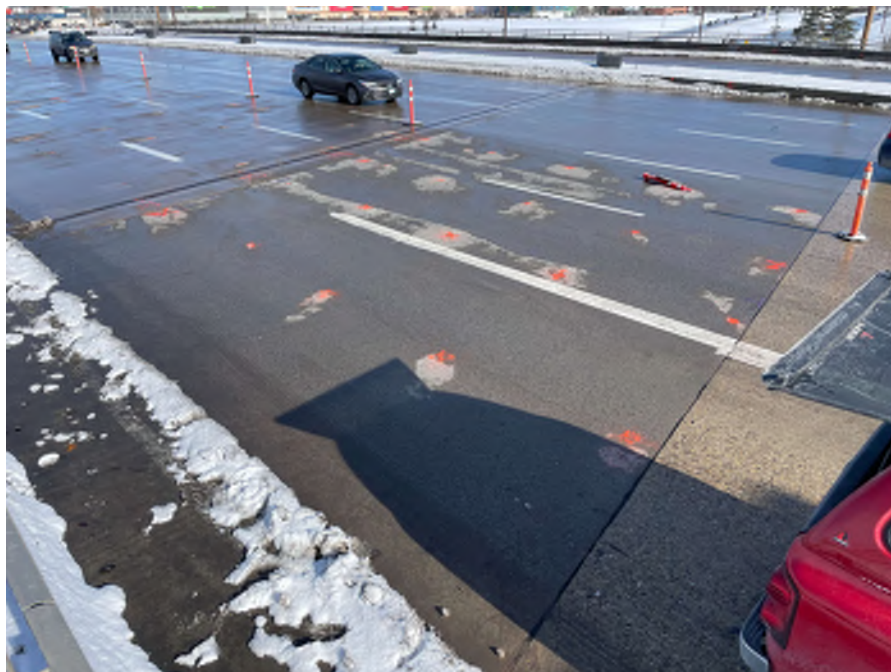
**Photo 15 - South approach slab, SB lanes**

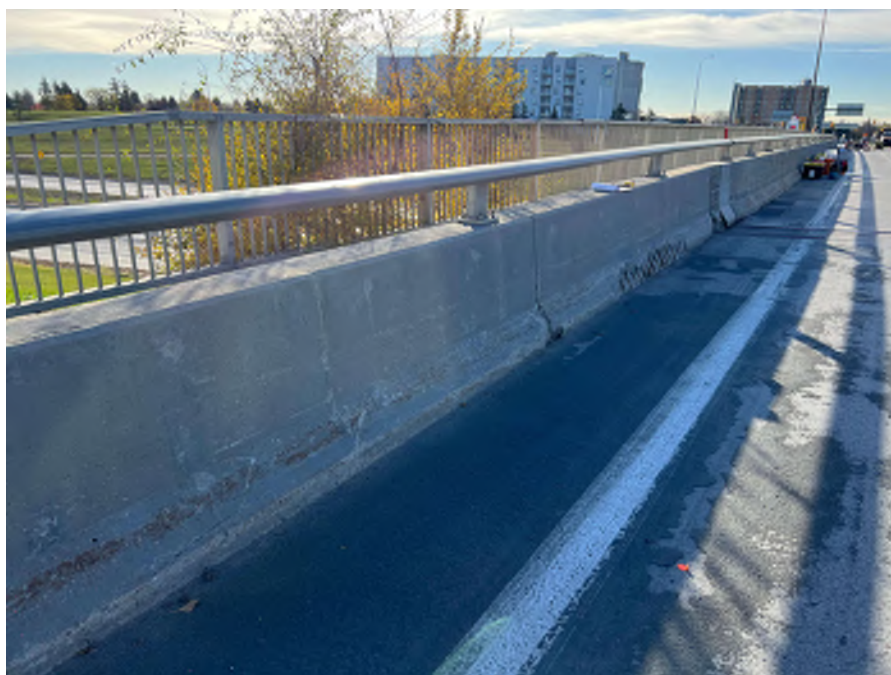
**Photo 16 - Typical approach traffic barrier**

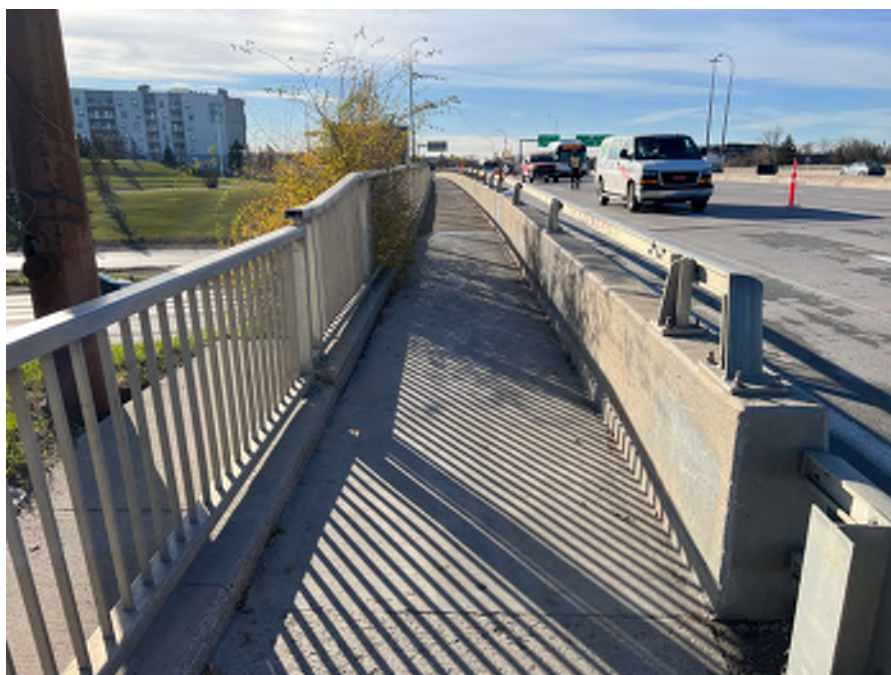
**Photo 17 - Typical approach sidewalk**

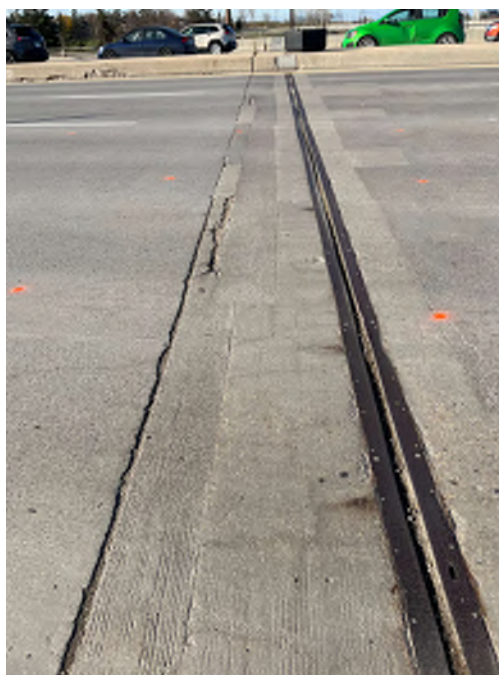
**Photo 18 - SU1 expansion joint**

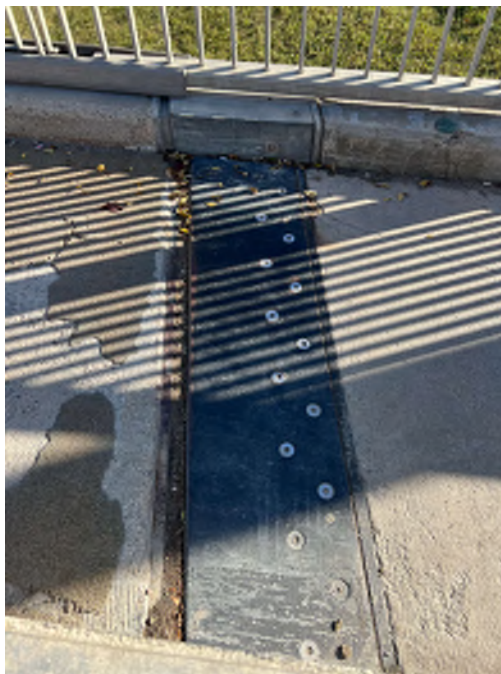
**Photo 19 - SU1 expansion joint over sidewalk**

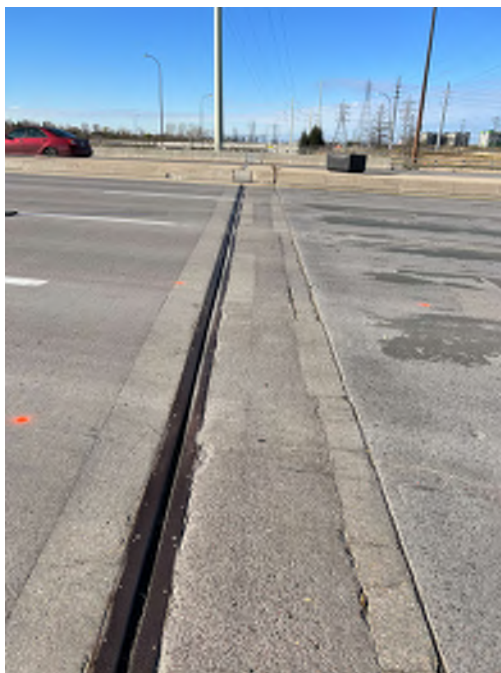
**Photo 20 - SU5 expansion joint**

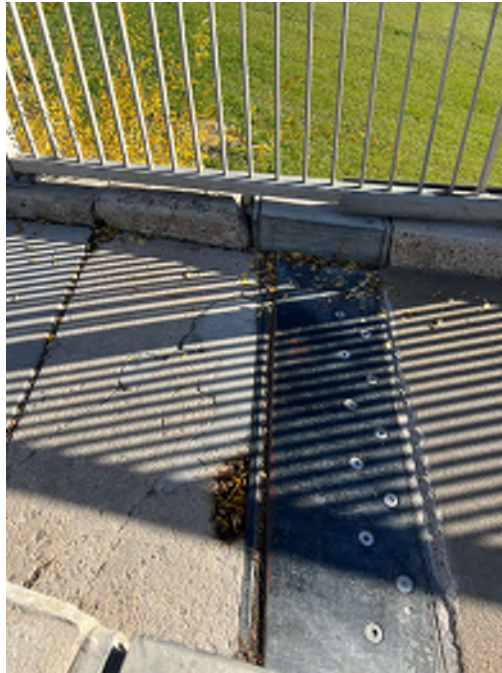
**Photo 21 - SU5 expansion joint over sidewalk**

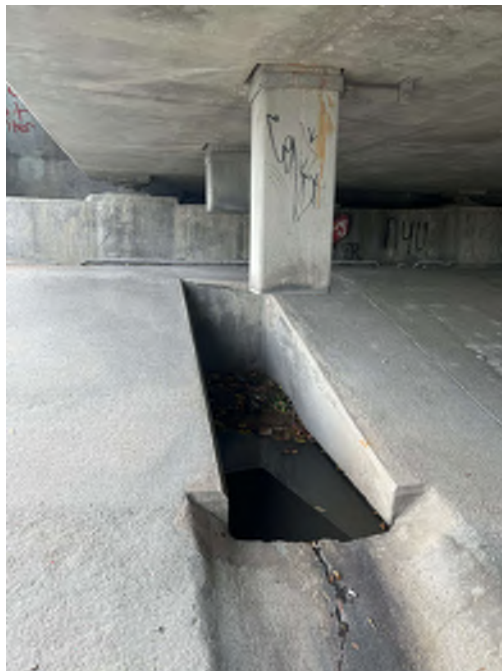
**Photo 22 - Typical drains**

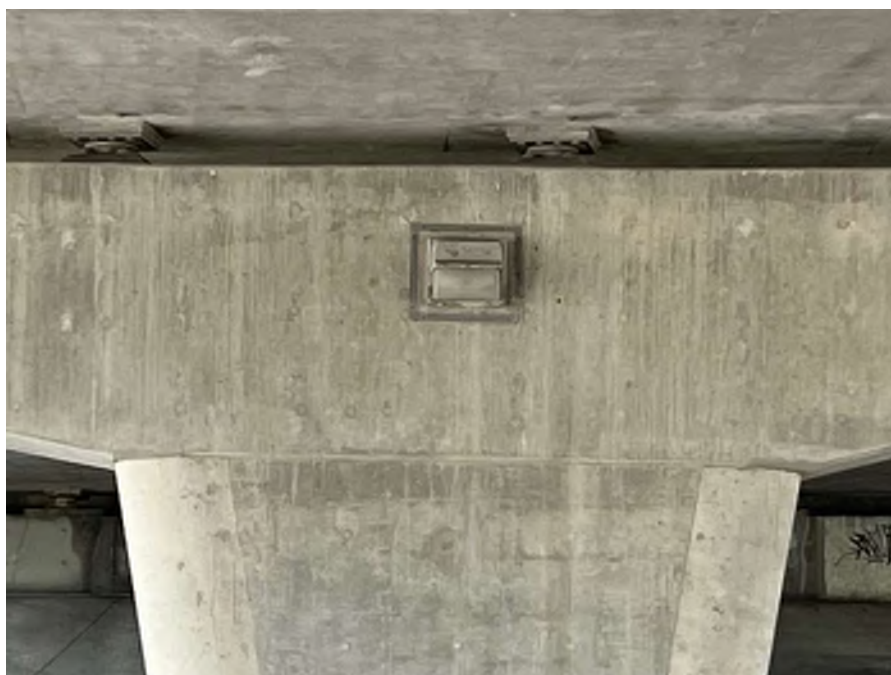
**Photo 23 - Typical pier mounted light**

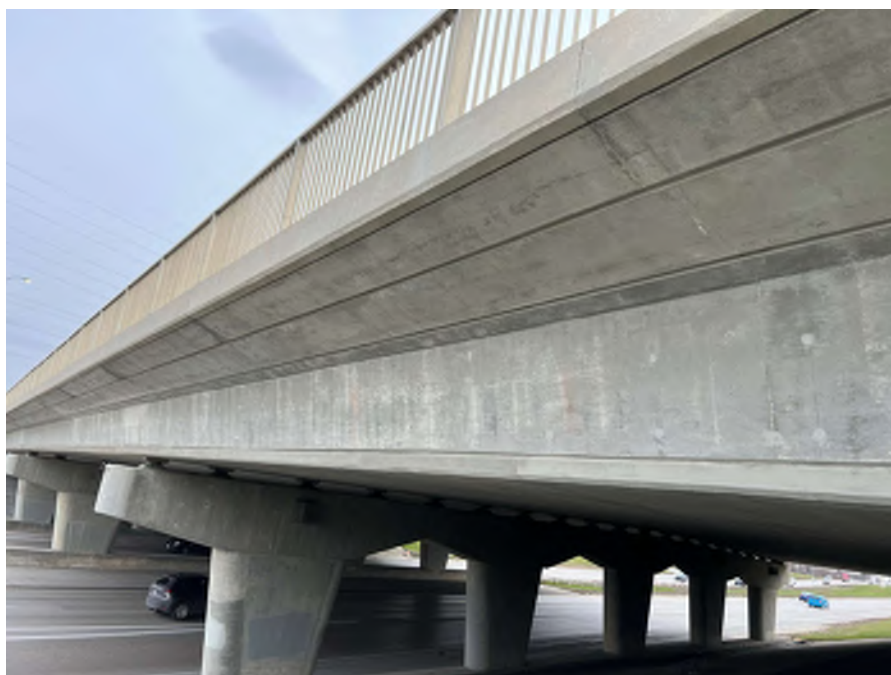
**Photo 24 - West exterior soffit**

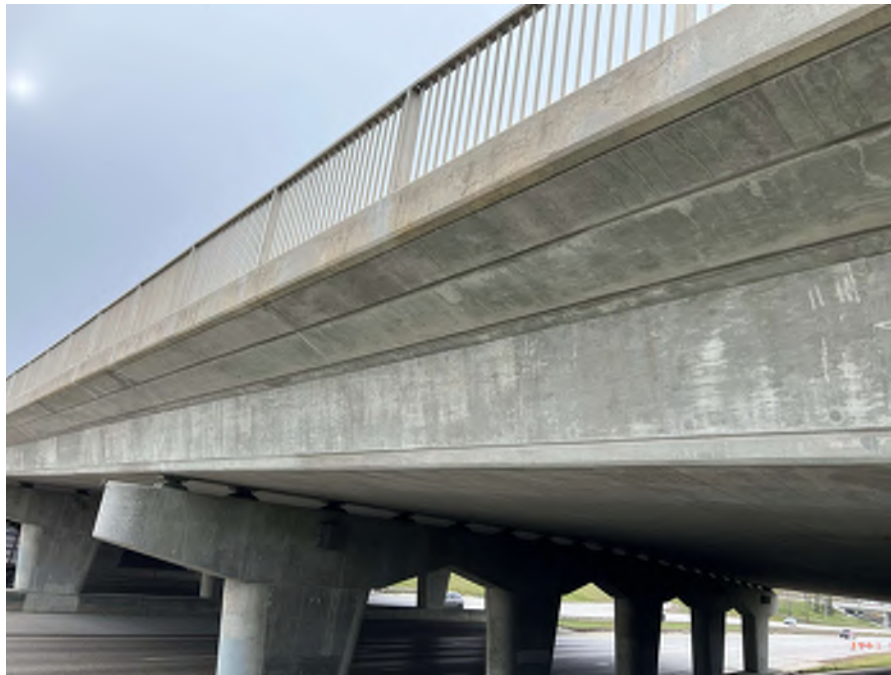
**Photo 25 - East exterior soffit**

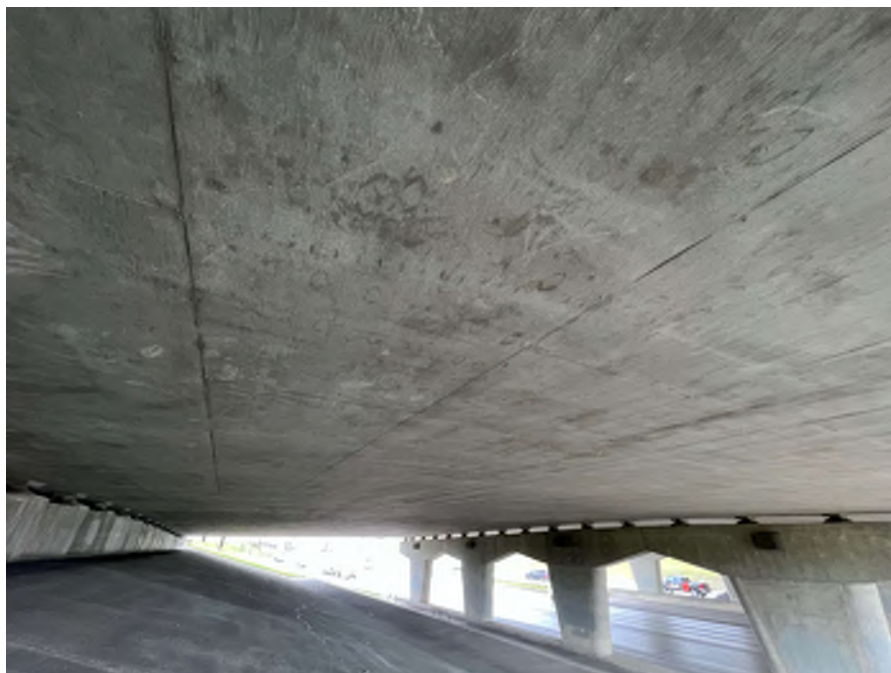
**Photo 26 - Typical Span 1 soffit**

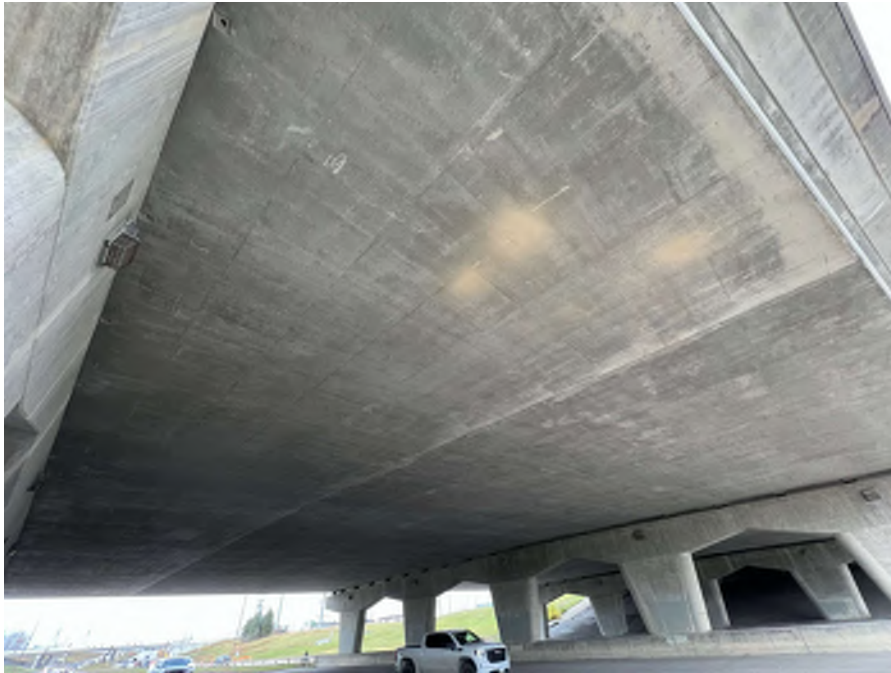
**Photo 27 - Typical Span 2 soffit**

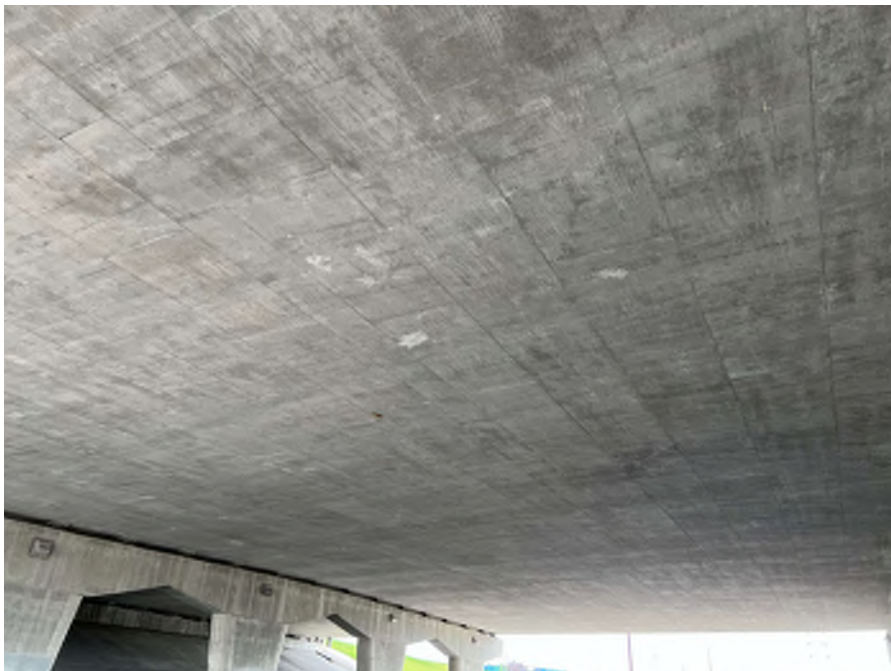
**Photo 28 - Typical Span 3 soffit**

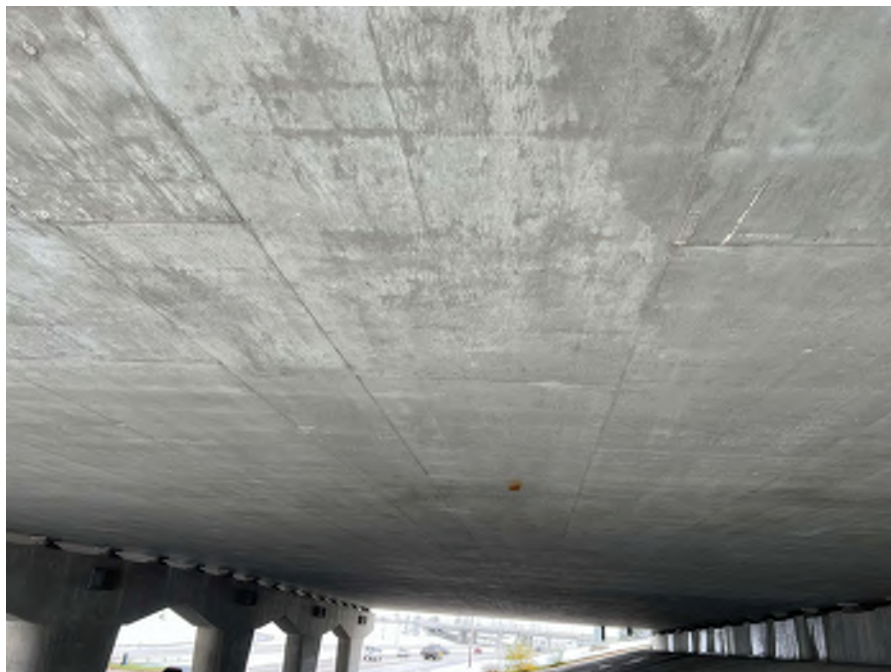
**Photo 29 - Typical Span 4 soffit**

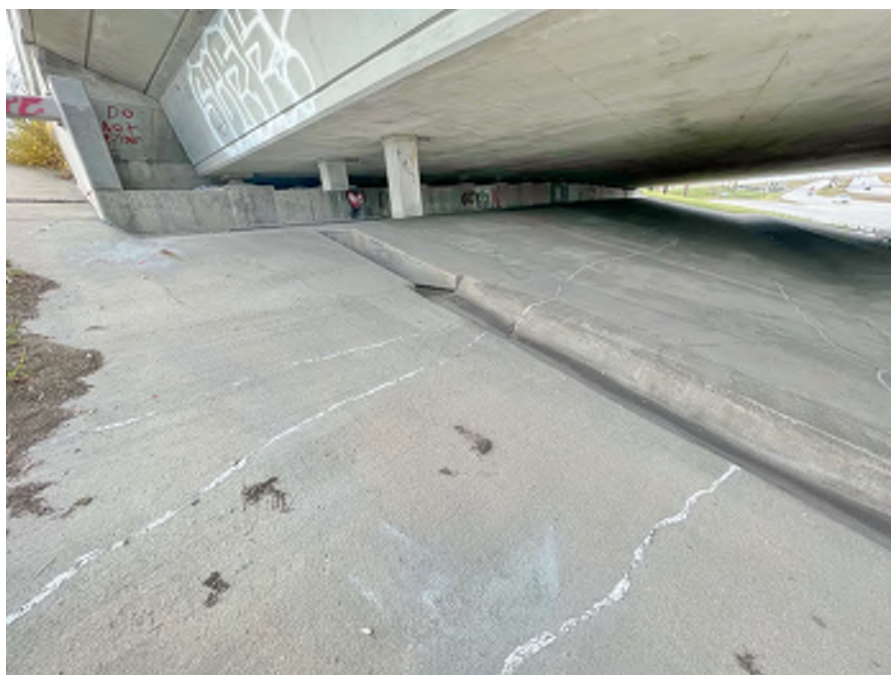
**Photo 30 - SU1 South abutment elevation**

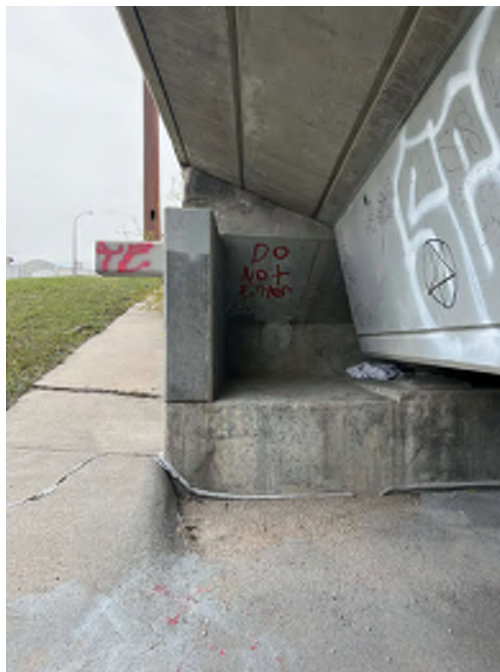
**Photo 31 - SU1 abutment backwall**

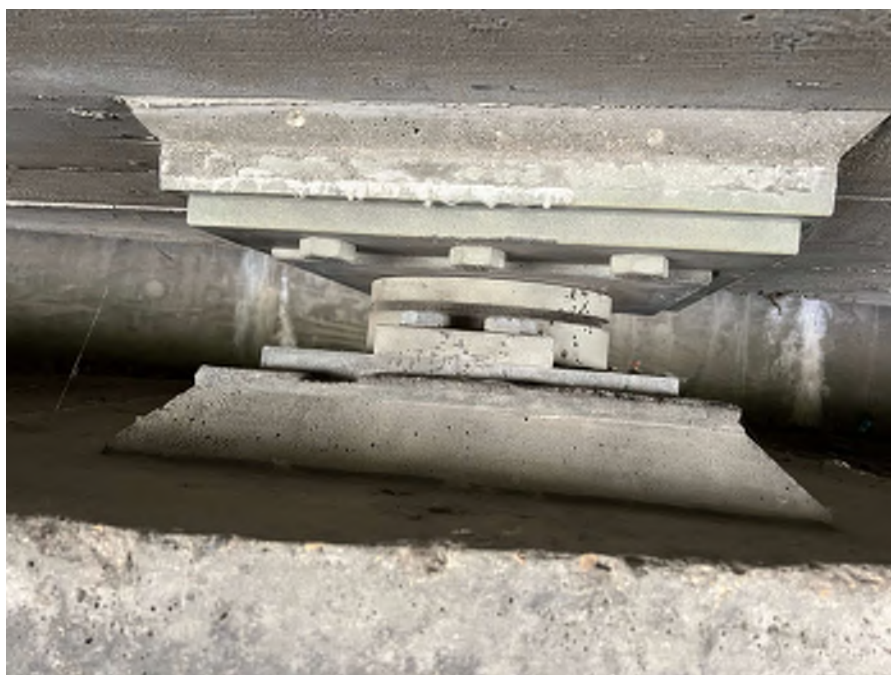
**Photo 32 - Typical SU1 abutment bearing**

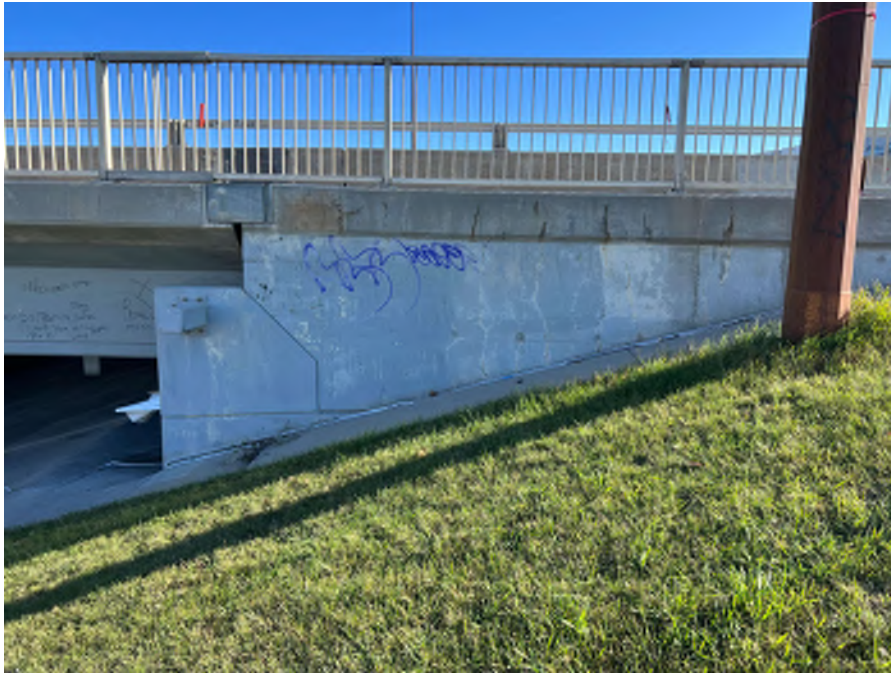
**Photo 33 - SW wingwall**
