### DETAILED BRIDGE CONDITION SURVEY

## Pembina Highway Bridge Over Abinojii Mikanah (Bishop Grandin)

(Site No. B-215)

November 22, 2024

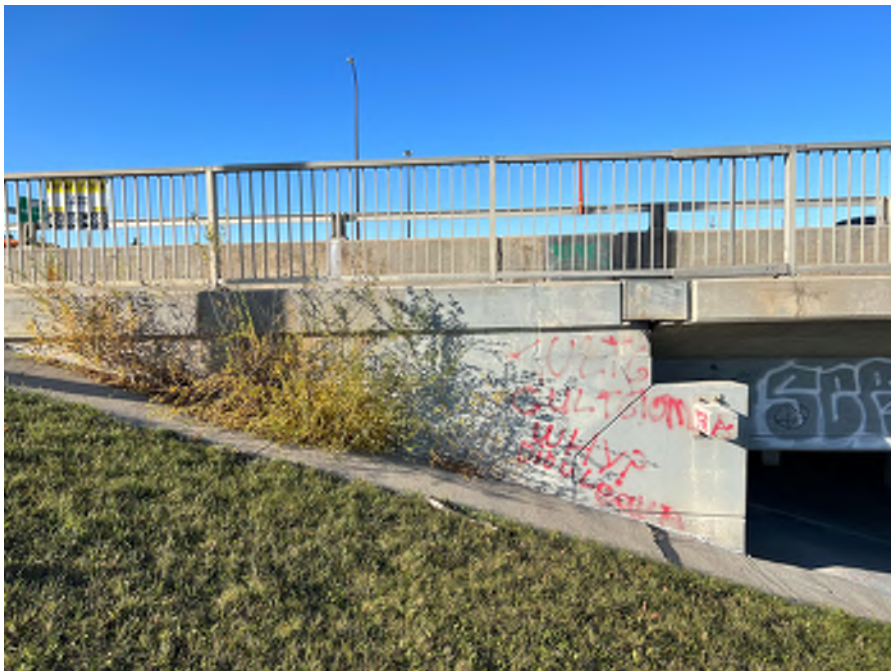
**Photo 34 - SE wingwall**

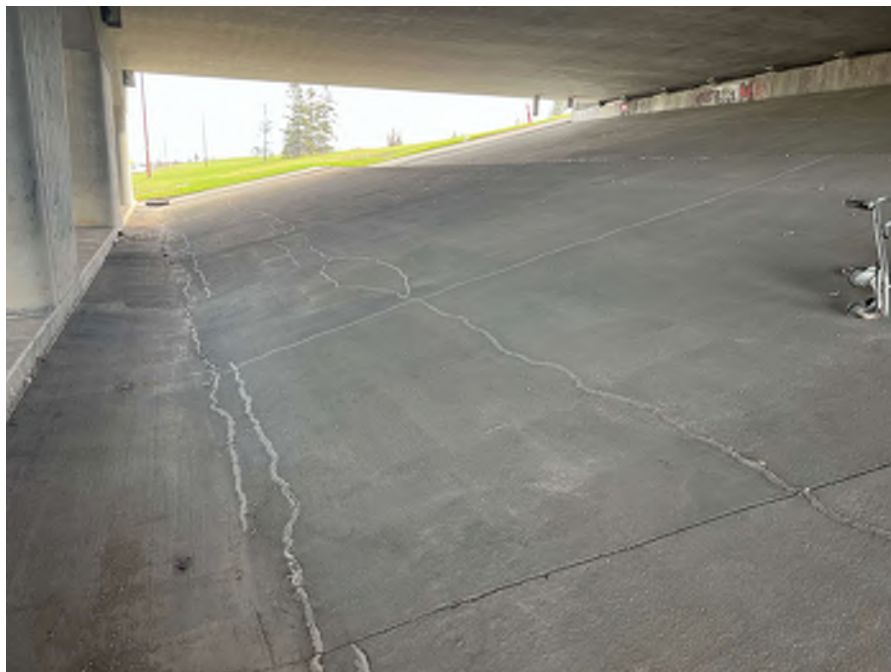
<b>Element Group:</b>	Embankments & Streams					<b>Length:</b>	-
<b>Element Name:</b>	Slope Protection					<b>Width:</b>	-
<b>Location:</b>	North & South Abutments					<b>Height:</b>	-
<b>Description:</b>	Slope Paving					<b>Count:</b>	2
<b>Material:</b>	Cast-in-Place Concrete					<b>Total Quantity:</b>	2
<b>Element type:</b>	Reinforced Concrete					<b>Limited Inspection:</b>	No
<b>Environment:</b>	Benign					<b>Perform. Deficiencies</b>	<b>Maint. Needs</b>
<b>Condition Data:</b>	<b>Units</b>	<b>Exc.</b>	<b>Good</b>	<b>Fair</b>	<b>Poor</b>	None	None
	Each	0	0	2	0		
<b>Comments:</b> - Transverse and longitudinal cracking throughout with previous patching wearing off / failing in exposed areas at ends. Wide cracks and spalls notes on drain troughs. - Slope paving at both abutments appear to be settling ~50mm. - Crack total (Narrow: 178m, Medium: 44m, Wide: 39m). - Spalling total (0.11 sq.m).							
<b>Photo Ref.:</b>	Photo 35	Photo 36	Photo 50	Photo 51	Photo 78	Photo 79

**Photo 35 - South abutment slope paving - bottom portion**

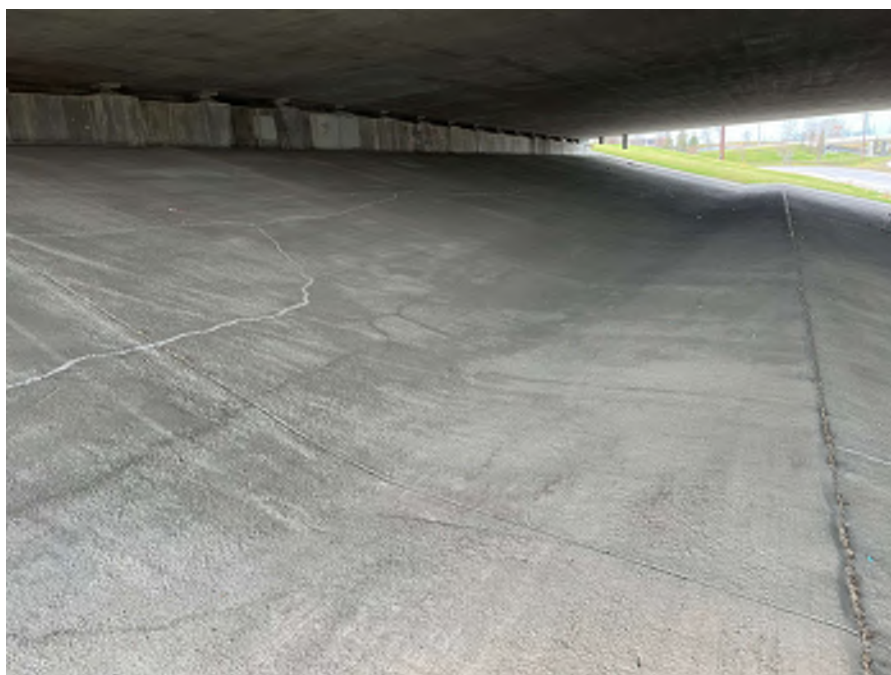
**Photo 36 - South abutment slope paving - top portion**

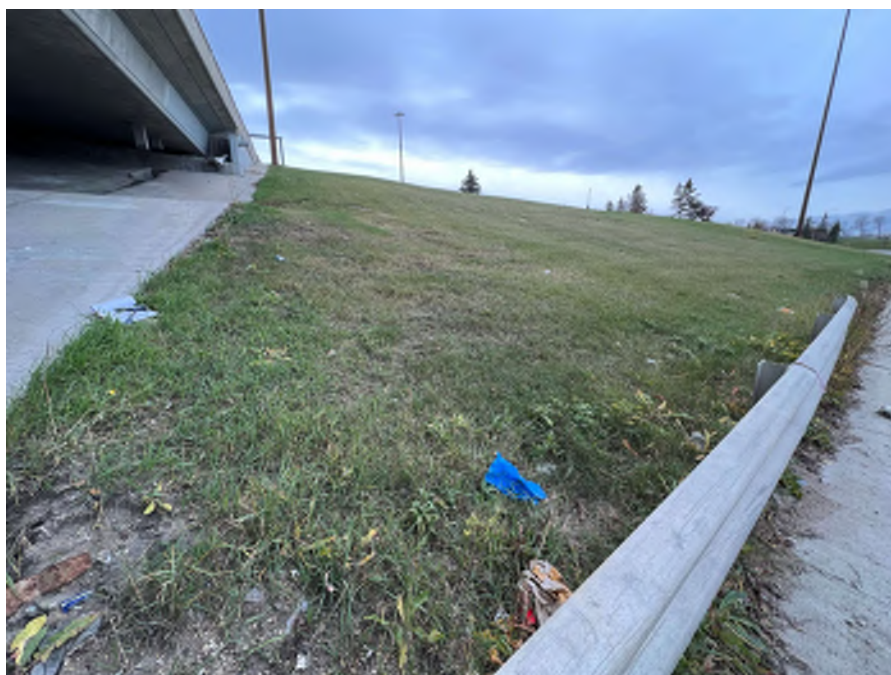
**Photo 37 - SW embankment**

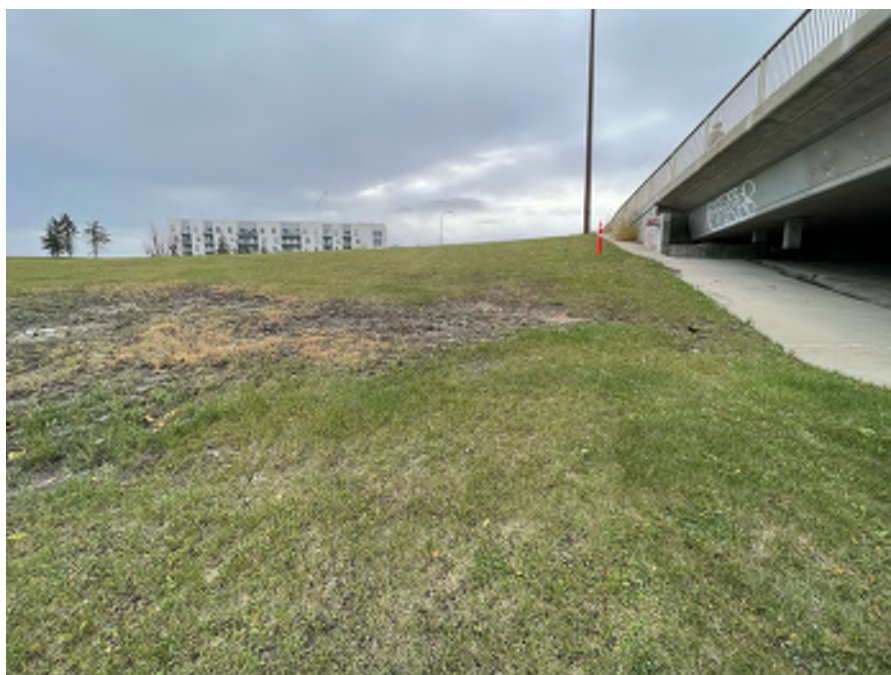
**Photo 38 - SE embankment**

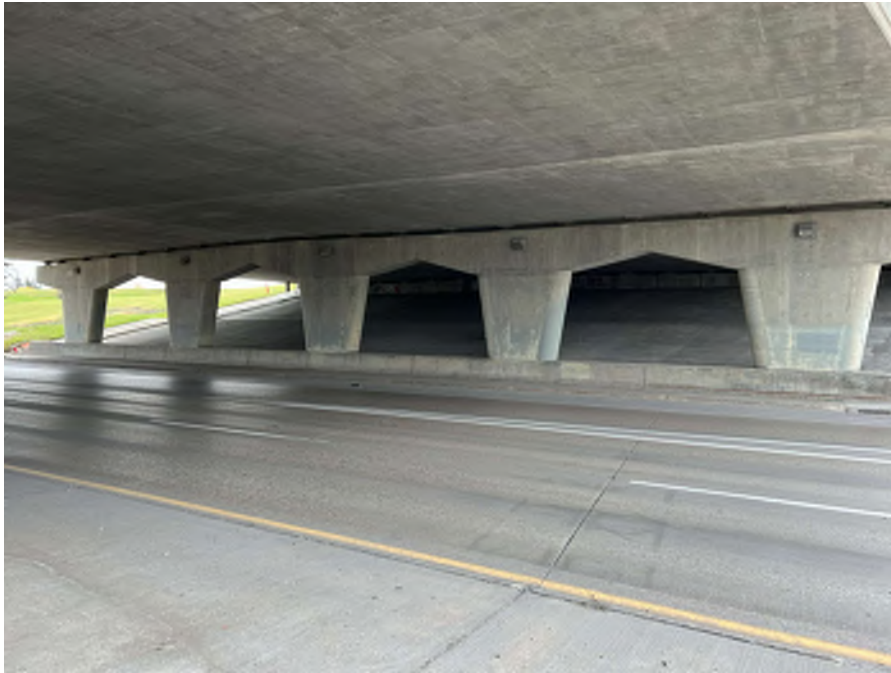
**Photo 39 - SU2 pier elevation**

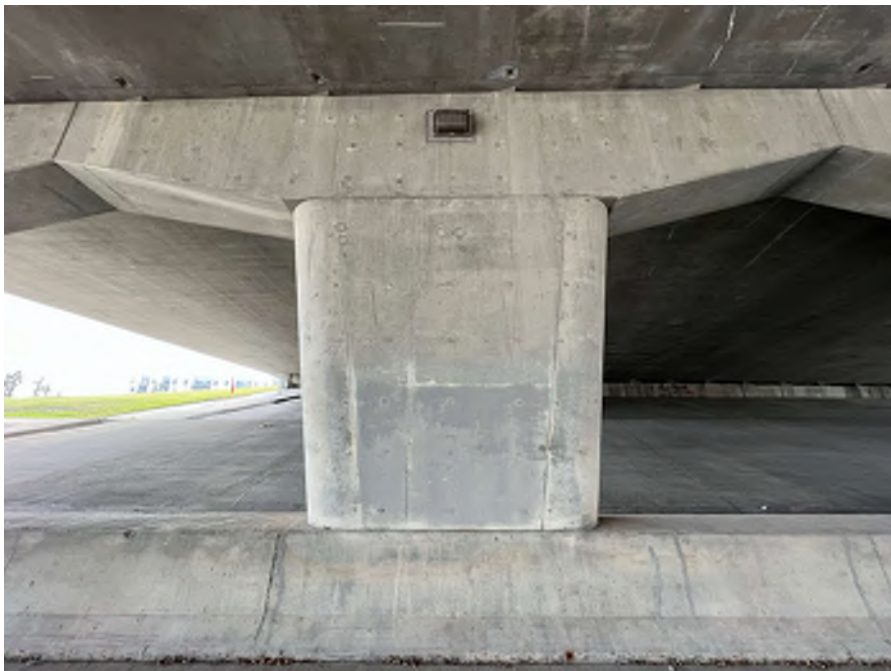
**Photo 40 - Typical SU2 pier cap, shaft, and base pedestal**

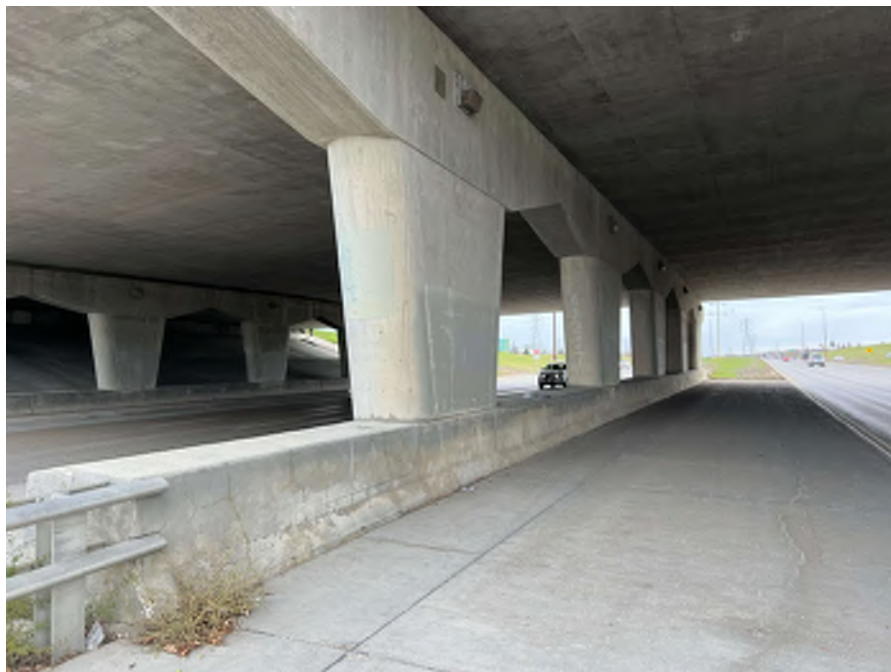
**Photo 41 - SU3 pier elevation**

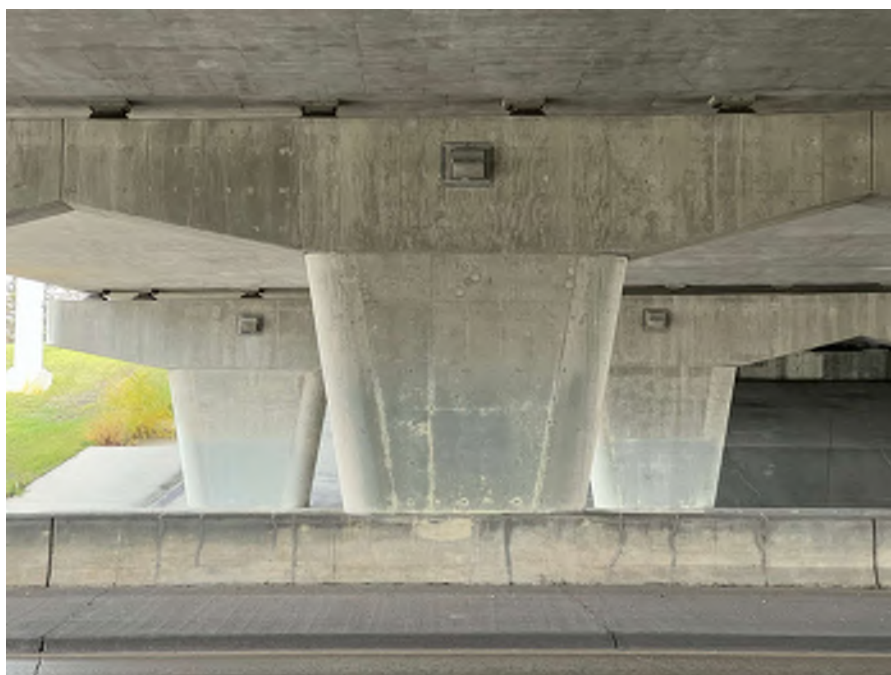
**Photo 42 - Typical SU3 pier cap, shaft, and base pedestal**

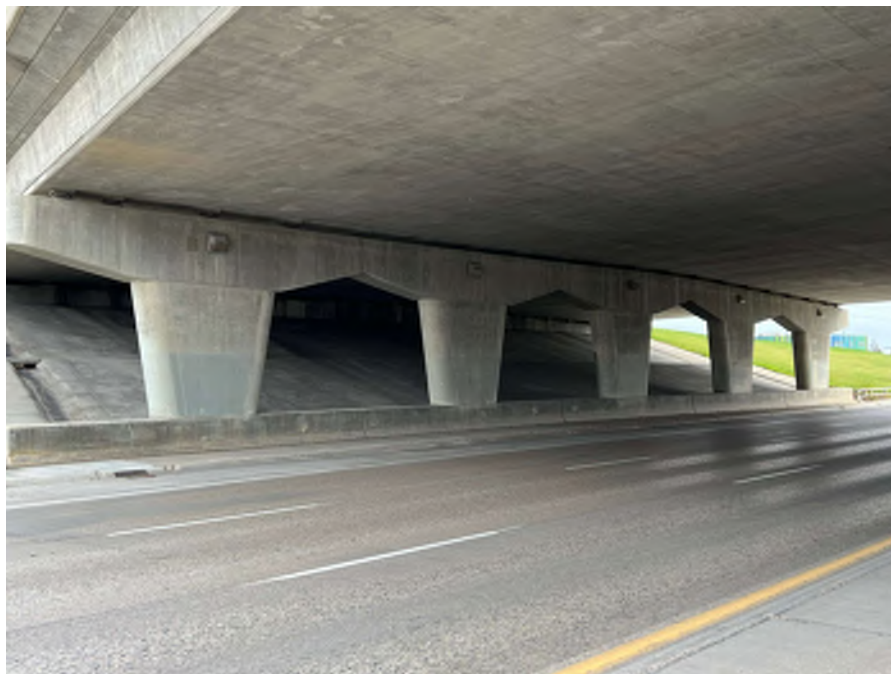
**Photo 43 - SU4 pier elevation**

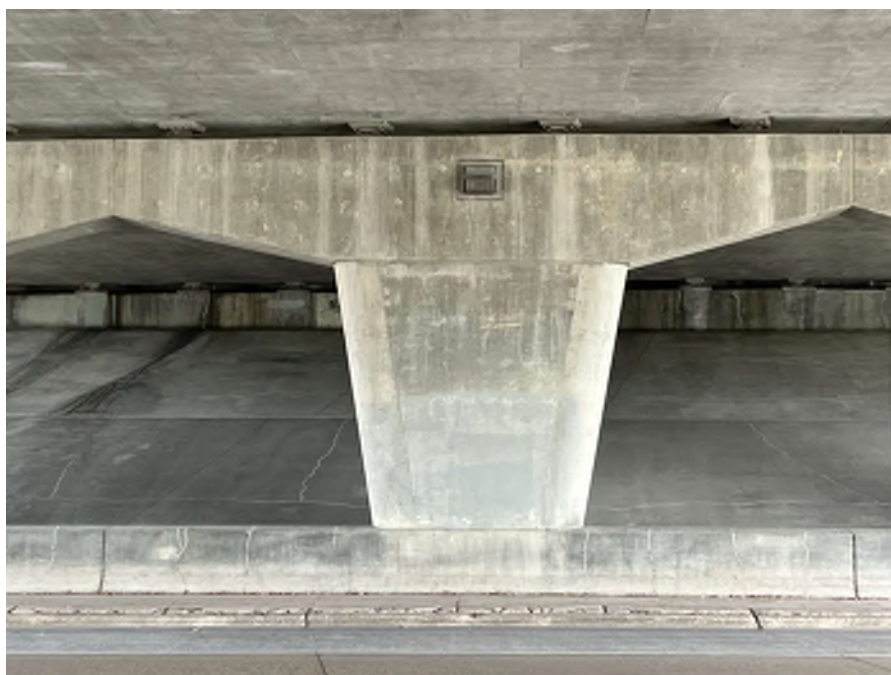
**Photo 44 - Typical SU4 pier cap, shaft, and base pedestal**

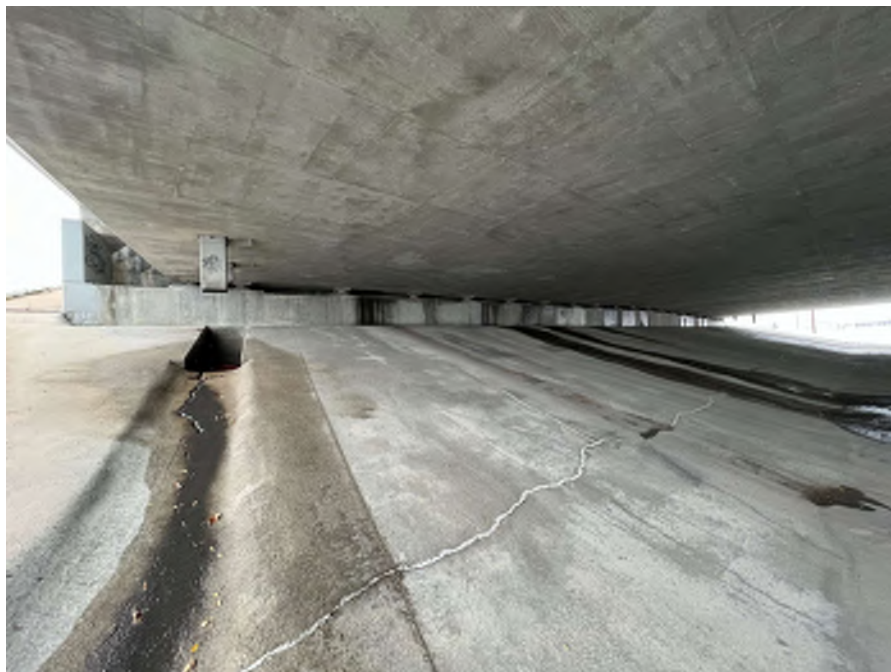
**Photo 45 - SU5 North abutment elevation**

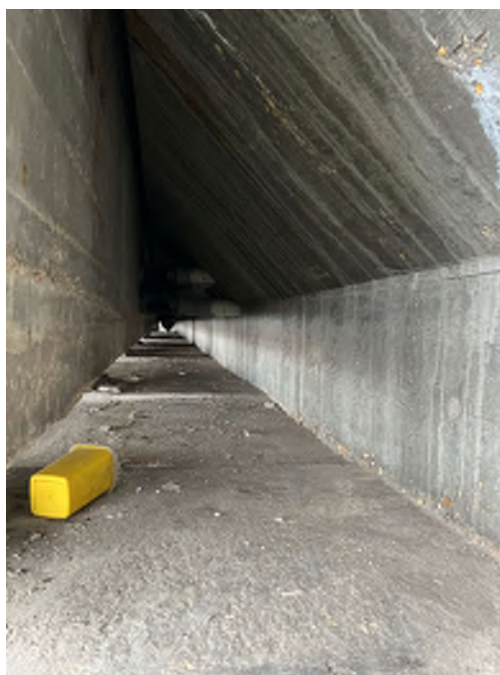
**Photo 46 - SU5 abutment backwall**

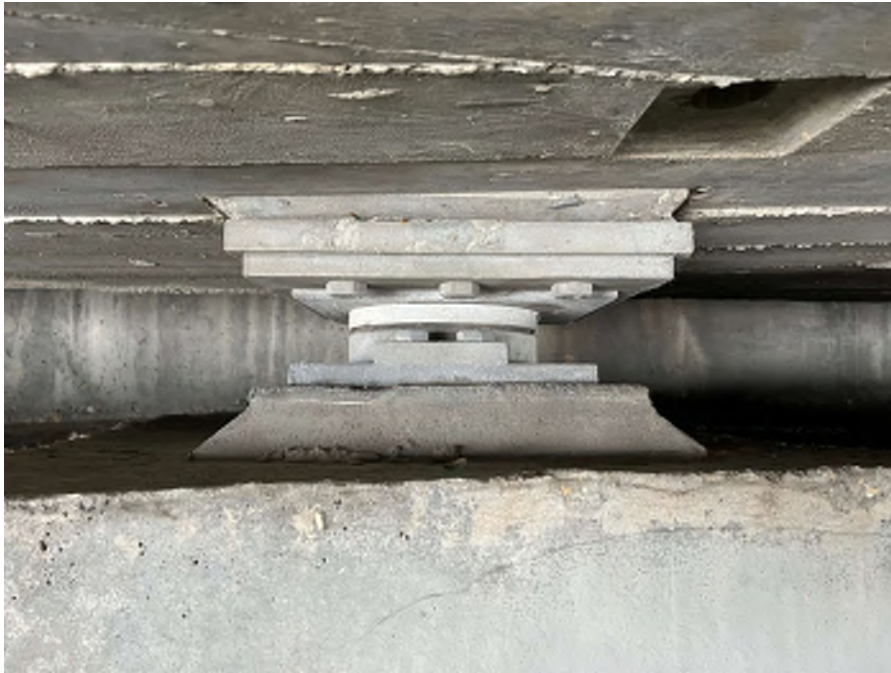
**Photo 47 - Typical SU5 abutment bearing**

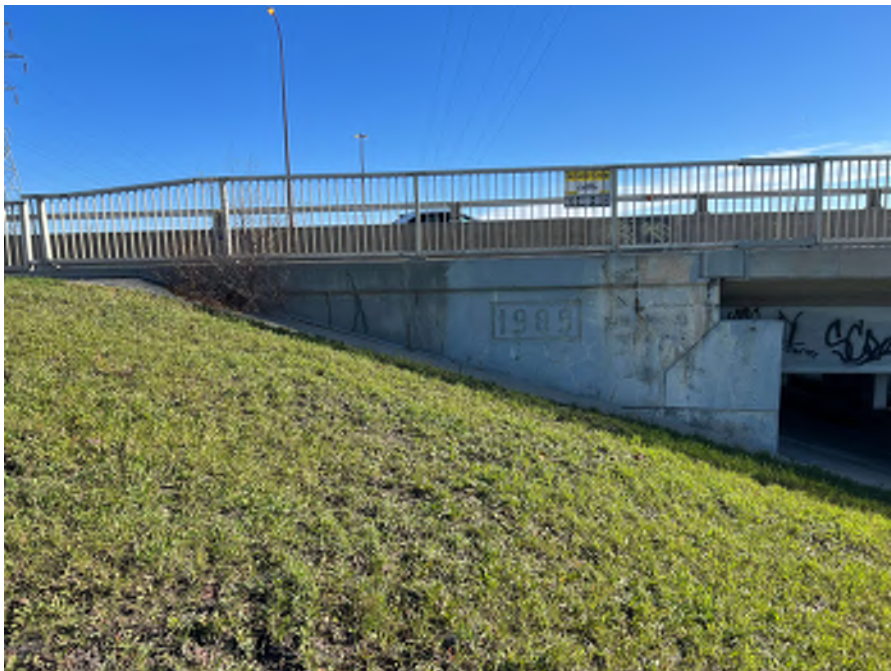
**Photo 48 - NW wingwall**

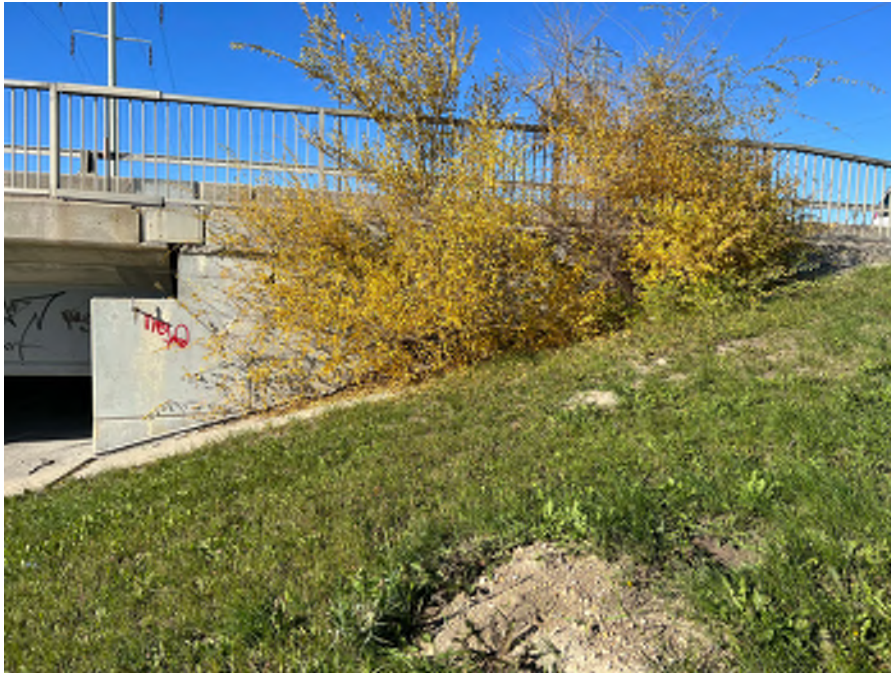
**Photo 49 - NE wingwall**

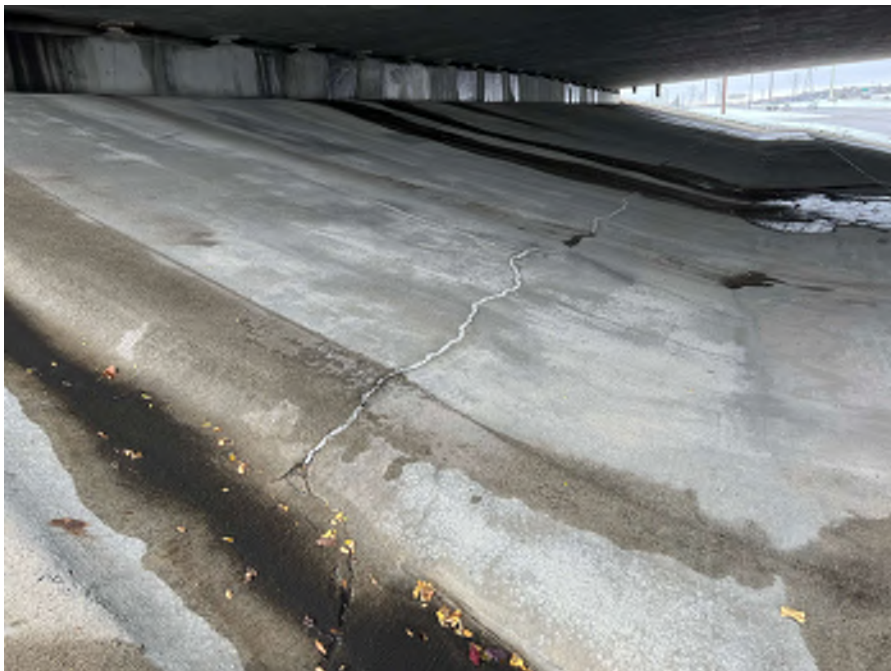
**Photo 50 - North abutment slope paving - top portion**

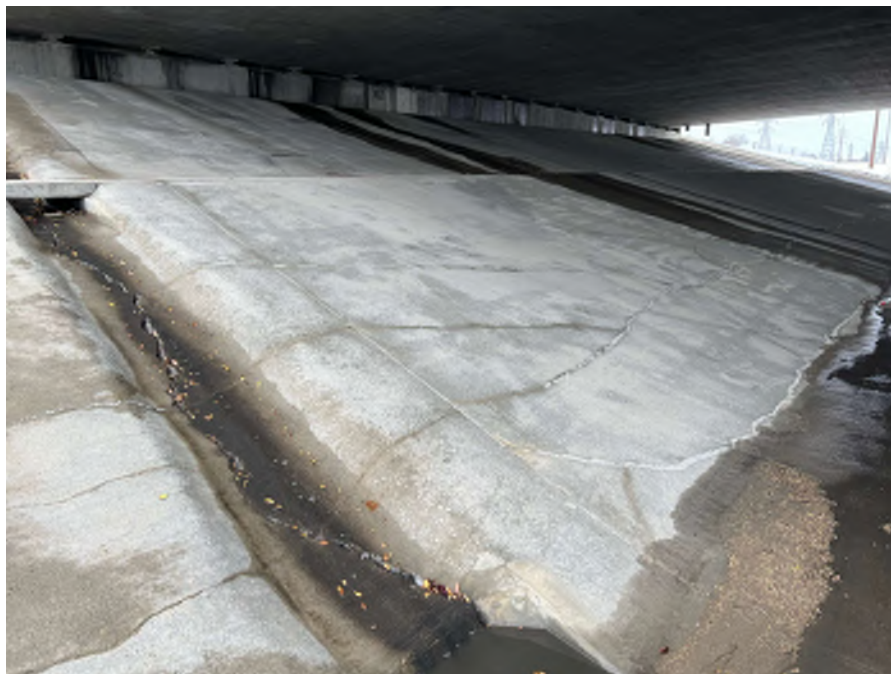
**Photo 51 - North abutment slope paving - bottom portion**

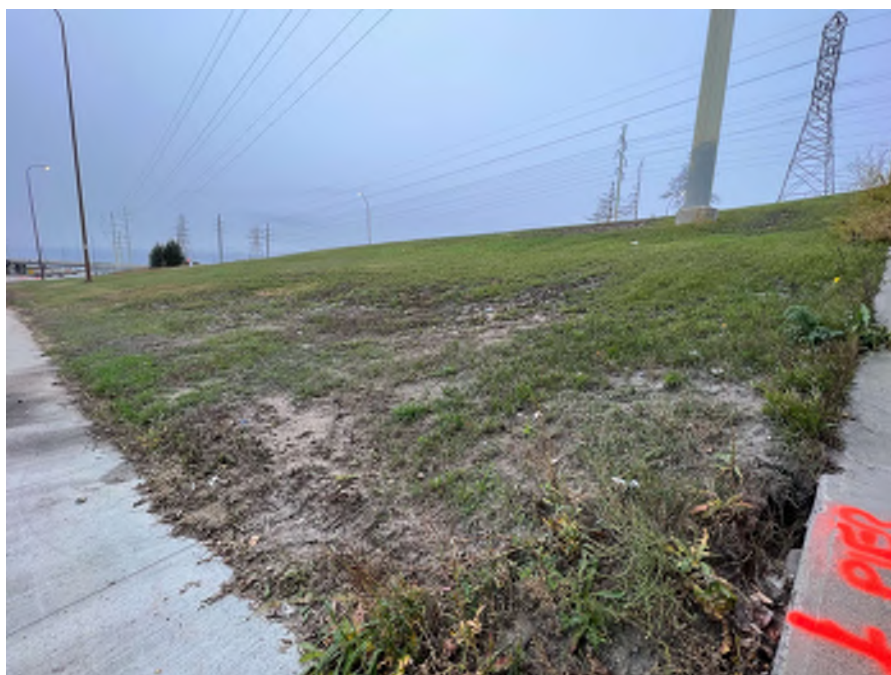
**Photo 52 - NW embankment**

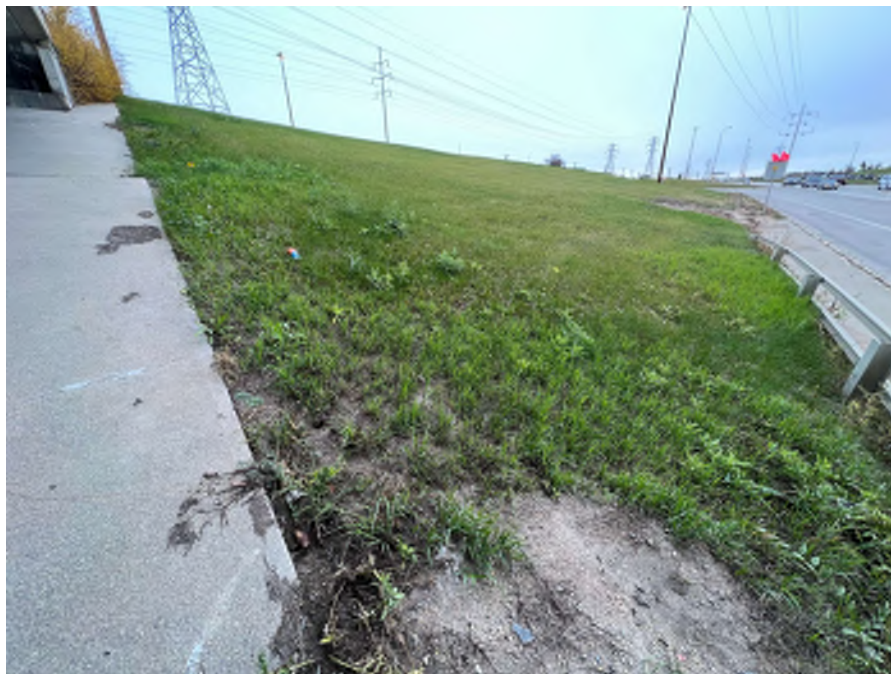
**Photo 53 - NE embankment**

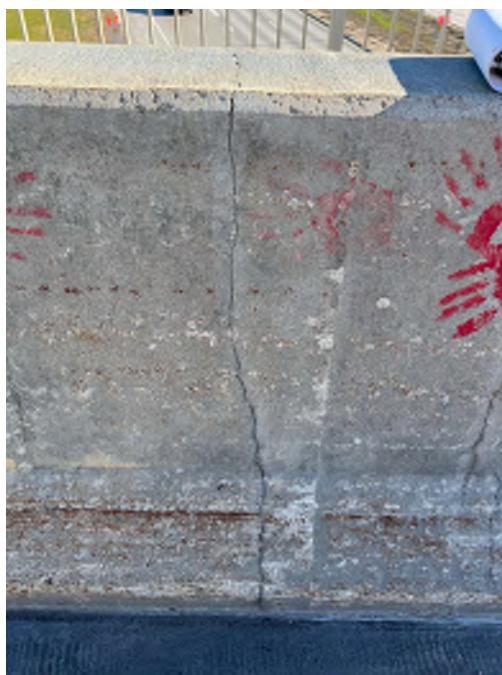
**Photo 56 - Typical vertical narrow to medium cracking on traffic barrier inside face**

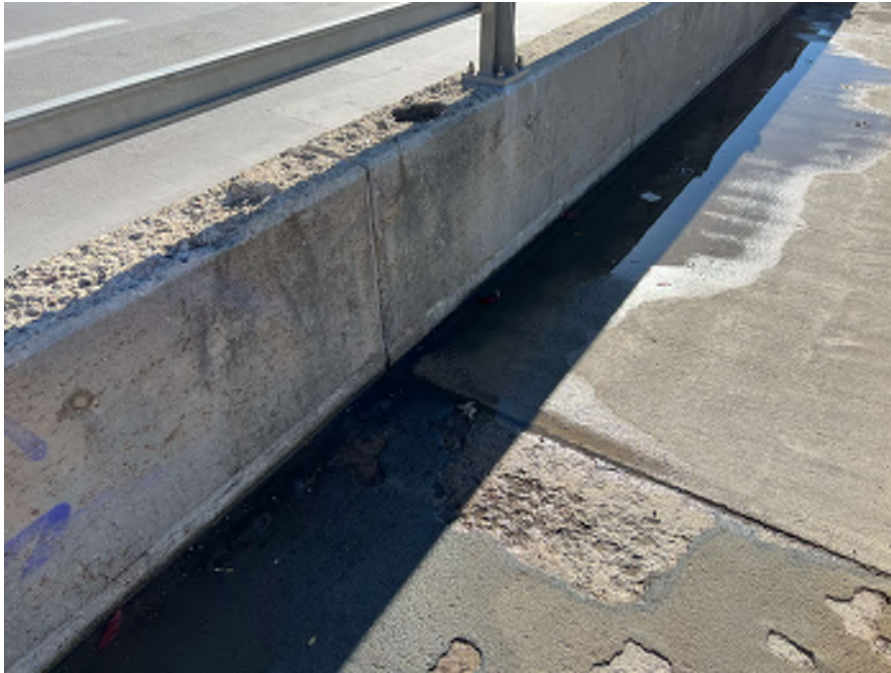
**Photo 57 - West barrier and sidewalk area of severe scaling and spalling**

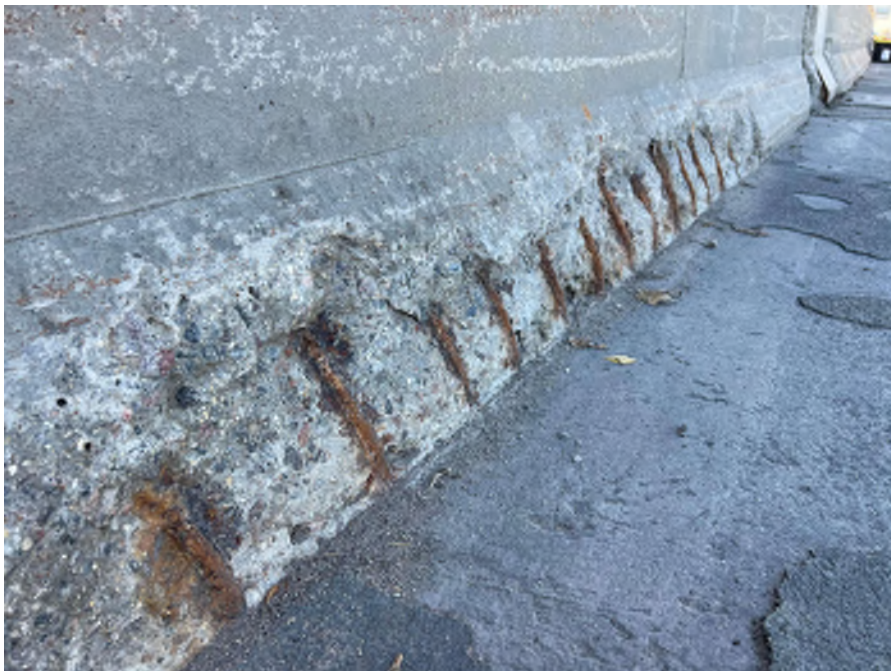
**Photo 58 - NE approach barrier, spalls with exposed rebar**

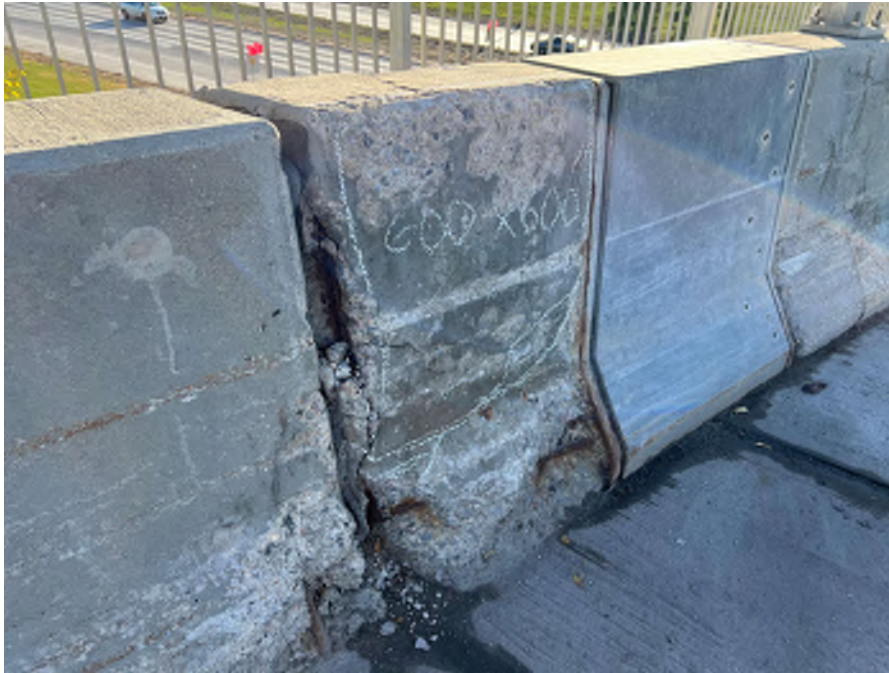
**Photo 59 - NE approach barrier, delaminations near expansion joint**

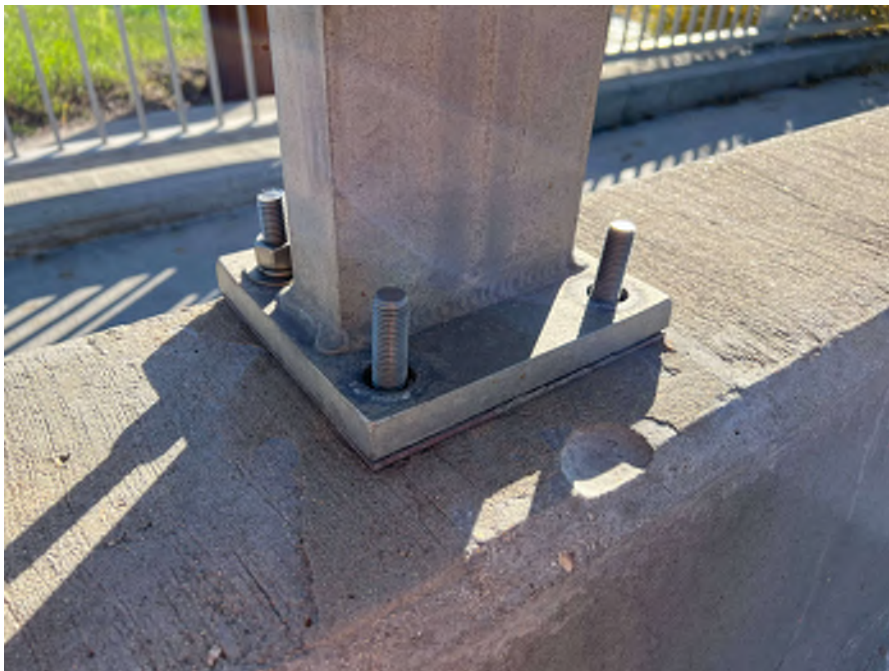
**Photo 60 - East traffic barrier rail showing post missing 2 nuts and washers.**

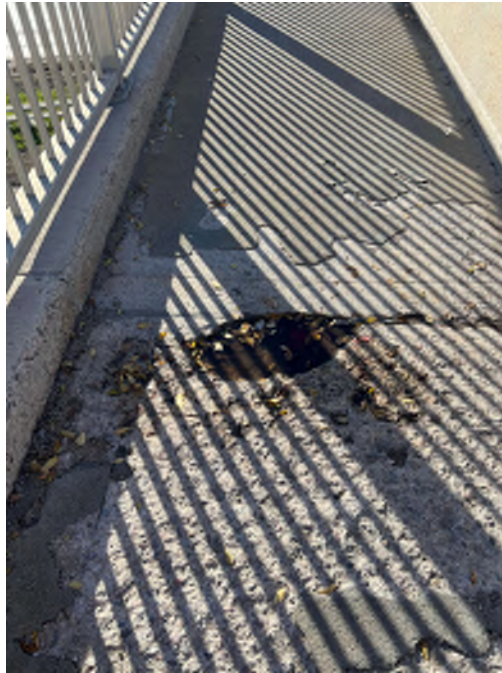
<b>Element Group:</b>	Sidewalks / Curbs					<b>Length:</b>	89.46
<b>Element Name:</b>	Sidewalks					<b>Width:</b>	1.53
<b>Location:</b>	East and West of Bridge					<b>Height:</b>	0.00
<b>Description:</b>	Pedestrian Sidewalk					<b>Count:</b>	2
<b>Material:</b>	Cast-in-Place Concrete					<b>Total Quantity:</b>	272.85
<b>Element type:</b>	Reinforced Concrete					<b>Limited Inspection:</b>	No
<b>Environment:</b>	Moderate					<b>Perform. Deficiencies</b>	<b>Maint. Needs</b>
<b>Condition Data:</b>	<b>Units</b>	<b>Exc.</b>	<b>Good</b>	<b>Fair</b>	<b>Poor</b>	None	None
	Sq.m.	0.0	272.6	0.2	0.2		
<b>Comments:</b> - Epoxy polymer surface is spalling off of ~50% of East and West sidewalks with light surface scaling on some of the exposed areas. - Hairline to medium transverse cracks noted on some exposed areas. - Pot hole / severe concrete spalling on East sidewalk (0.15 sq.m. rated poor).							
<b>Photo Ref.:</b>	Photo 10	Photo 61	Photo 62

**Photo 61 - East sidewalk worn epoxy coating and pothole**

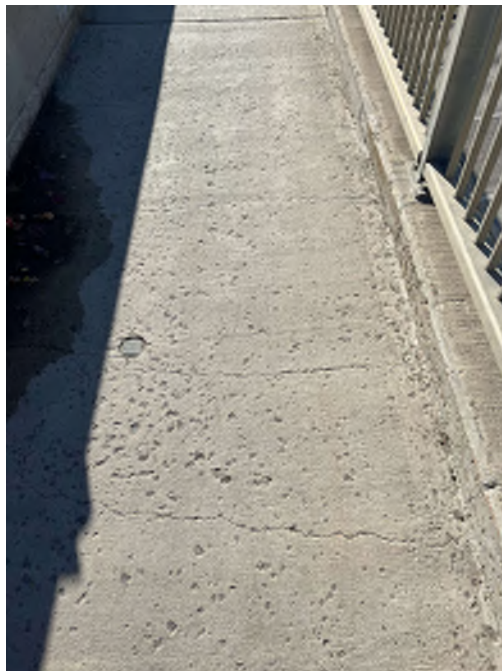
**Photo 62 - West sidewalk hairline to medium transverse cracks**

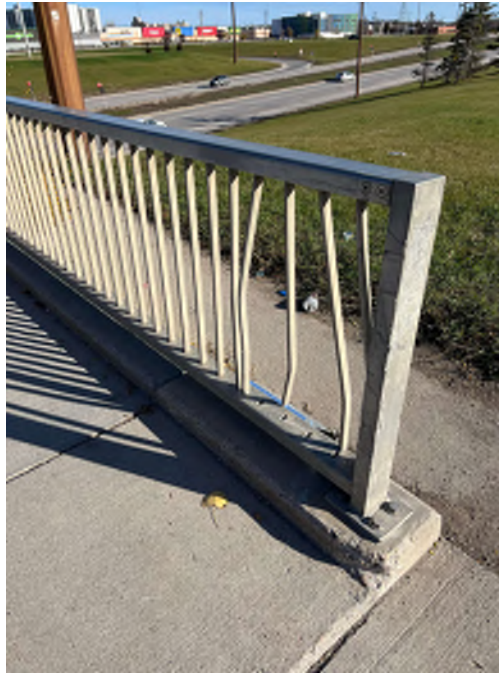
**Photo 63 - Pedestrian handrail panel with 4 broken pickets at SE corner**

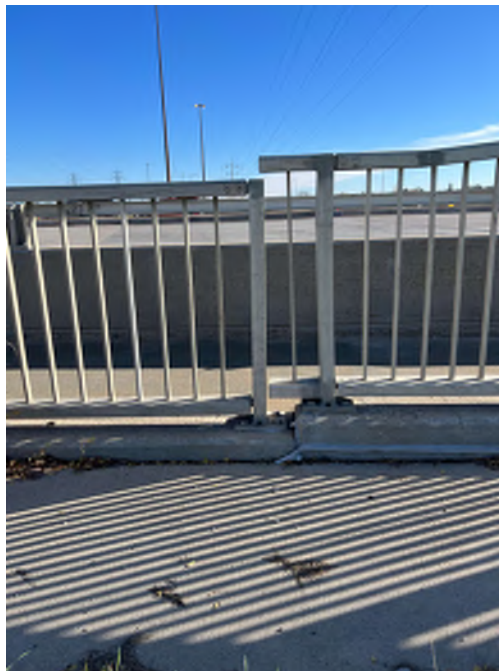
**Photo 64 - Pedestrian handrail at NW corner showing differential settlement (~80mm)**

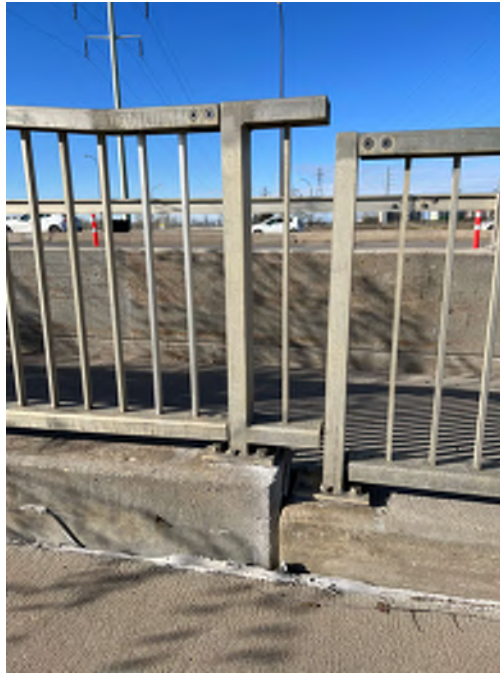
**Photo 65 - Pedestrian handrail at NE corner showing differential settlement (~90mm)**

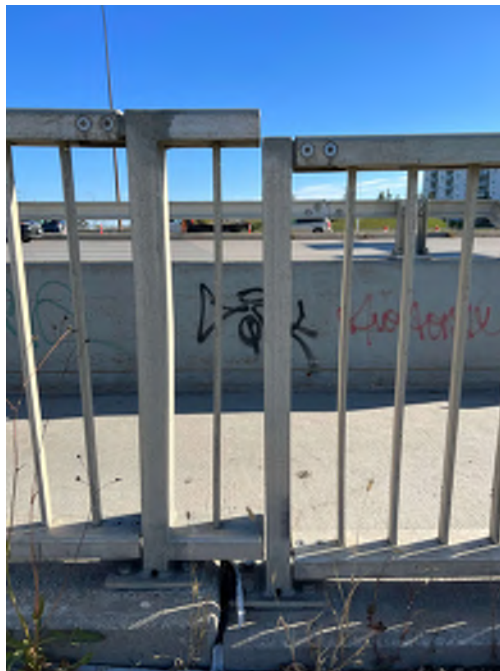
**Photo 66 - Pedestrian handrail at SW corner showing differential settlement (~50mm)**

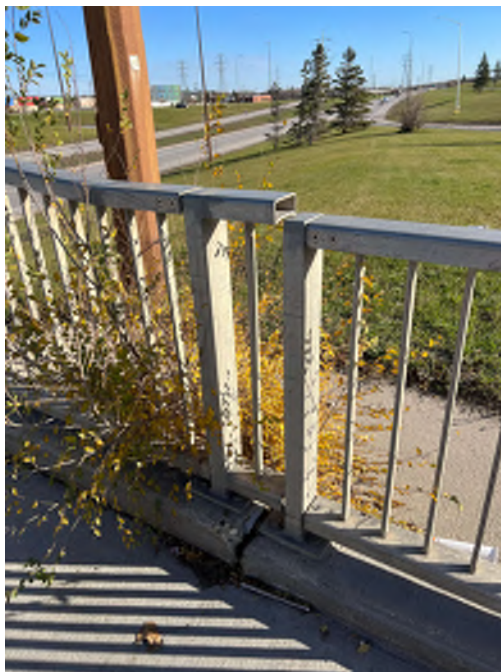
**Photo 67 - Pedestrian handrail at SE corner showing differential settlement (~50mm)**

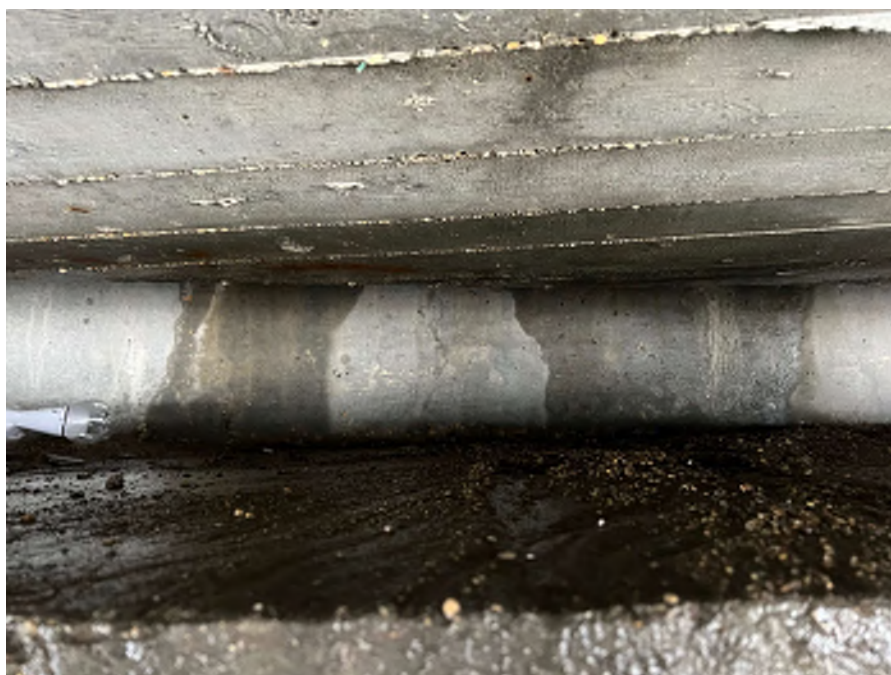
**Photo 68 - Typical leakage on abutment backwall**

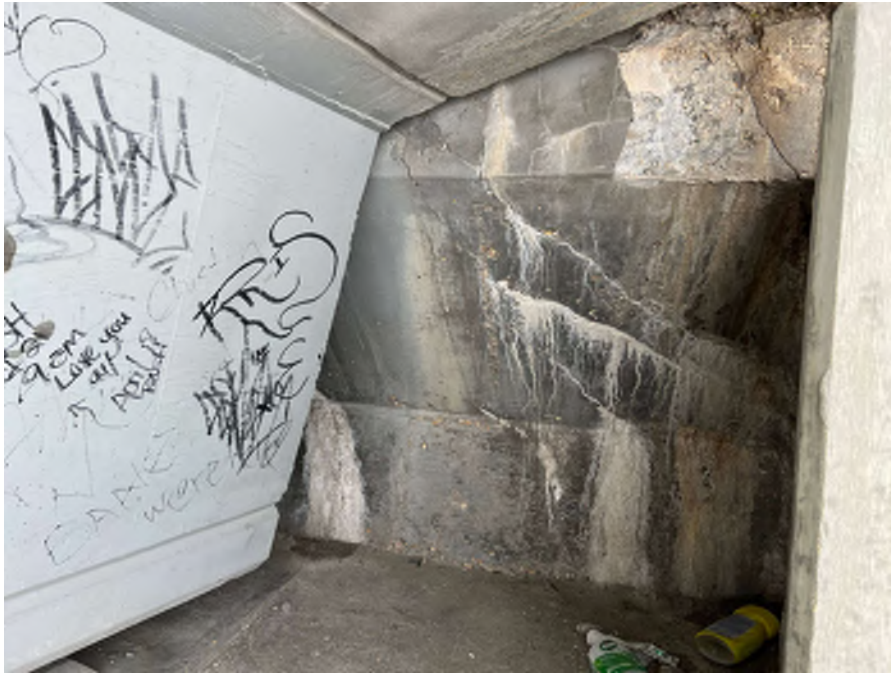
**Photo 69 - SU5 abutment backwall cracking at East end**

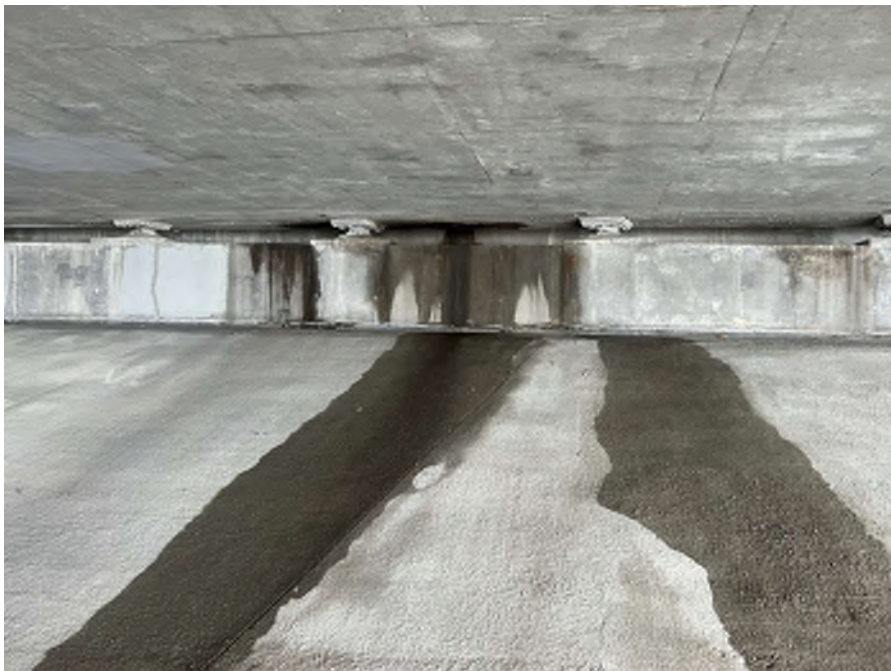
**Photo 70 - Leakage on abutment seat and slope paving**

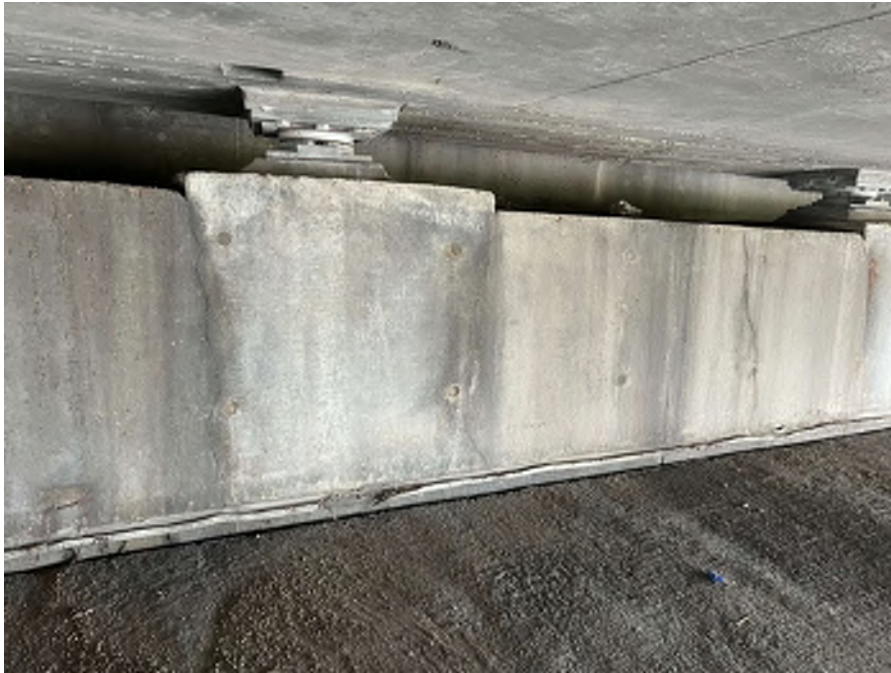
**Photo 71 - Abutment wall typical narrow to medium vertical cracks**

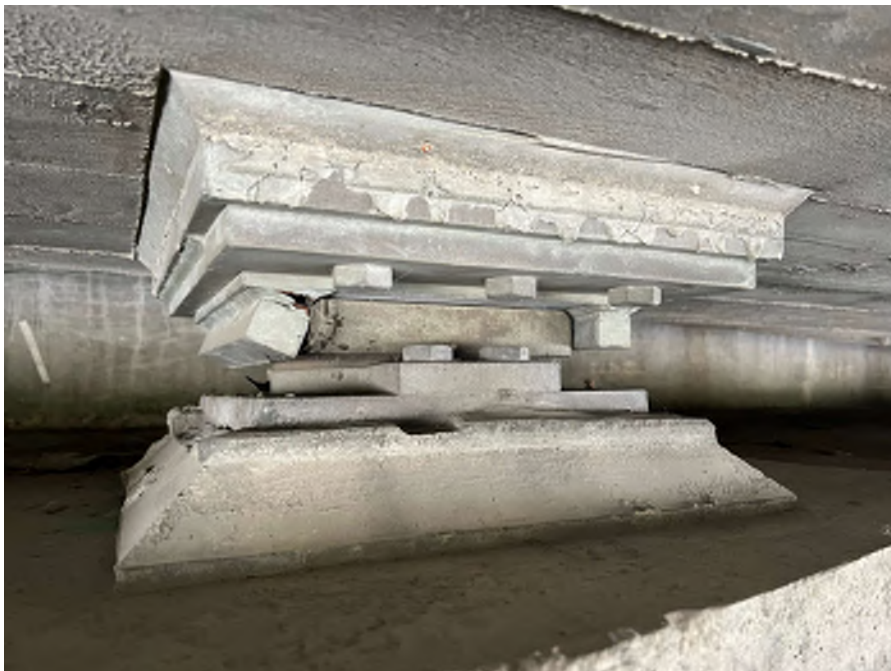
**Photo 72 - SU1 abutment bearing 11 from West with cracked bearing plate**

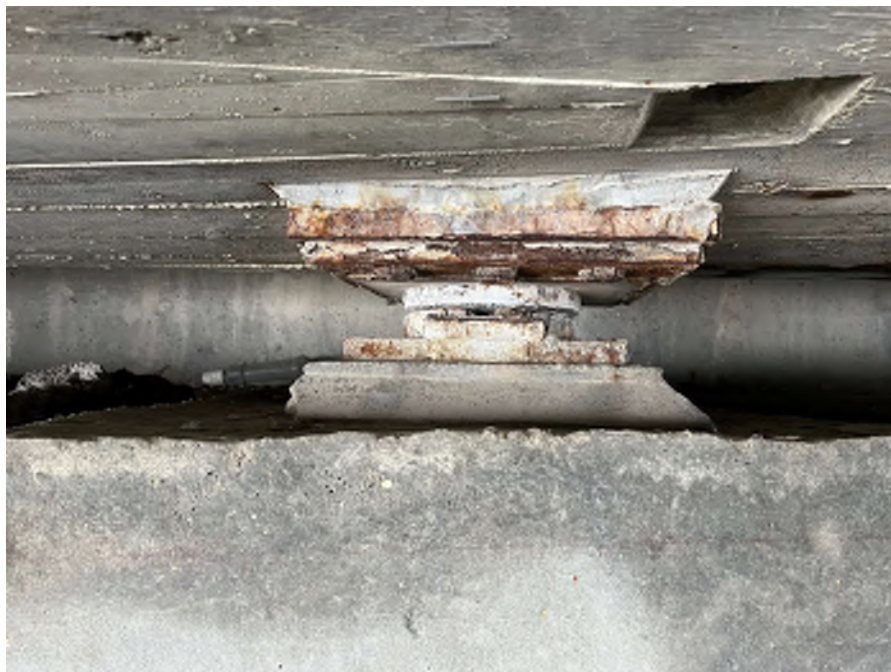
**Photo 73 - SU5 abutment bearing 3 from East with corroded steel**

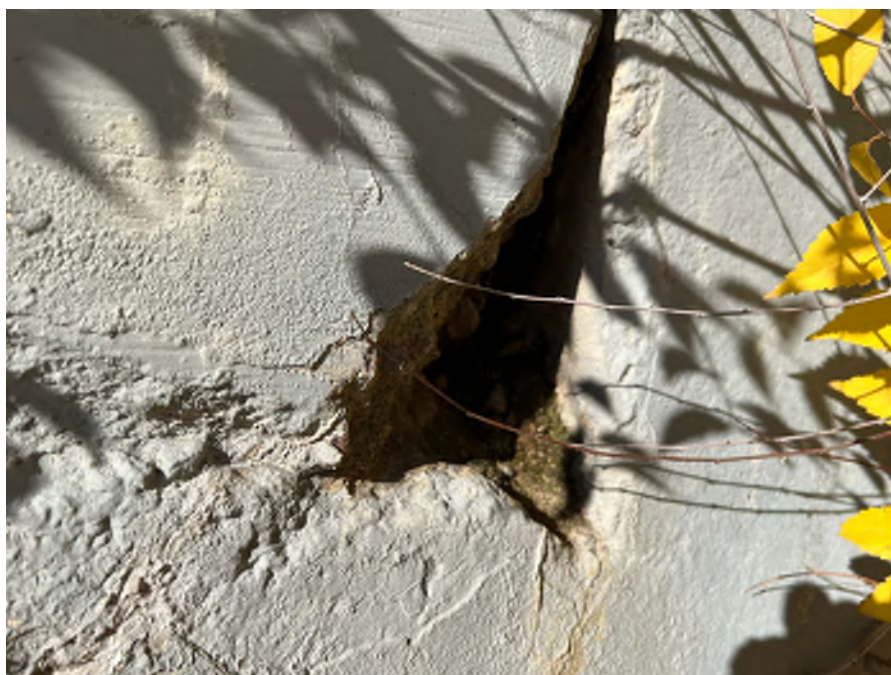
**Photo 74 - Spall on corner of NE wingwall**

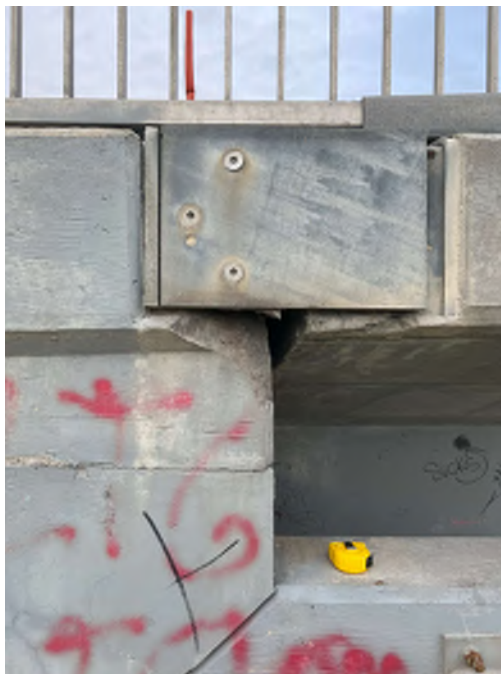
**Photo 75 - Spall on corner of SE wingwall**

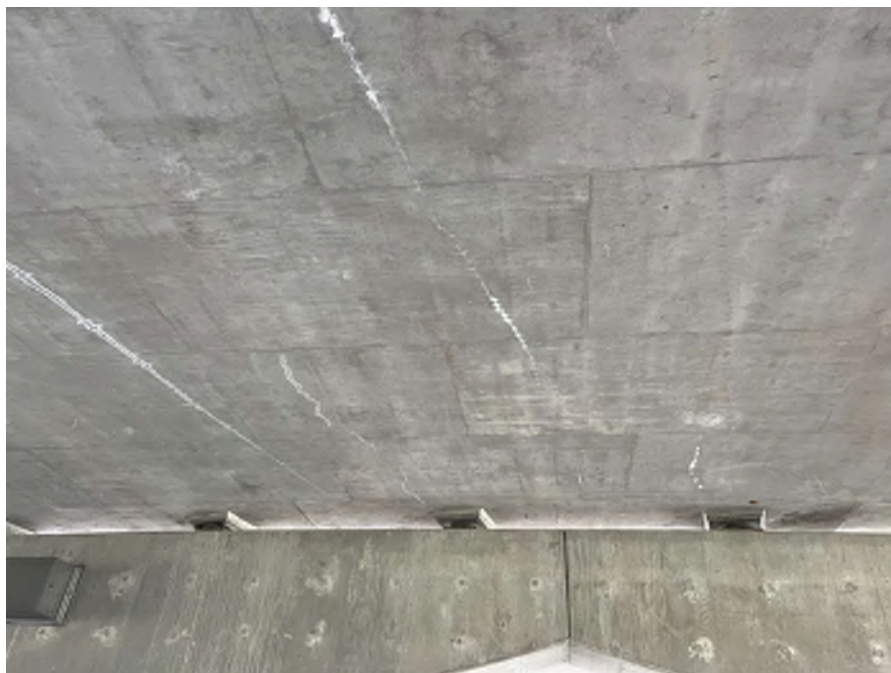
**Photo 76 - Typical soffit hairline to narrow cracking with efflorescence near piers**
