### DETAILED BRIDGE CONDITION SURVEY

## Pembina Highway Bridge Over Abinojii Mikanah (Bishop Grandin)

(Site No. B-215)

November 22, 2024

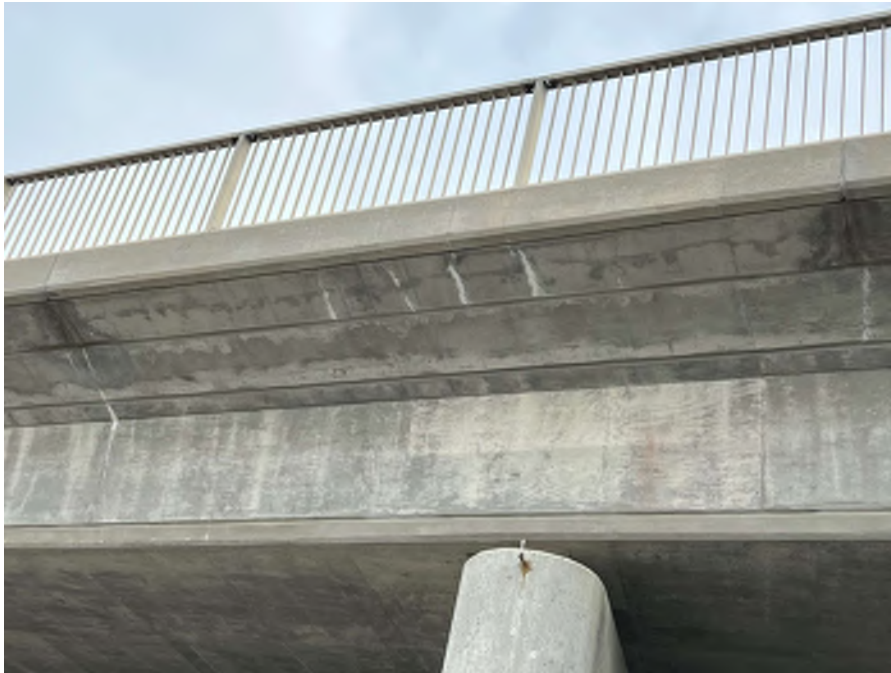
**Photo 77 - Typical exterior soffit narrow cracks with efflorescence**

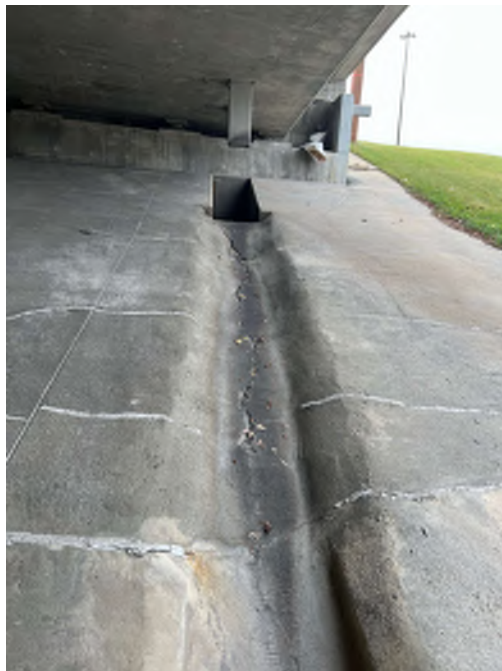
**Photo 78 - SW drain gutter typical wide cracking on slope paving**

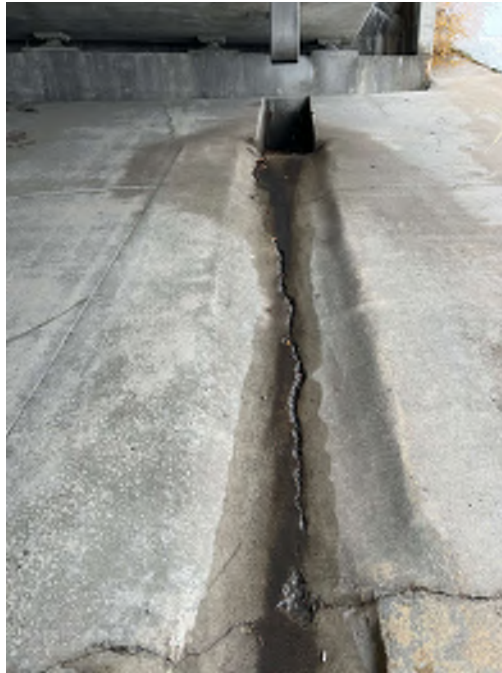
**Photo 79 - NE drain gutter typical wide cracking on slope paving**

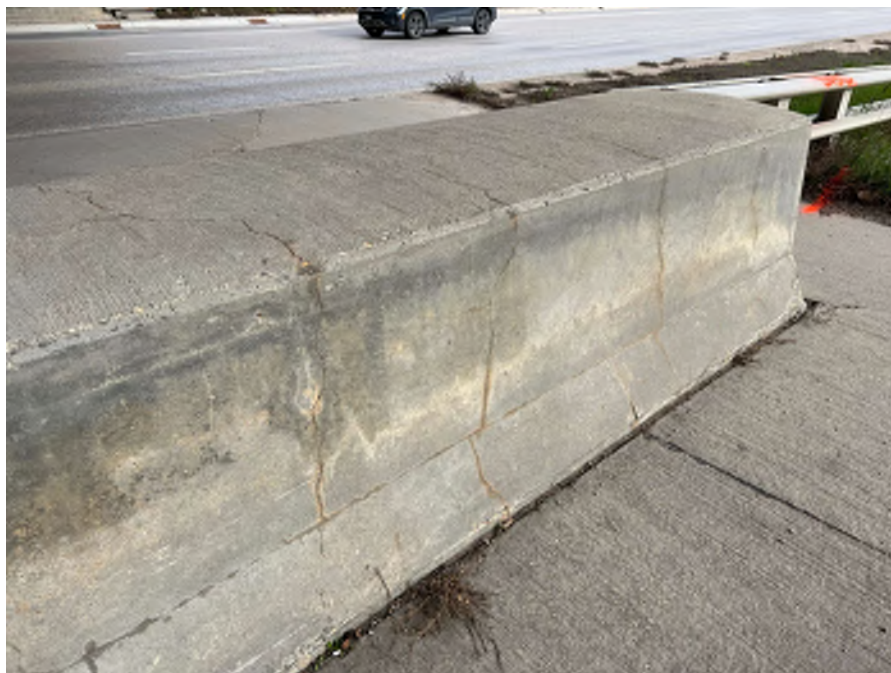
**Photo 80 - Typical narrow vertical cracks on pier base pedestals**

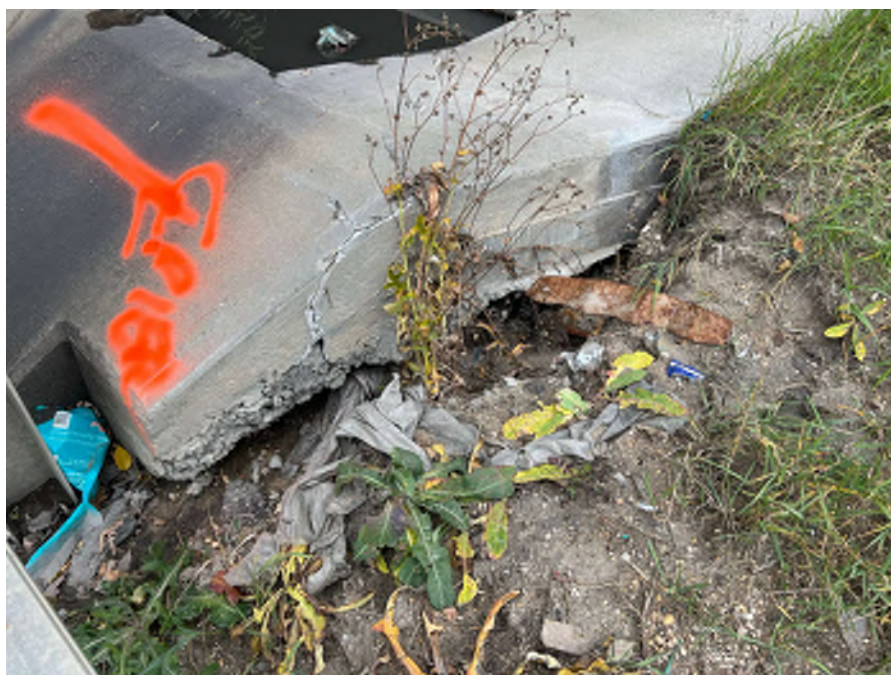
**Photo 81 - SW embankment near SU2 pier run off erosion hole**

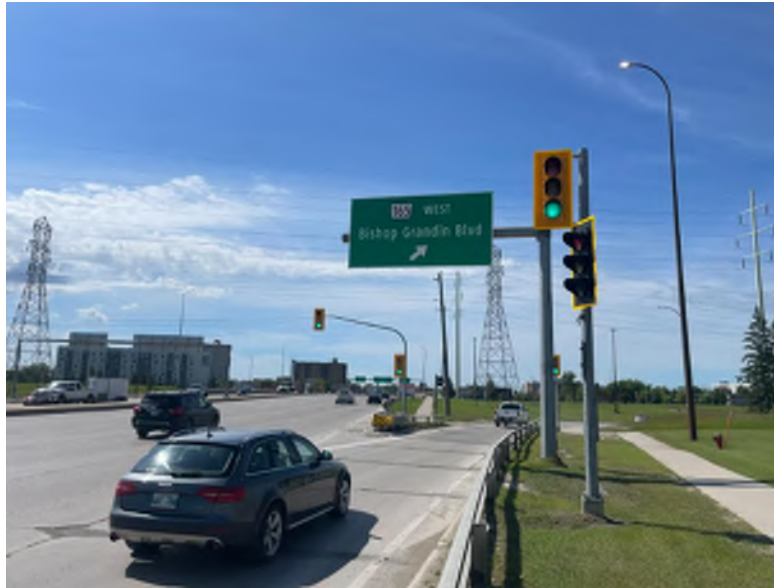
## 1. S-647: SB Pembina at WB Abinojii Ramp Cantilever Structure

- Date of inspection: October 26, 2023, and June 21, 2024
- Leg / Base – generally good condition
- Arm – generally good condition
- Front of Signs – generally good condition
- Sign Attachments – generally good condition

- No maintenance work is recommended for the structure

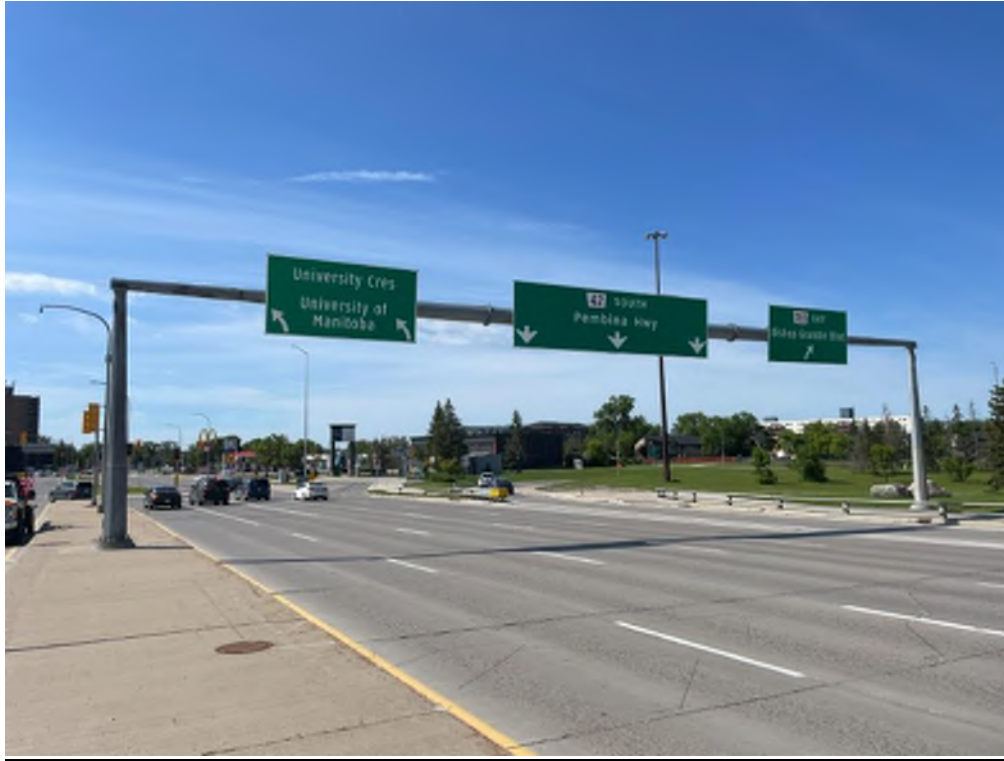
### 3. S-650: SB Pembina Hwy Approaching University Crescent Monotube Bridge Structure

- Date of inspection: October 26, 2023, and June 21, 2024
- West Leg – generally good condition
- East Leg – generally good condition
- Top Chord – generally good condition
- Front of Signs – generally good condition
- Sign Attachments – generally good condition

- No maintenance work is recommended for the structure

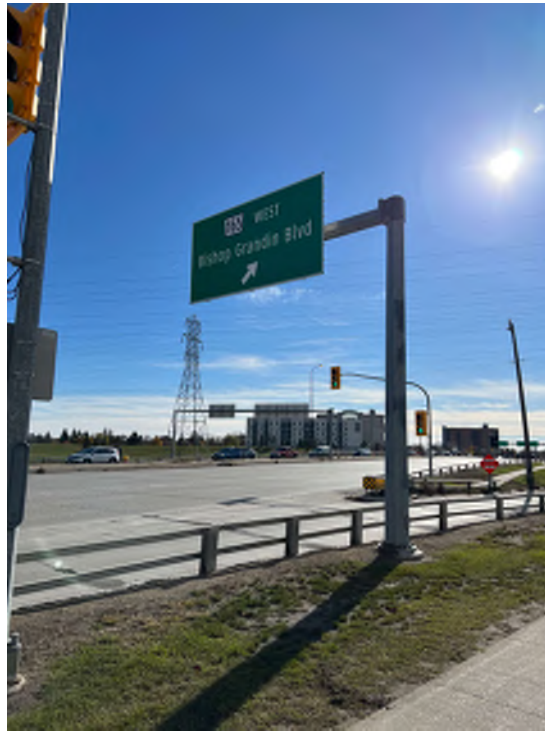
**Photo 1 - Overhead sign structure, front view**

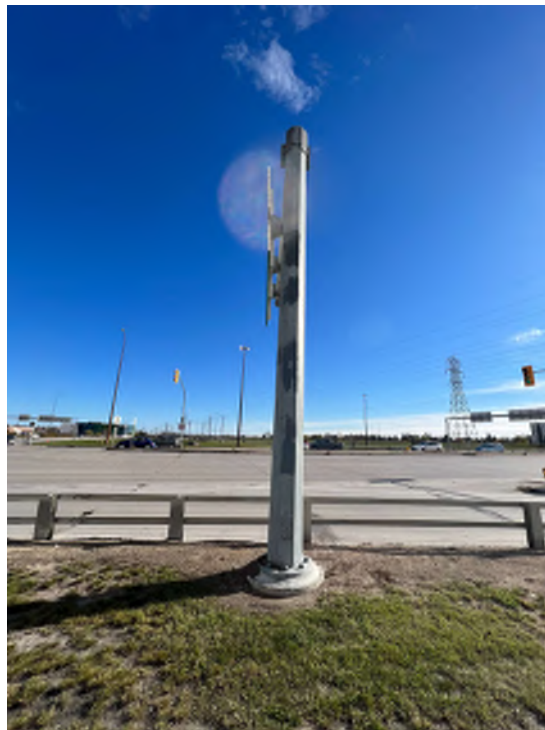
**Photo 2 - Overhead sign structure, side view**

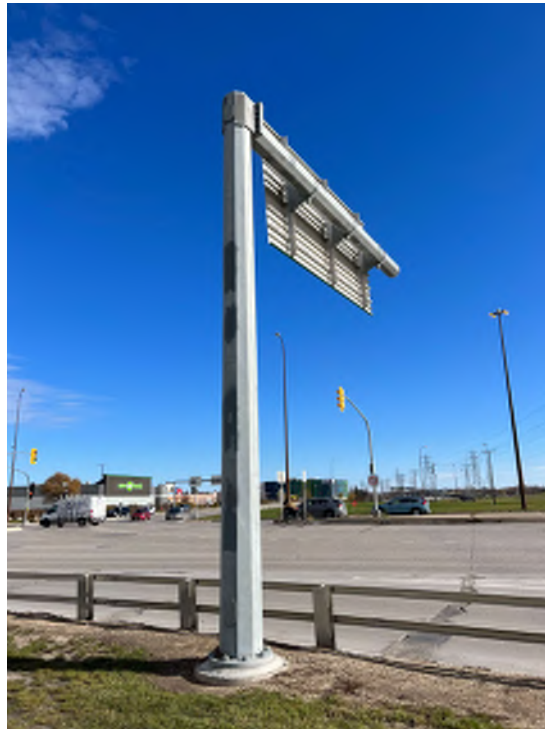
**Photo 3 - Overhead sign structure, rear view**

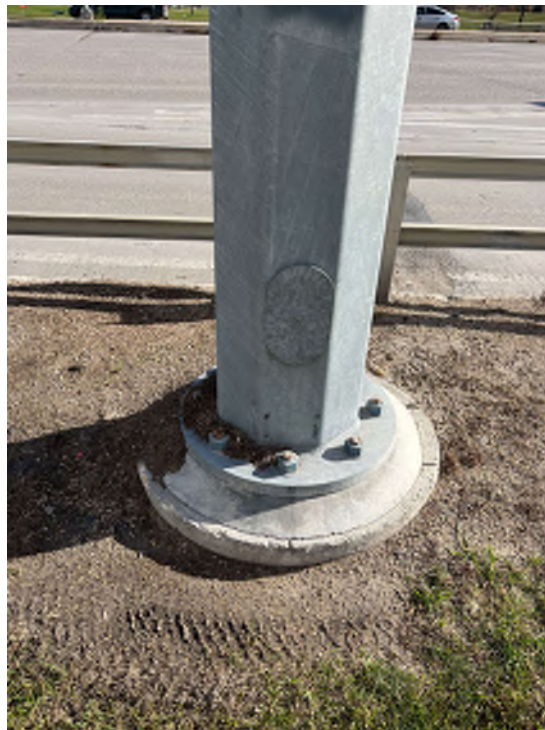
**Photo 4 - Overhead sign structure, base plate and foundation**

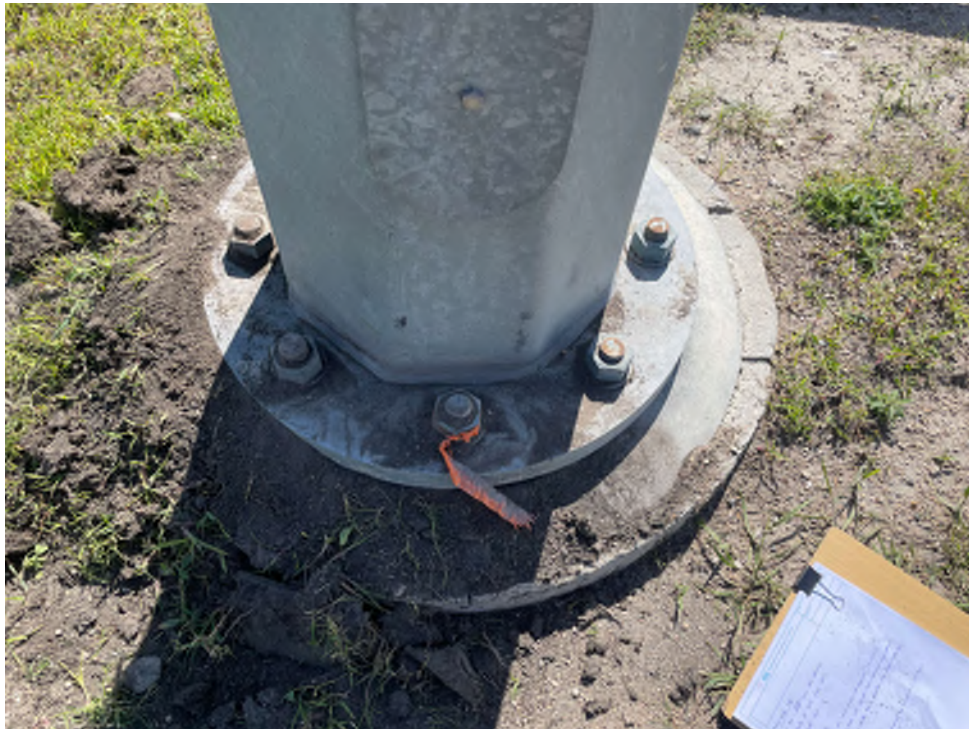
**Photo 5 - Base plate, additional view 1**

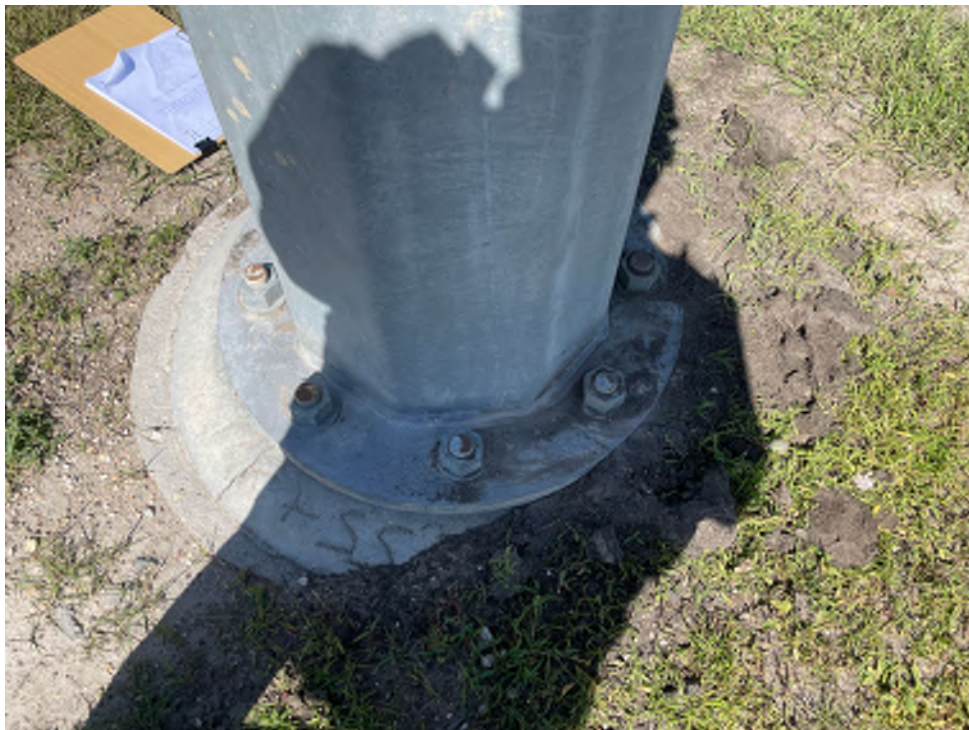
**Photo 6 - Base plate, additional view 2**

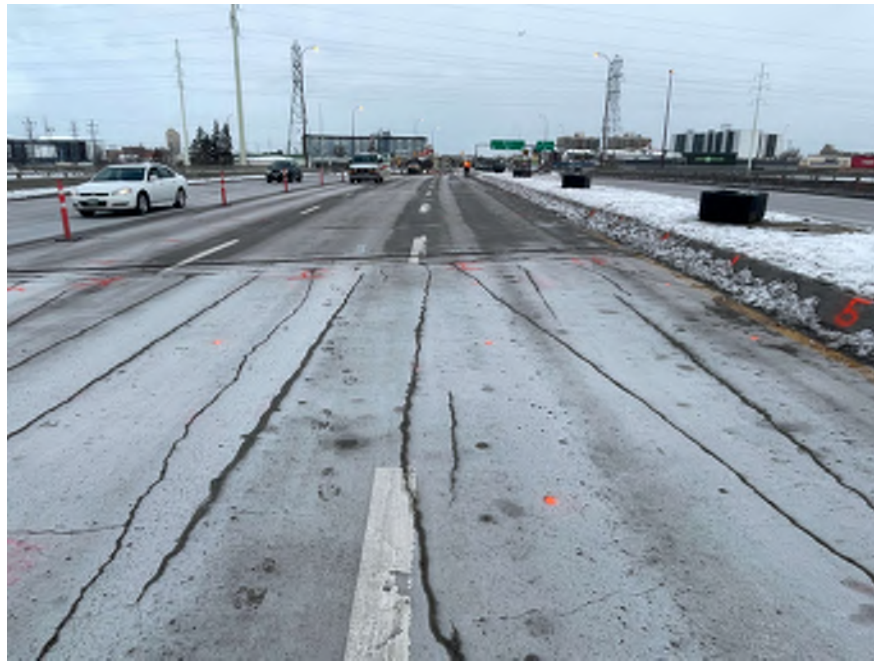
**Photo 1 - Typical approach slab medium to wide longitudinal cracking**

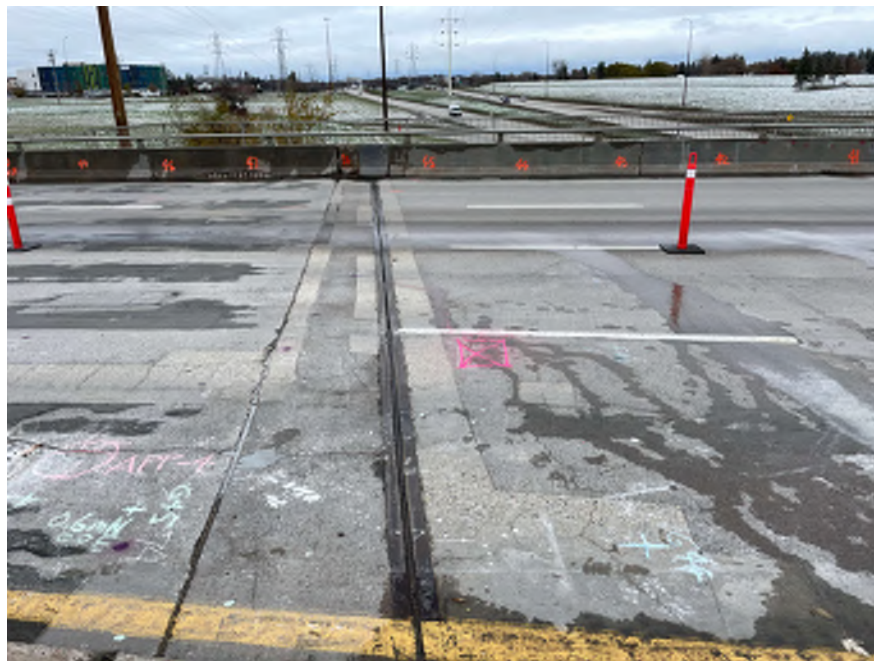
**Photo 2 - Typical expansion joint, showing uneven expansion across bridge width**

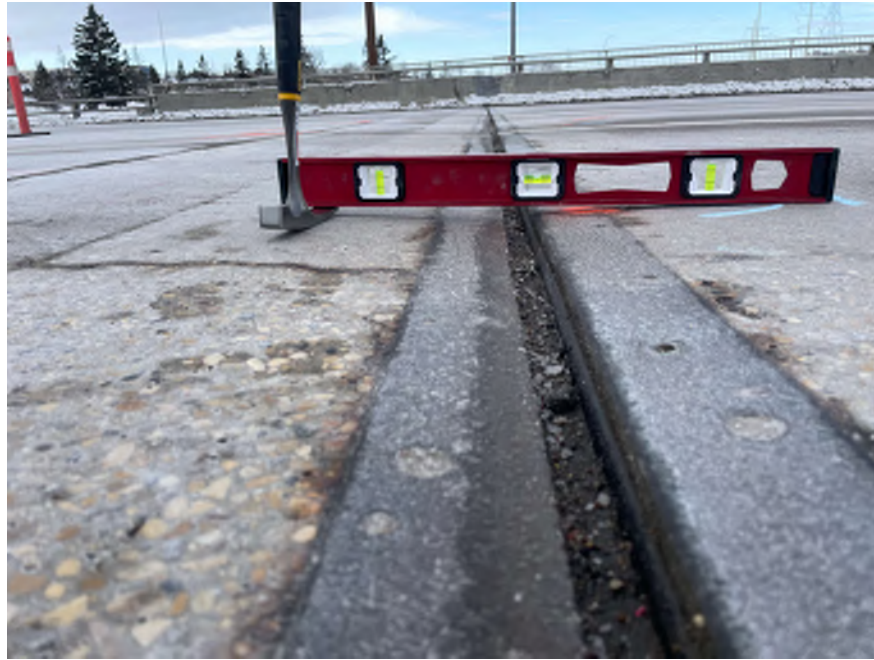
**Photo 3 - Approach slab settlement, 10-20 mm noted at all approach slab locations, compared to deck blockout elevation**

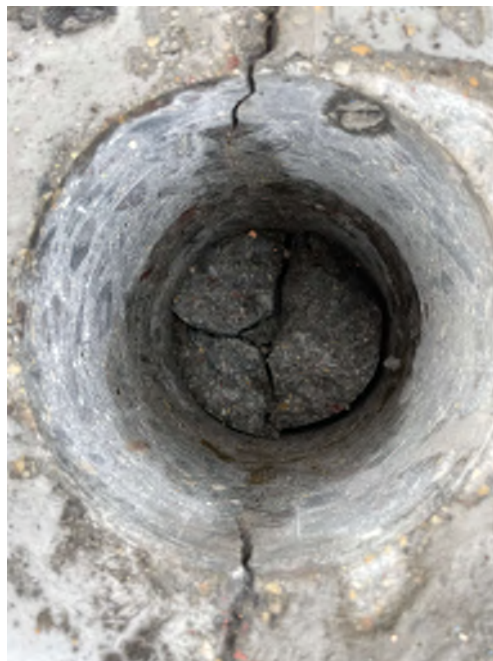
**Photo 4 - Approach slab core APP7, taken through a wide longitudinal crack which extended the depth of the core**

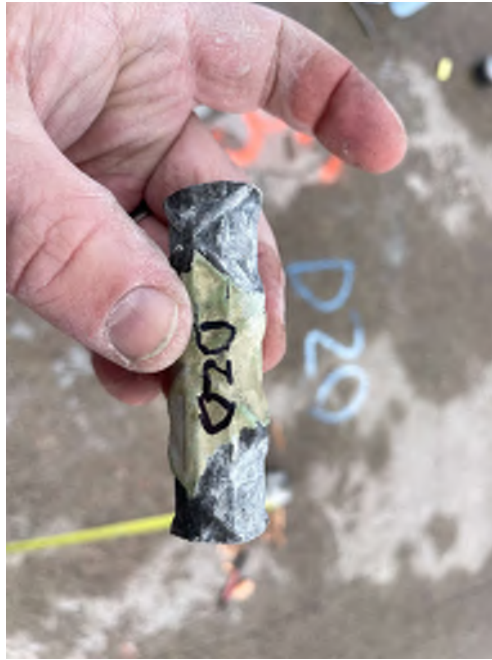
**Photo 5 - Deck core D20, epoxy coated rebar condition, coated has failed and is debonding**

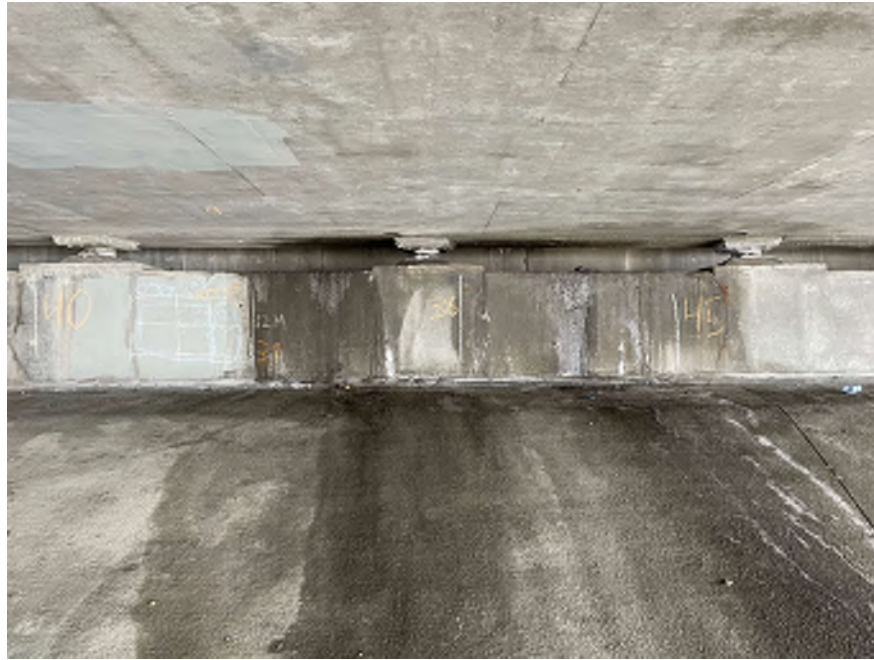
**Photo 7 - Abutment wall, intermittment leakage across width of bridge and showing vertical cracking**

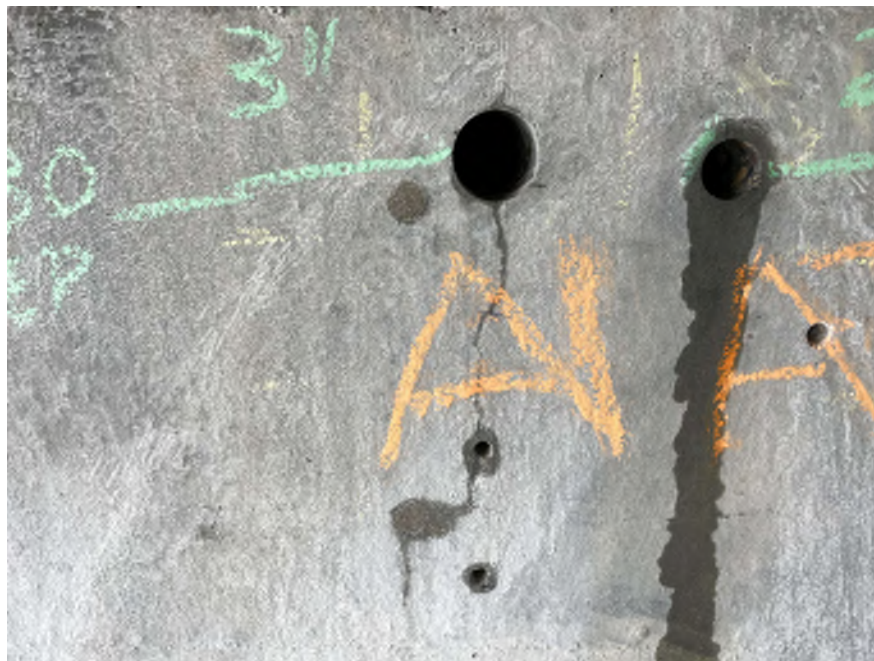
**Photo 8 - Abutment core A1, core taken through narrow to medium crack**

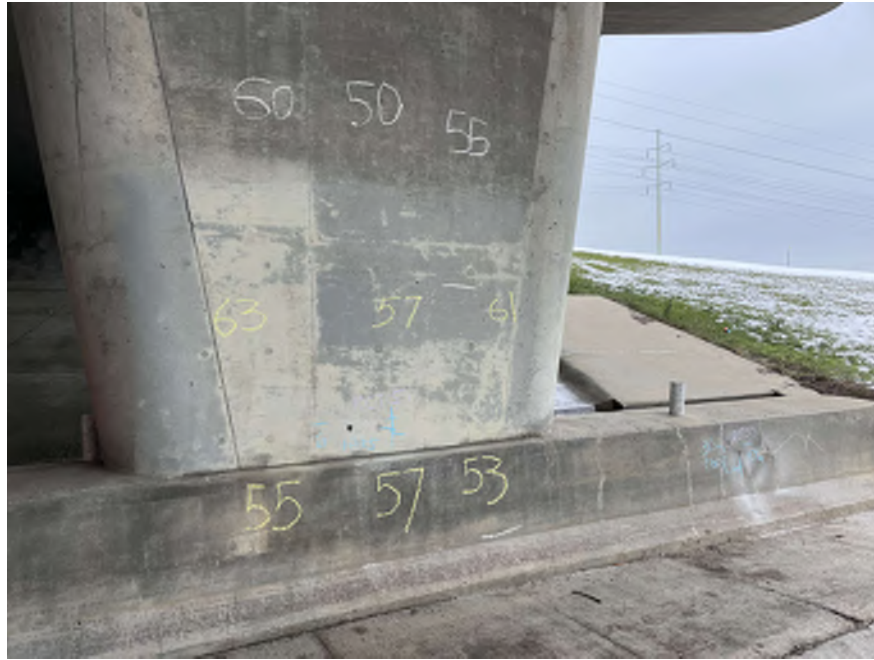
**Photo 9 - Typical bottom of pier condition note cracking on barrier wall at base of pier**

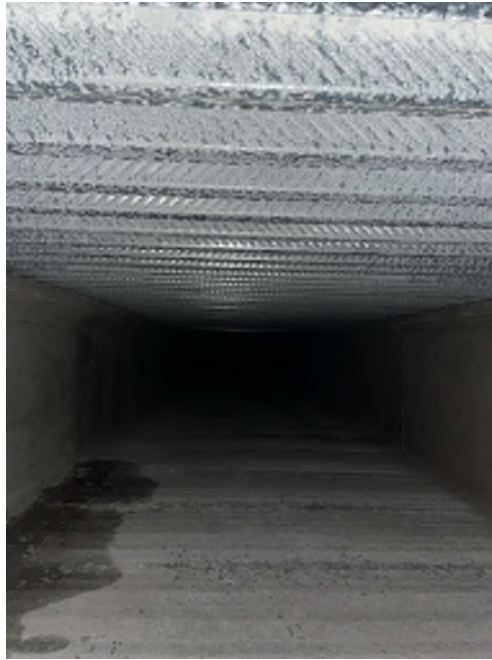
**Photo 11 - Deck core hole D12, view inside box girders, note white corrosion oxidation product on SIP formwork**

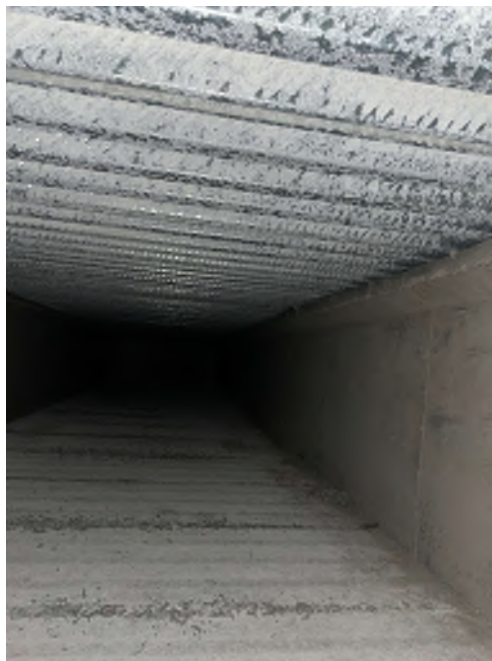
**Photo 12 - Deck core hole D12, view inside box girders, note white corrosion oxidation product on SIP formwork, additional view**

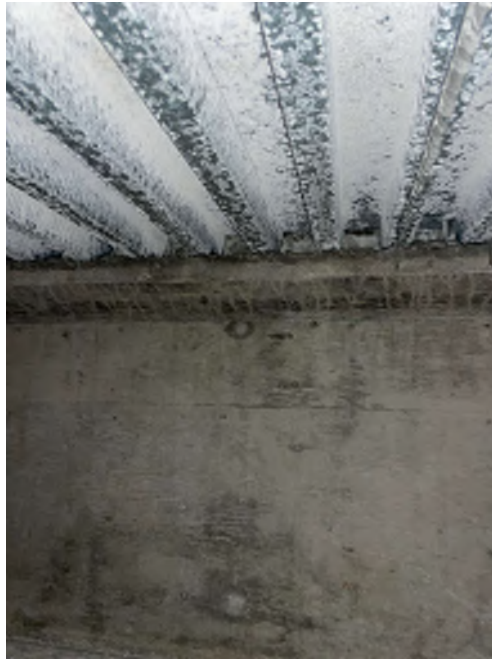
**Photo 13 - Deck core hole D12, view inside box girders, girder web and top flange, note dampness and staining**

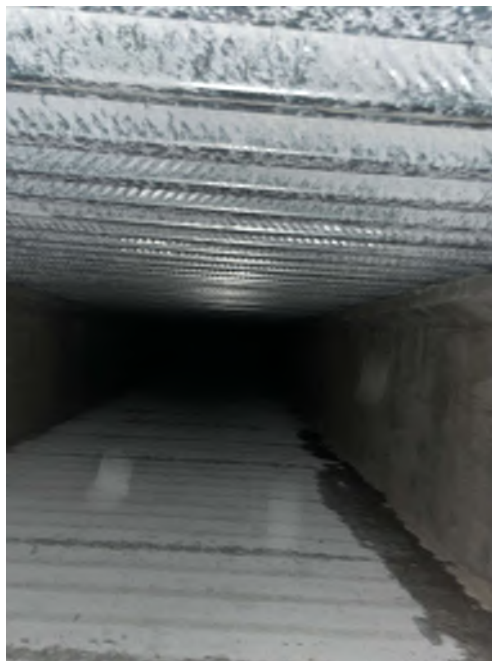
**Photo 14 - Deck core hole D29, view inside box girders, note white corrosion oxidation product on SIP formwork**

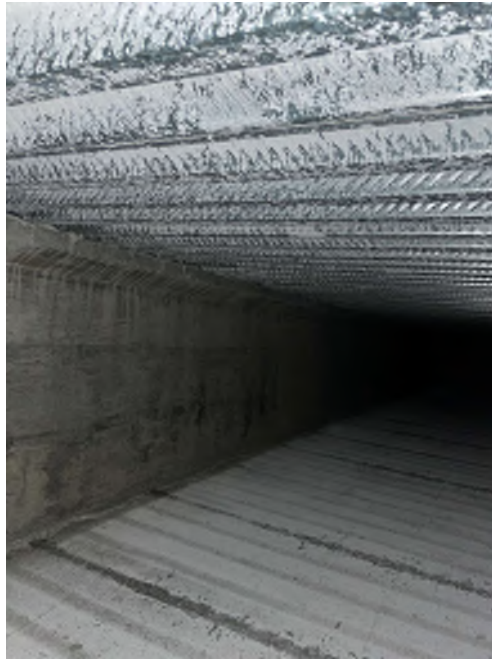
**Photo 15 - Deck core hole D29, view inside box girders, girder web and top flange, note dampness and staining**

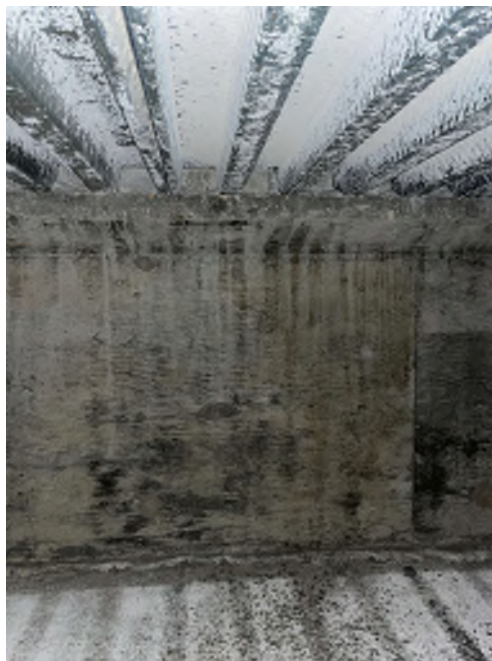
**Photo16 - Deck core hole D29, view inside box girders, girder web and top flange, note dampness and staining, additional view**

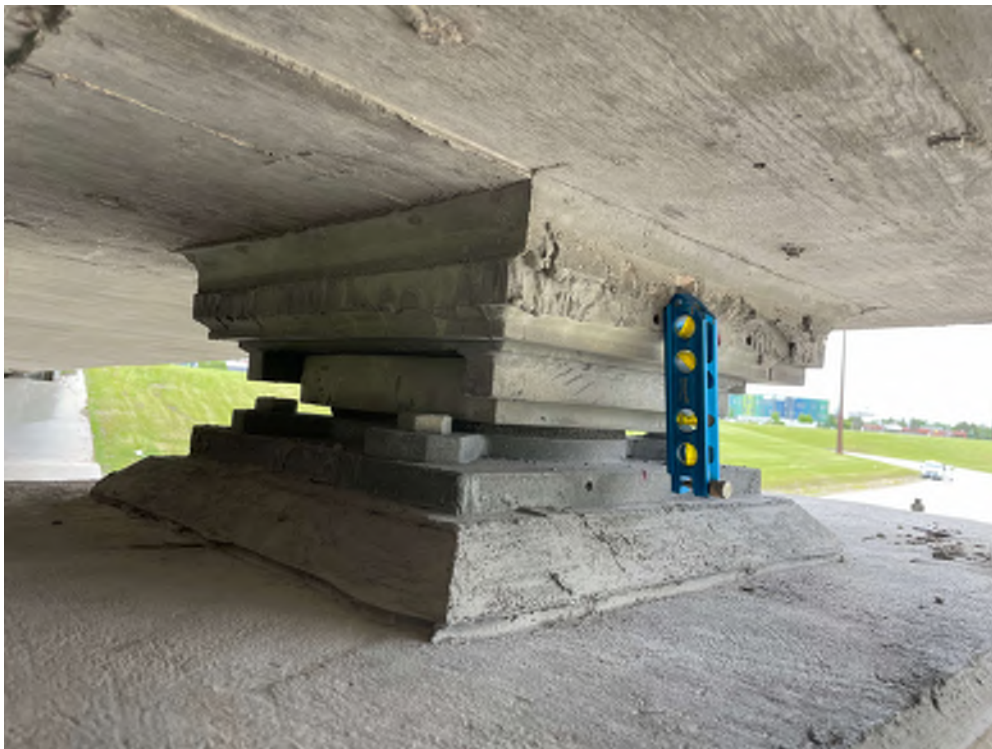
**Photo 04 - SU3 Pier, Line "T" East exterior bearing**

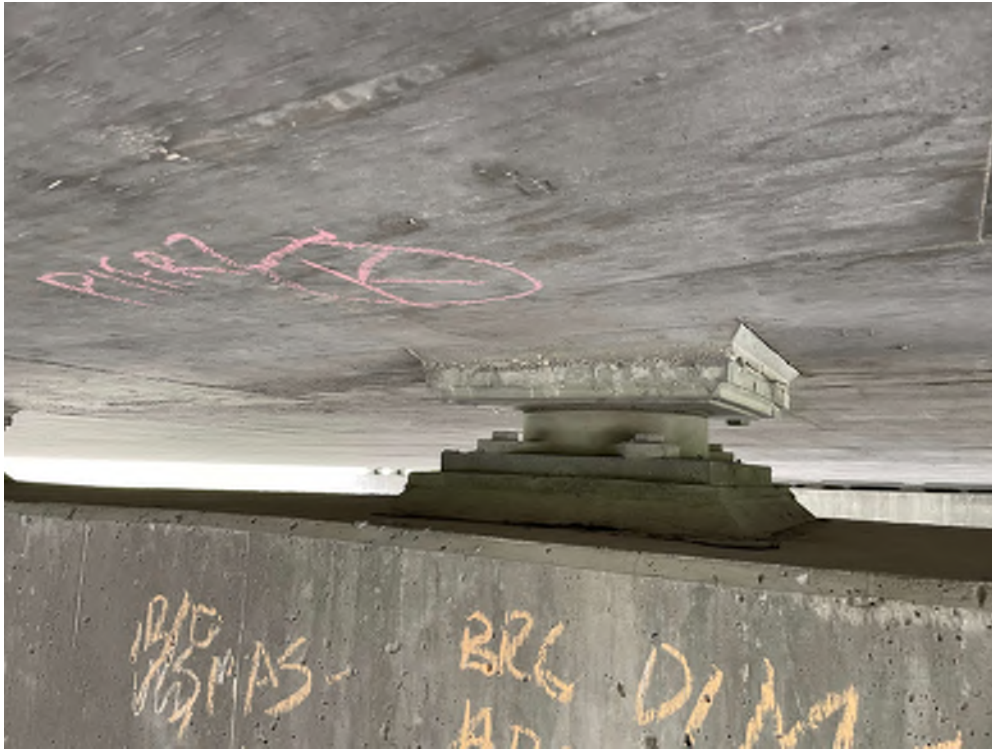
**Photo 05 - SU3 Pier, Line "K" bearing near transverse centreline – note- confirmatory measurements taken on bearing**

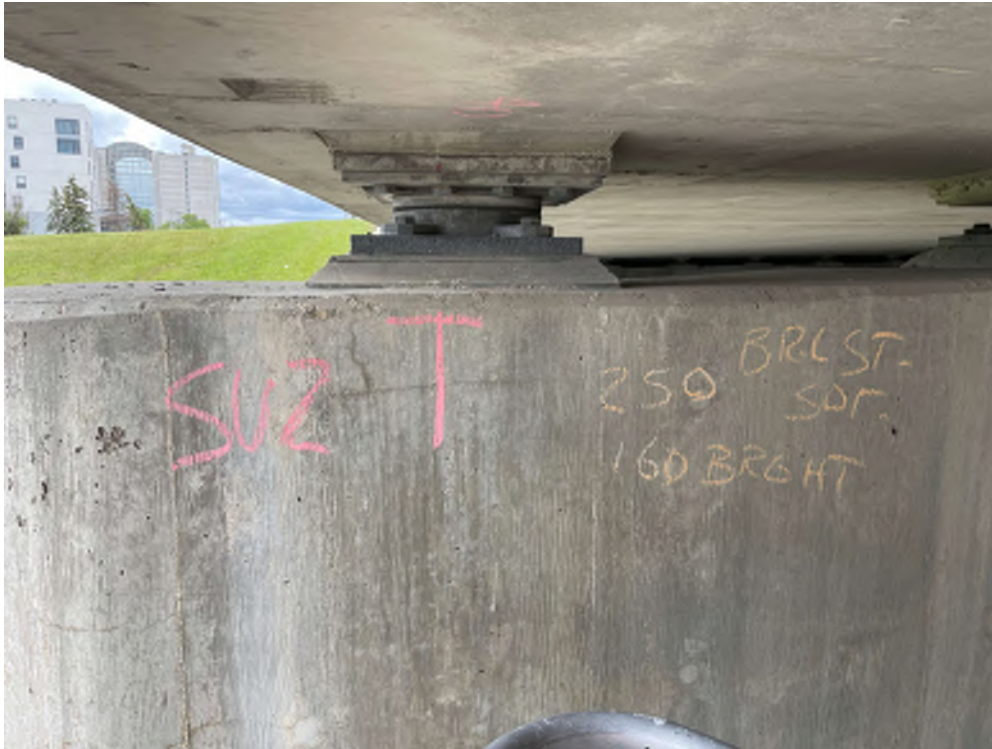
**Photo 11 - SU2 Pier, Line "T" East exterior bearing**

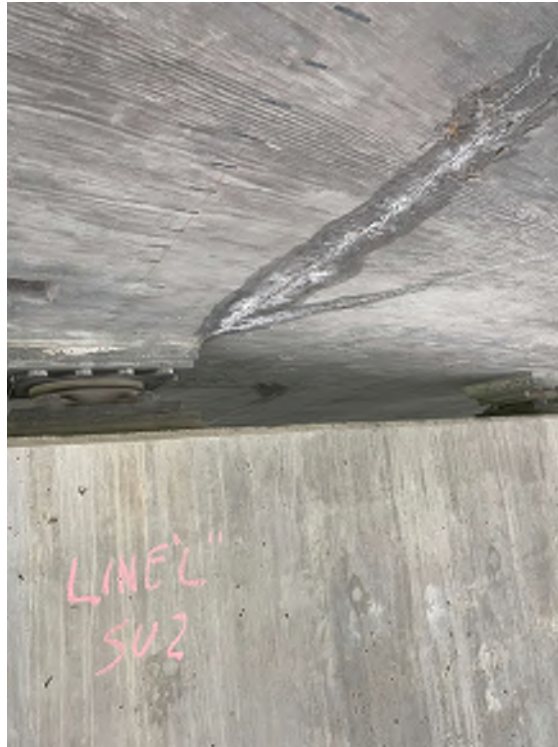
**Photo 15 - Span 2, narrow crack with efflorescence and wetness near Line "L"**

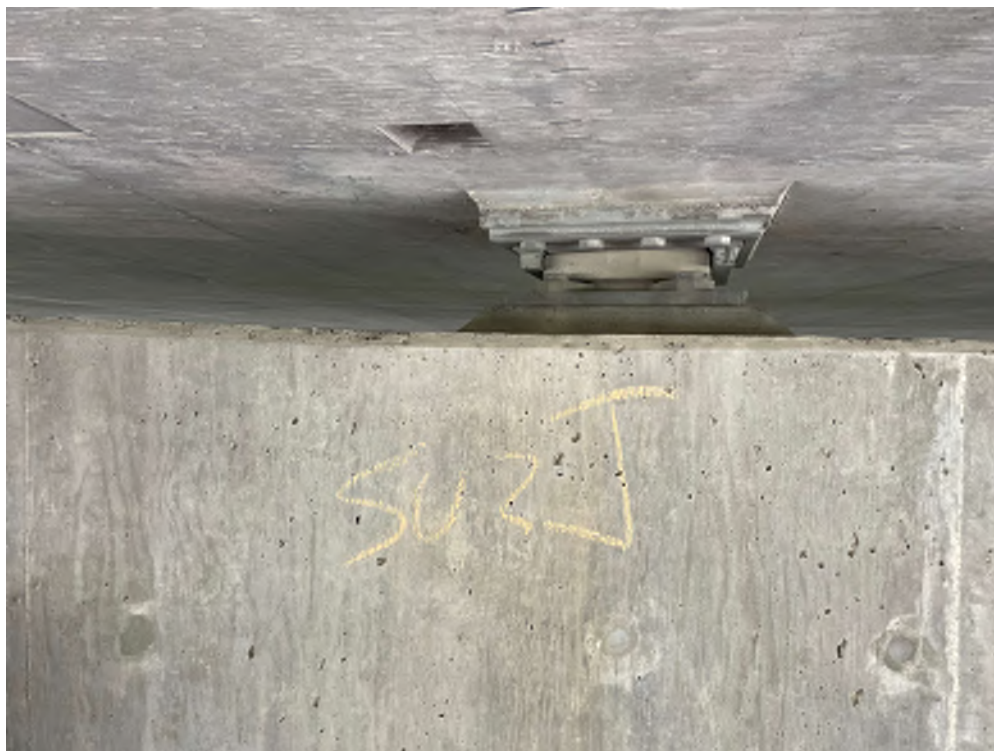
**Photo 16 - SU2, Line "J", showing bearing type near centreline of bridge**

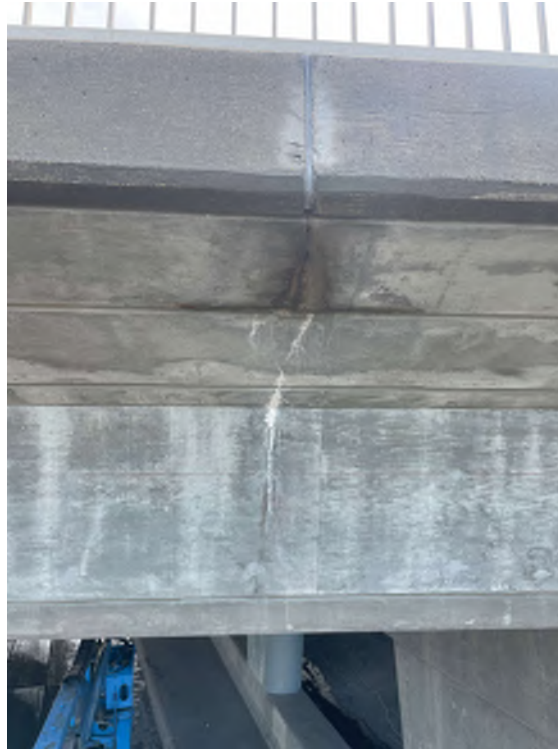
**Photo 17 - Deck overhang at sidewalk curb joint near SU2, note wetness and efflorescence**

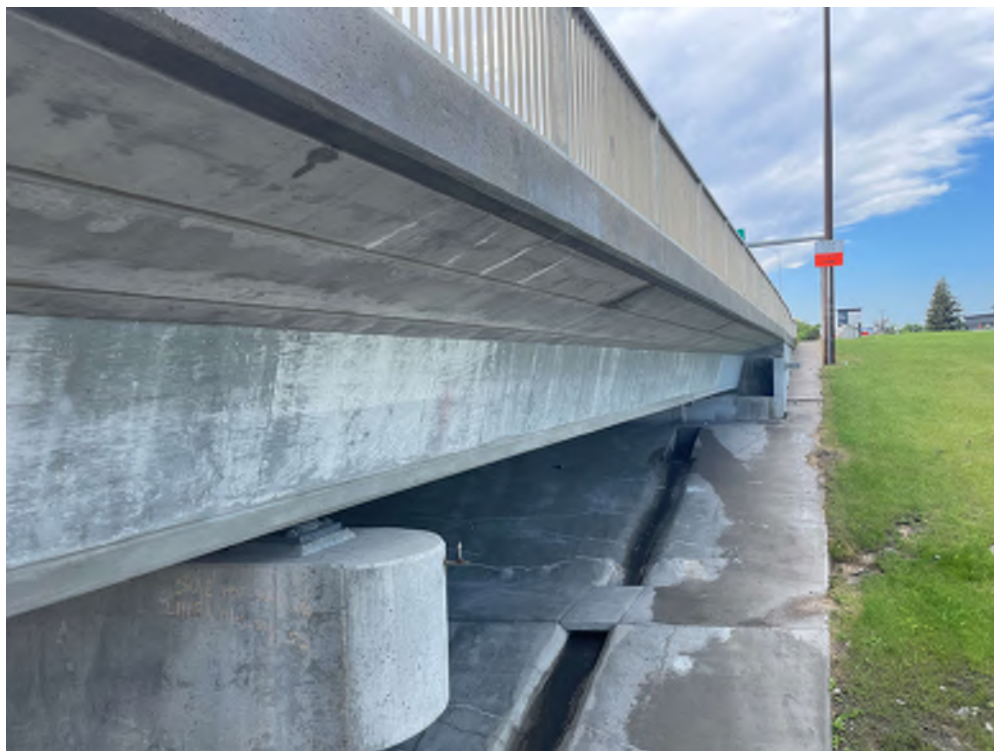
**Photo 18 - Span 1, west deck overhang**

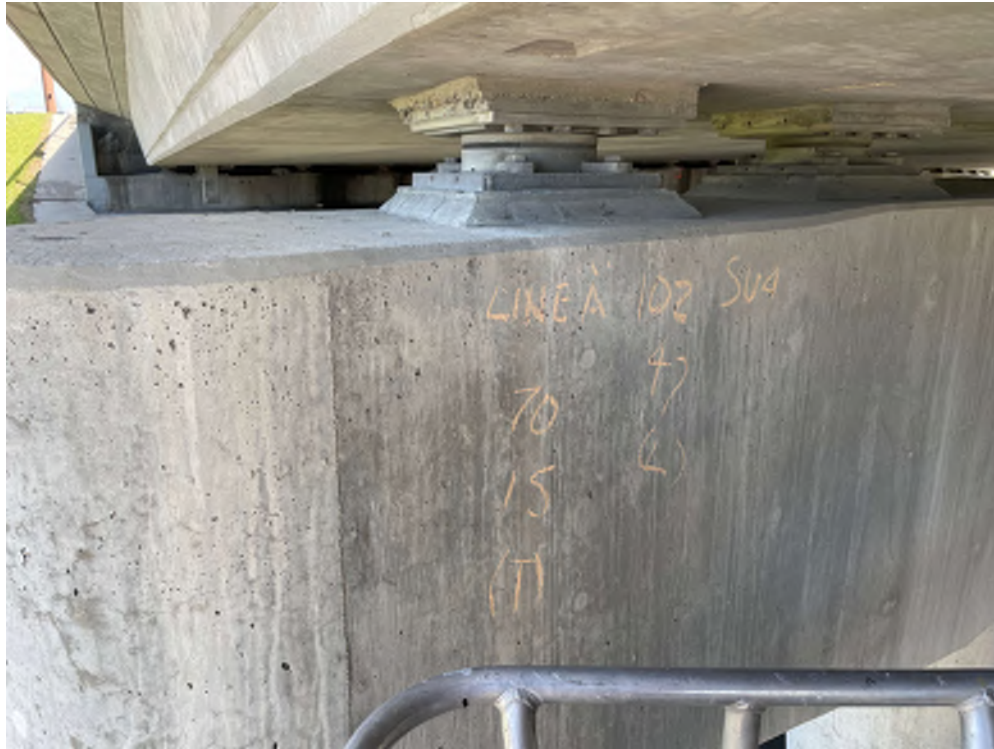
**Photo 19 - SU4, Line "A" west exterior bearing**

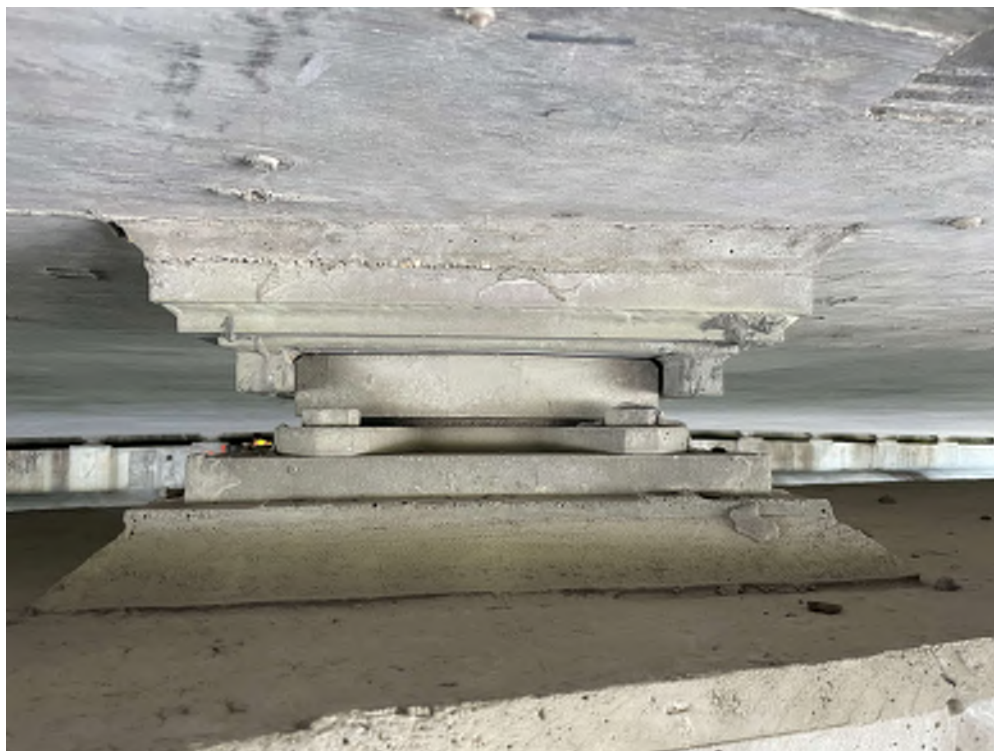
**Photo 22 - SU4, Line "K" unidirectional bearing**

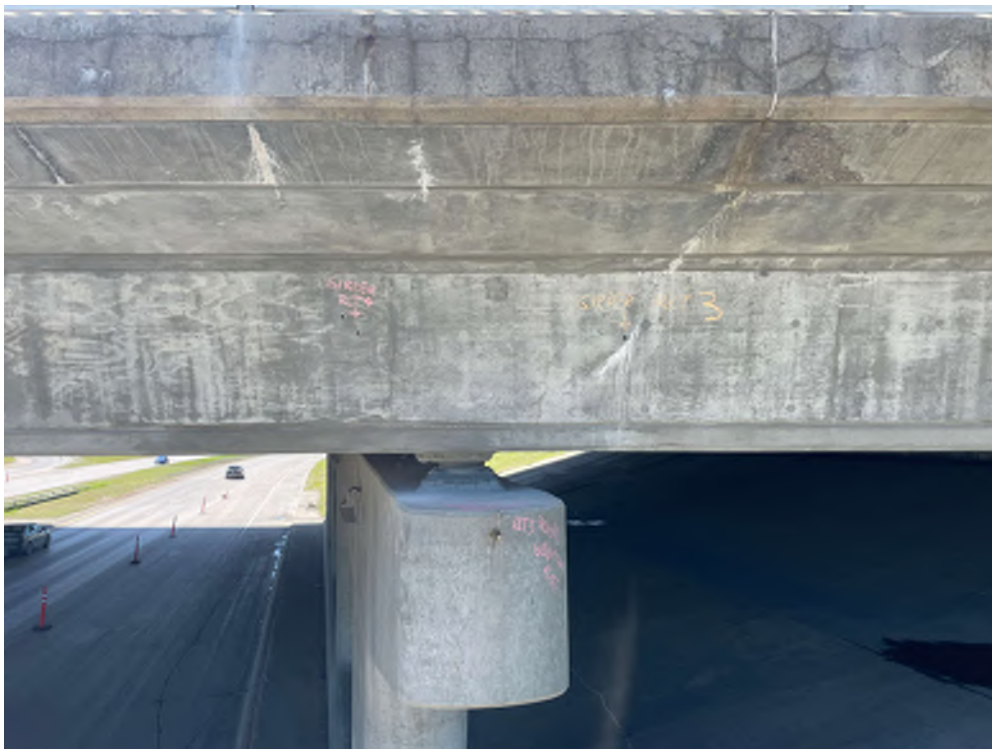
**Photo 24 - Girder RCT Locations 3 and 4, east exterior girder face near SU4**

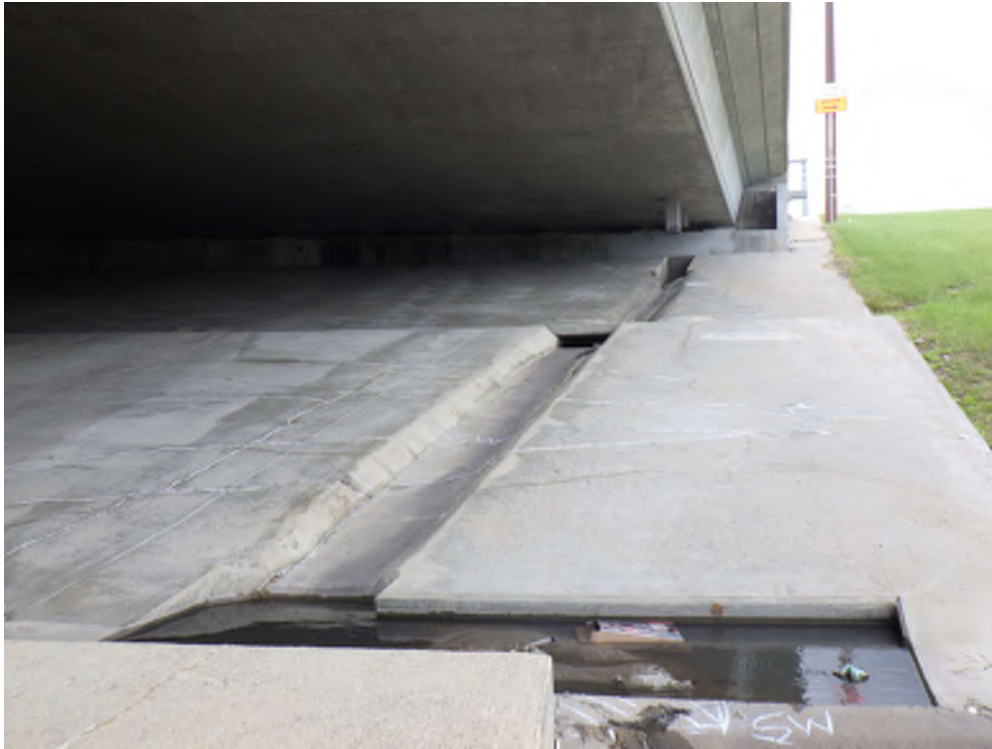
**Photo 25 - SW slope paving drainage trough**

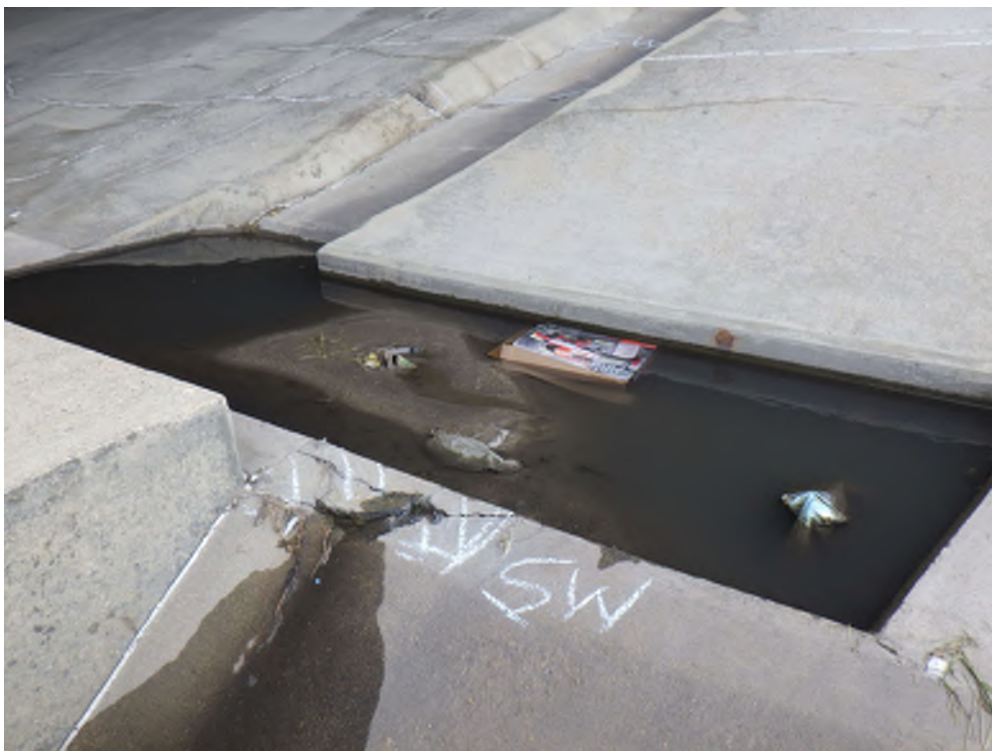
**Photo 26 - SW slope paving lower catch basin**

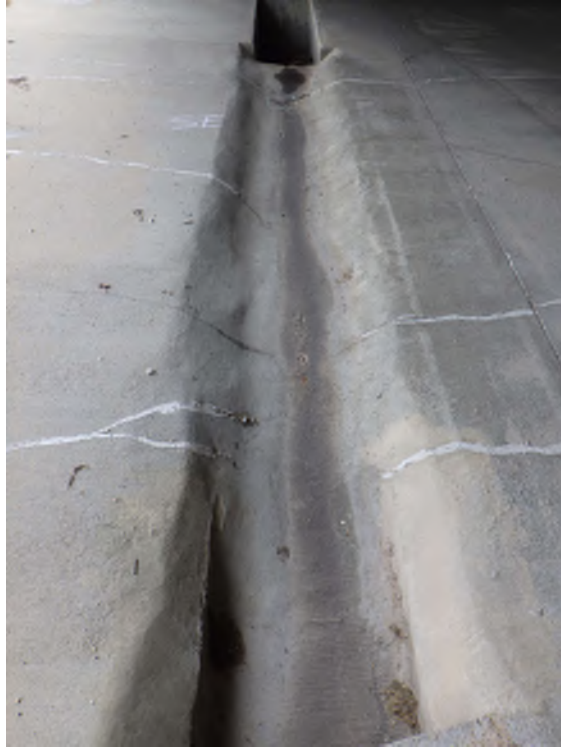
**Photo 29 - SE slope paving drainage trough, closer view of wide cracking and localized small delaminations**

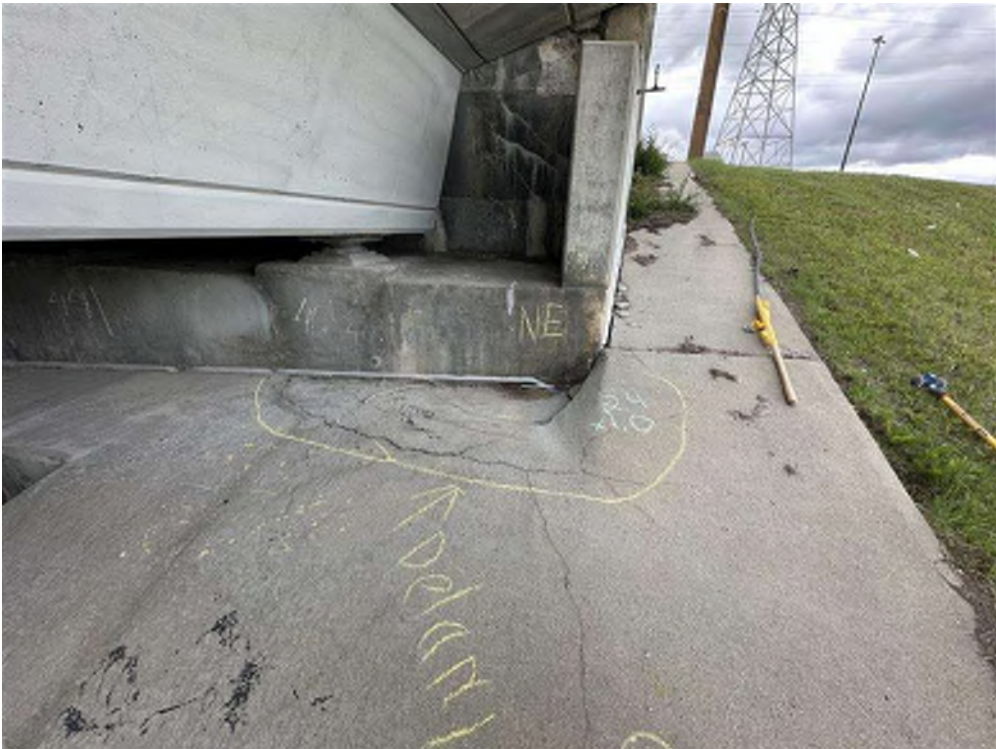
**Photo 34 - NE slope paving, delamination 1.0 m x 2.4 m**
