### DETAILED BRIDGE CONDITION SURVEY

## Pembina Highway Bridge Over Abinojii Mikanah (Bishop Grandin)

(Site No. B-215)

November 22, 2024

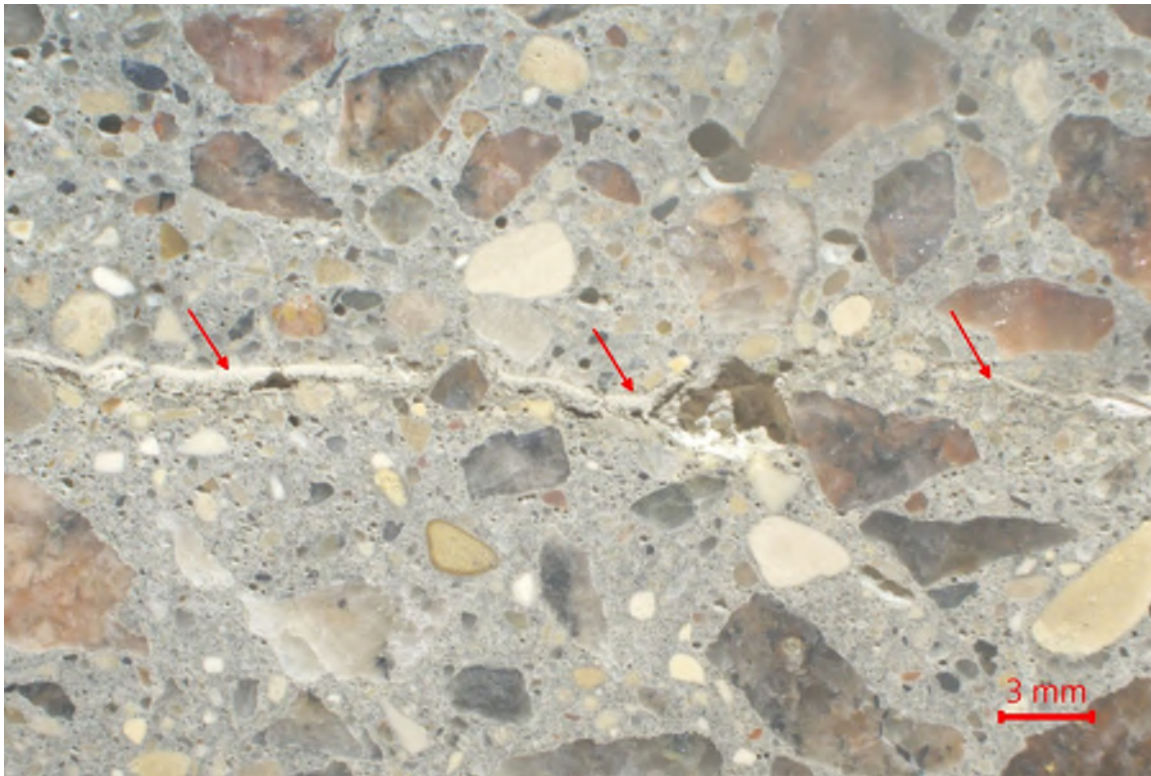
**Photo: 19**

2. The base and overlay concretes in sample D28 3406 were separated by a 1 mm (1/32") to 2 mm (1/16") thick layer of discontinuous, very light gray, very soft (Mohs hardness < 2), cementitious 'slurry'. The source of this material was not clear based on our examination. While the two concretes were well-consolidated and did not separate from one another during saw-cutting and sample preparation, the slurry layer represents a physical plane of weakness between the two concretes. Further, when the core was struck with a rock hammer at the contact, it fractured mostly along the contact plane. The top surface of the base concrete was oriented sub-horizontally, was undulose / wavy in profile, and appeared to have been rake-finished but with less amplitude compared to sample D13 3396. Depth of carbonation from the top surface of the base concrete ranged from negligible to 1 mm (1/32"). The general overall condition of the base and overlay concretes was considered good, with no evidence of mass deterioration mechanisms observed. Both concretes were of visually similar composition. The base concrete appeared air entrained, and the overlay concrete contained only a small amount of spherical entrained-sized air voids.

**Description:** Thin layer of soft, cementitious slurry material (red arrows) between the base concrete (bottom) and overlay concrete (top).

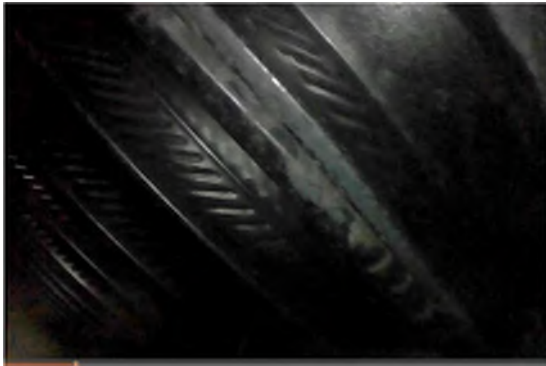
Figure 5: Stay-in-place Deck Forms at SAG1

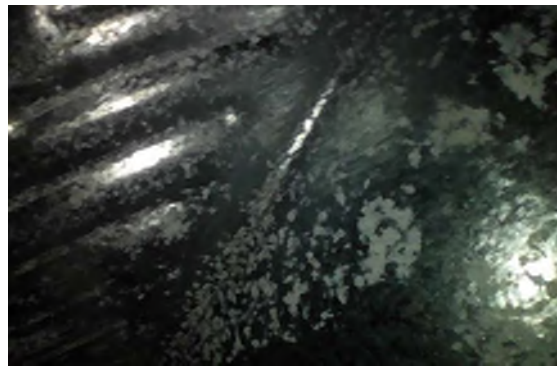
Overall, the stay-in-place forms on the deck underside appear to be in good condition. White zinc corrosion product was commonly observed. Figure 6 and Figure 7 show typical corrosion of the zinc galvanizing. The bridge was constructed in 1988, hence some corrosion of the zinc galvanizing deck forms is to be expected. However, there was no indication of steel corrosion at the present time. None of the borescope videos showed the presence of brown corrosion byproduct which is indicative of steel corrosion.

Figure 6: Stay-in-place Deck Forms at SAG3

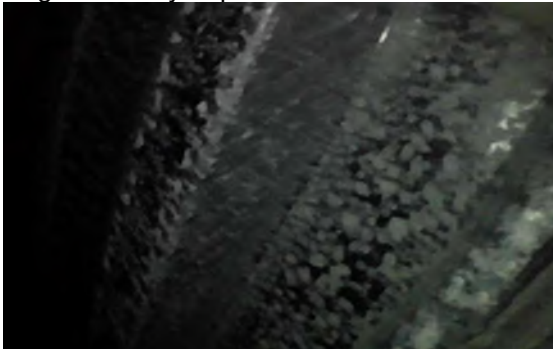
Figure 7: Stay-in-place Deck Forms at SAG4

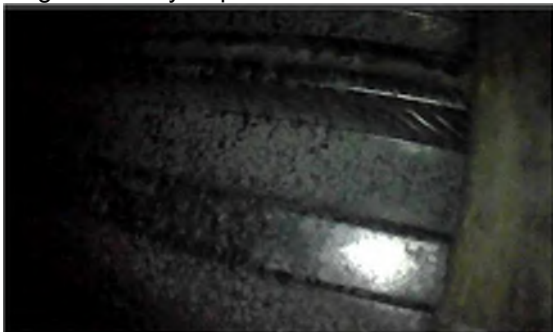
Figure 9: Stay-in-place Deck Forms at SAG7

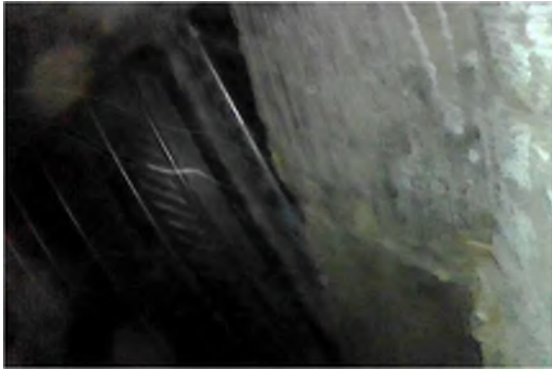
Figure 11: Stay-in-place Deck Forms at SAG11

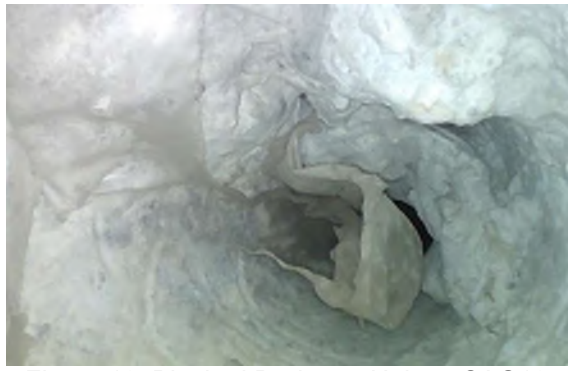
Figure 12: Blocked Drainage Hole at SAG12

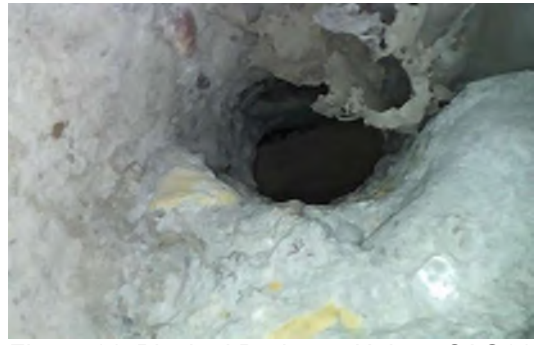
Figure 14: Blocked Drainage Hole at SAG14

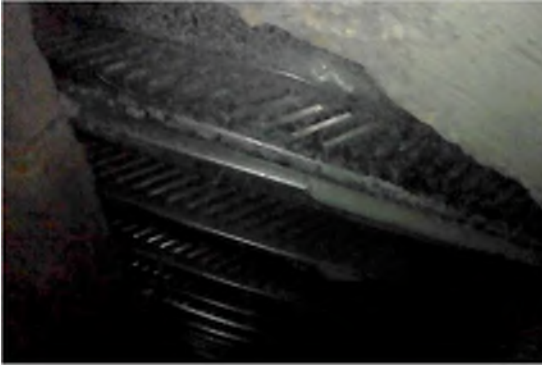
Figure 15: Stay-in-place Deck Forms at SAG15

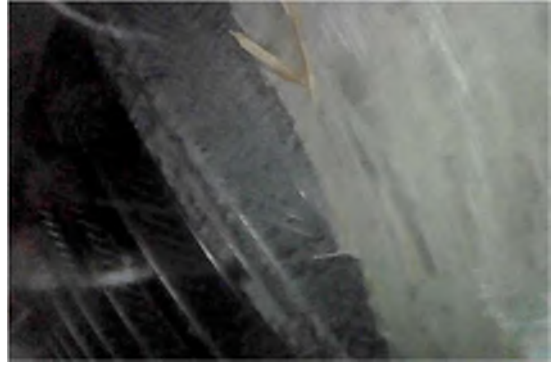
Figure 16: Stay-in-place Deck Forms at SAG16

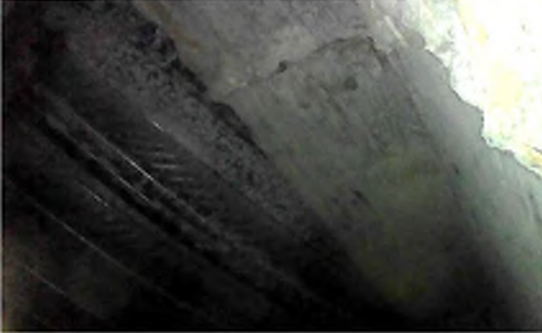
Figure 17: Stay-in-place Deck Forms at SAG17

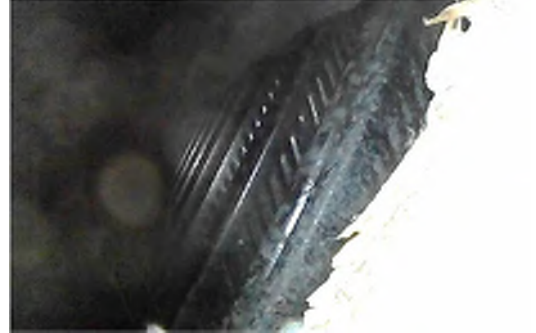
Figure 18: Stay-in-place Deck Forms at SAG18

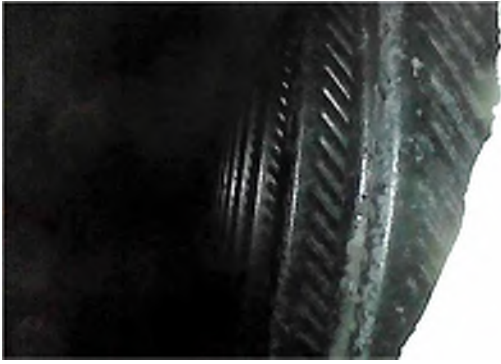
Figure 19: Stay-in-place Deck Forms at SAG19

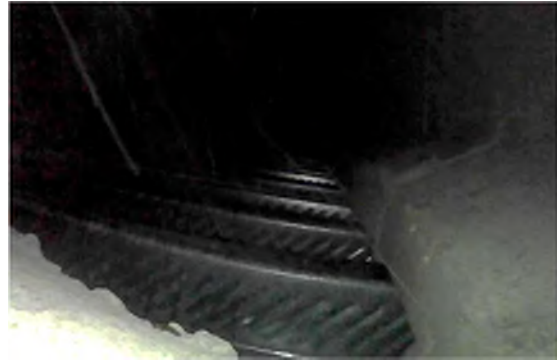
Figure 20: Stay-in-place Deck Forms at SAG20

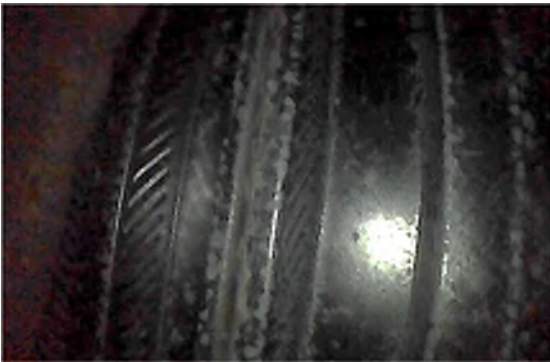
Figure 21: Stay-in-place Deck Forms at P1G1

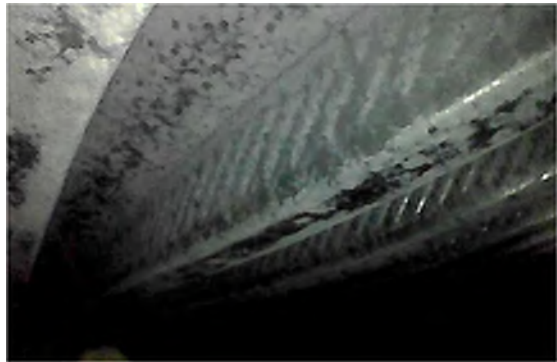
Figure 22: Stay-in-place Deck Forms at P1G2

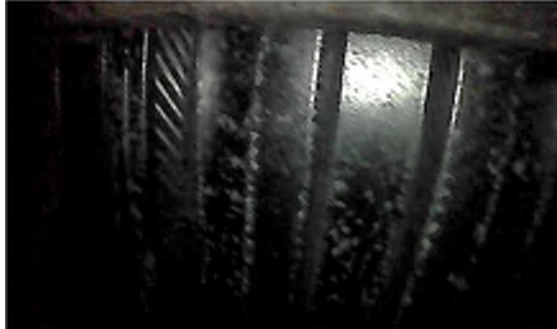
Figure 24: Stay-in-place Deck Forms at P1G4

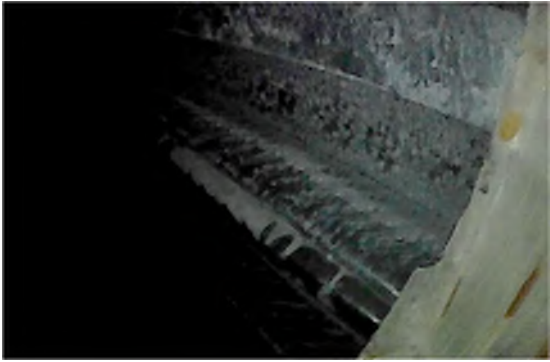
Figure 25: Stay-in-place Deck Forms at P1G5

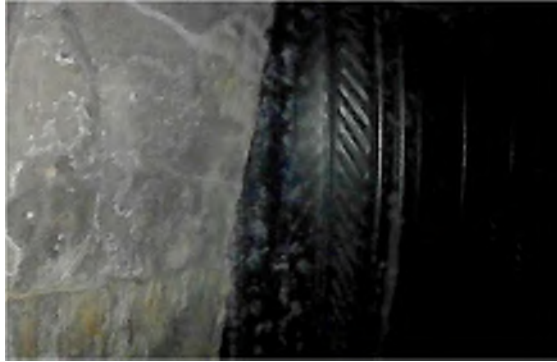
Figure 26: Stay-in-place Deck Forms at P1G6

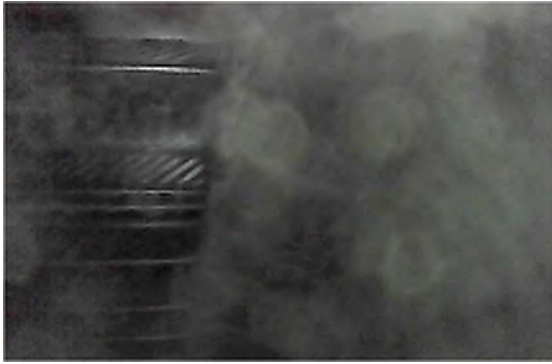
Figure 27: Stay-in-place Deck Forms at P1G7

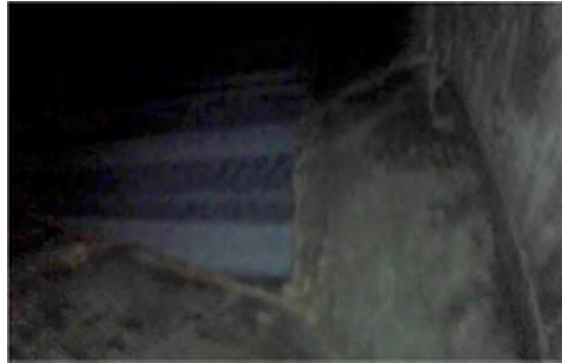
Figure 28: Stay-in-place Deck Forms at P1G8

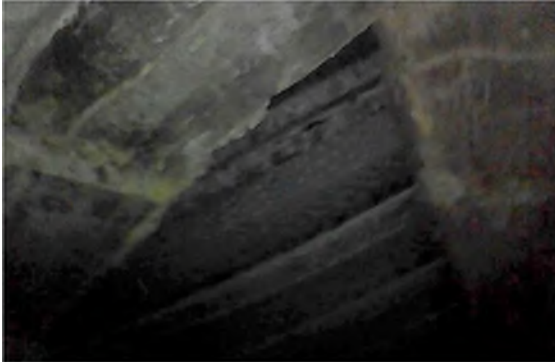
Figure 29: Stay-in-place Deck Forms at P1G9

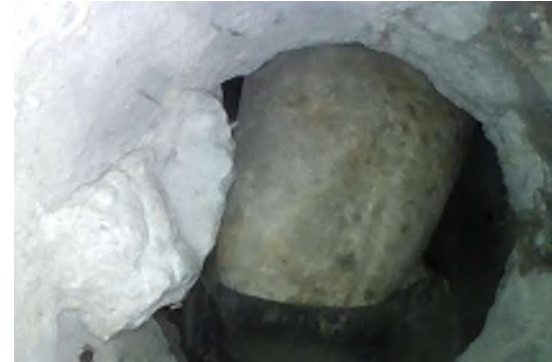
Figure 21 through Figure 33 show the condition of the deck underside along pier P1. However, drainage holes at girders 14 through 20 were inaccessible due to the sidewalk being too short to access the openings with the scaffold. At girder 10 the hole was blocked, so it was not possible for VCS to perform visual assessment at these locations (Figure 30).

Figure 30: Blocked Drainage Hole at P1G10

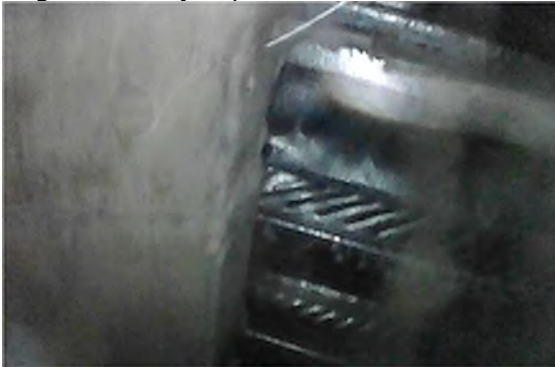
Figure 31: Stay-in-place Deck Forms at P1G11

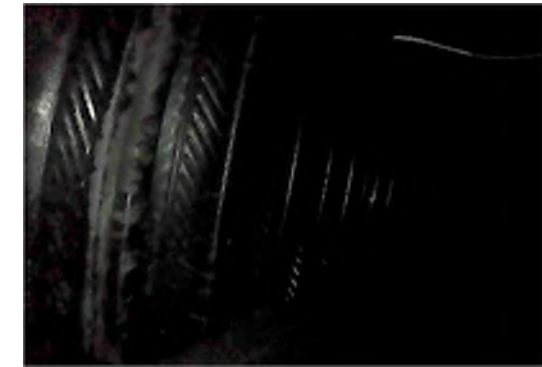
Figure 32: Stay-in-place Deck Forms at P1G12

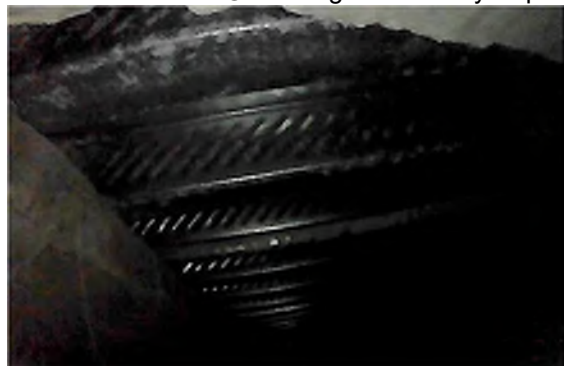
Figure 33: Stay-in-place Deck Forms at P1G13

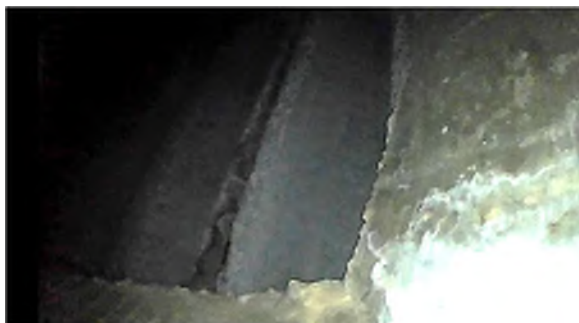
Figure 34: Stay-in-place Deck Forms at P3G9

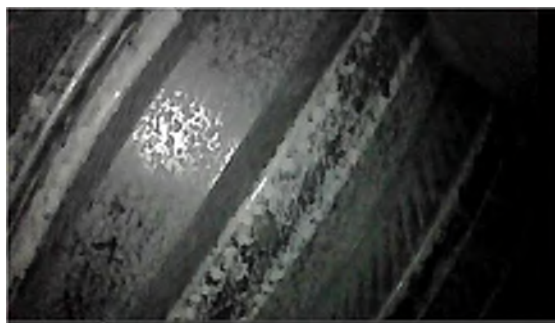
Figure 35: Stay-in-place Deck Forms at P3G10

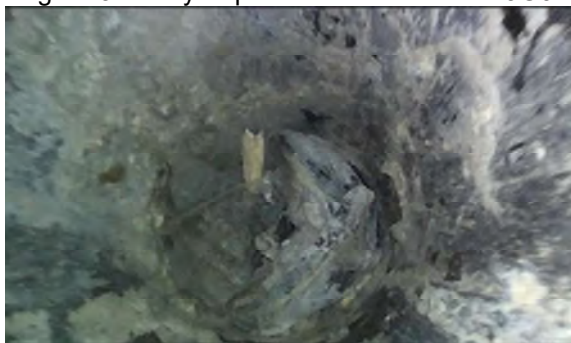
to access the openings with the scaffold. The drainage hole at girder 12 was blocked, so it was not possible for VCS to perform visual assessment at these locations (Figure 36).

Figure 36: Blocked Drainage Hole at P3G12

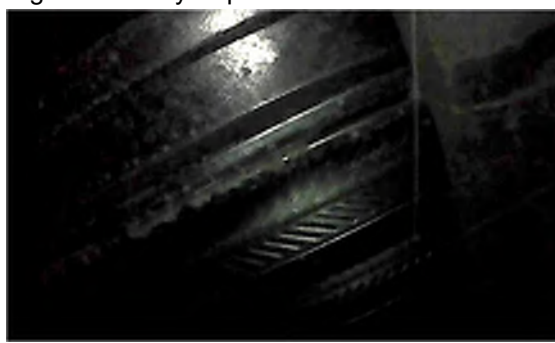
Figure 37: Stay-in-place Deck Forms at P3G13

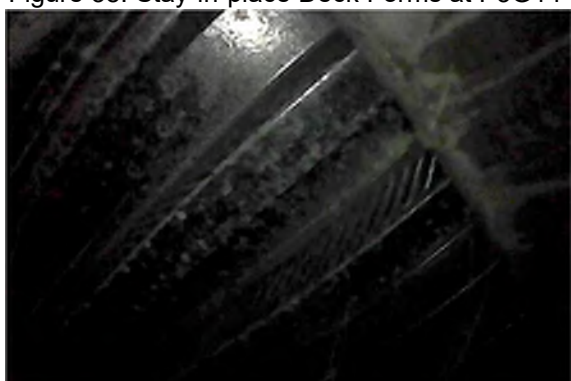
Figure 40: Stay-in-place Deck Forms at P3G16

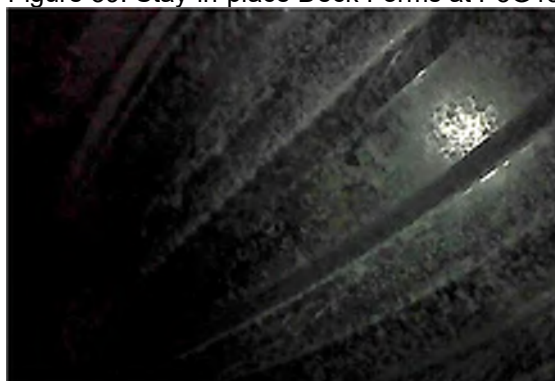
Figure 41: Stay-in-place Deck Forms at P3G17

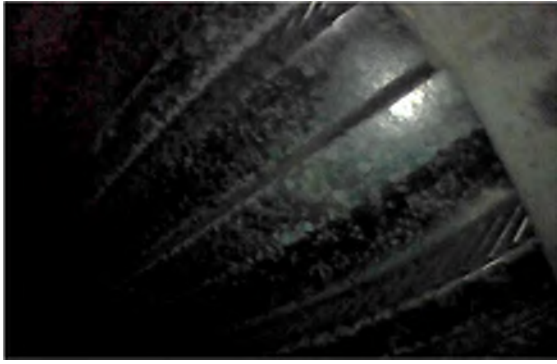
Figure 42: Stay-in-place Deck Forms at P3G18

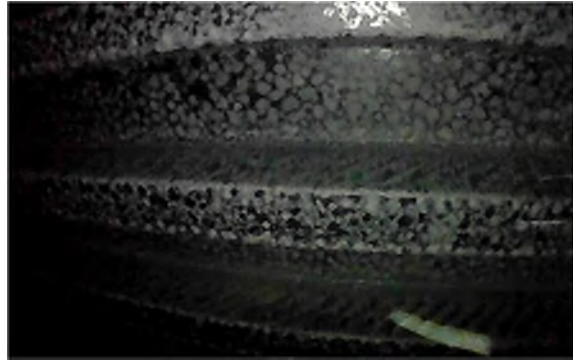
Figure 43: Stay-in-place Deck Forms at P3G19

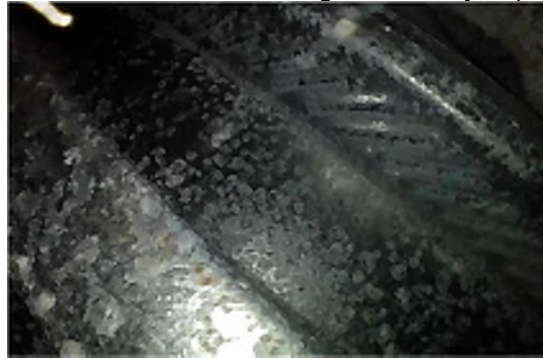
Figure 44: Stay-in-place Deck Forms at P3G20

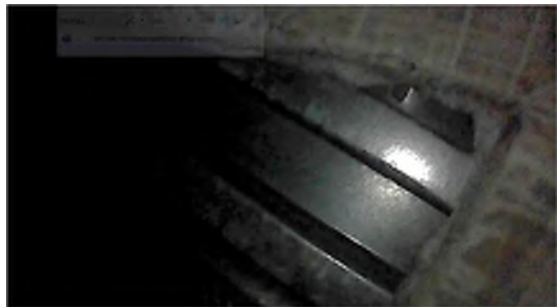
Figure 45: Stay-in-place Deck Forms at NAG1

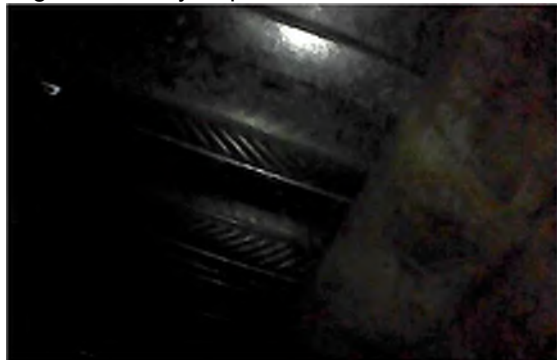
Figure 47: Stay-in-place Deck Forms at NAG3

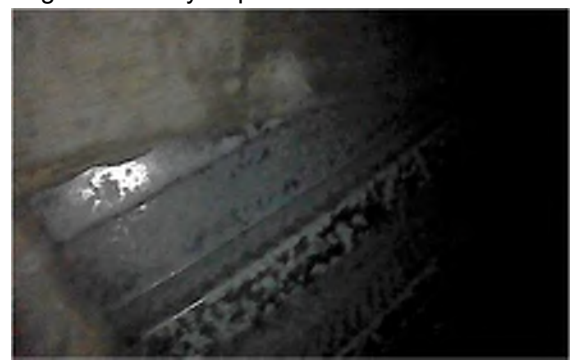
Figure 48: Stay-in-place Deck Forms at NAG4

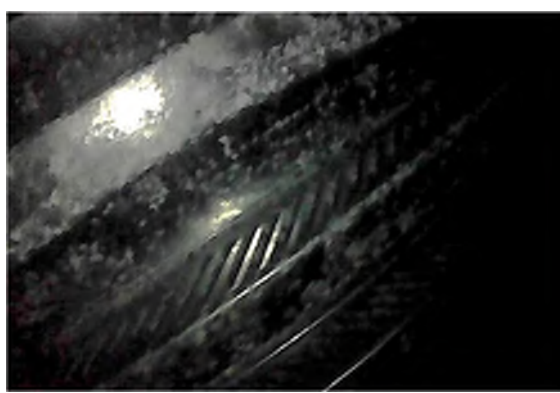
Figure 50: Stay-in-place Deck Forms at NAG6

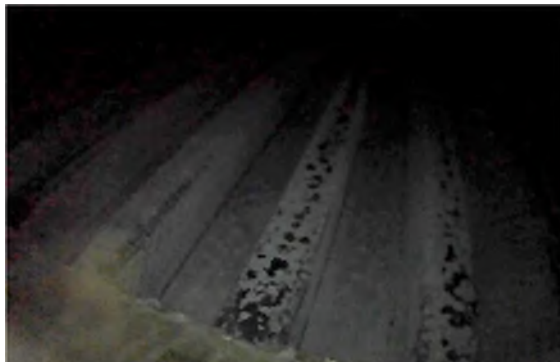
Figure 51: Stay-in-place Deck Forms at NAG7

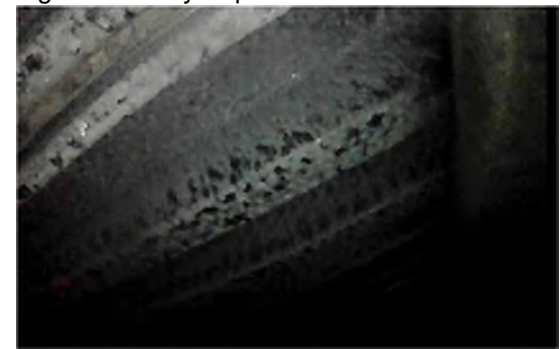
Figure 53: Stay-in-place Deck Forms at NAG10

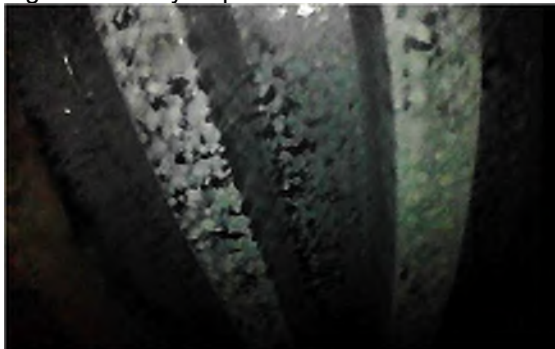
Figure 54: Stay-in-place Deck Forms at NAG11

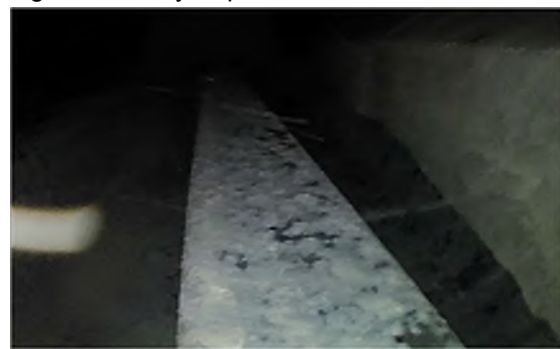
Figure 55: Stay-in-place Deck Forms at NAG12

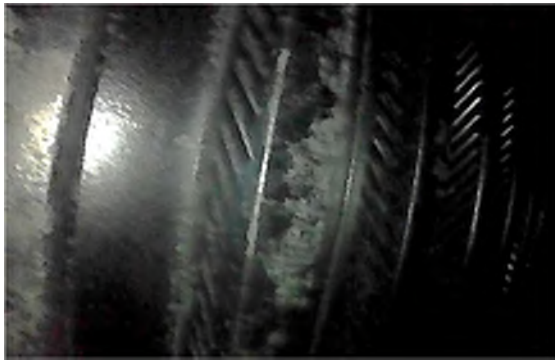
Figure 56: Stay-in-place Deck Forms at NAG13

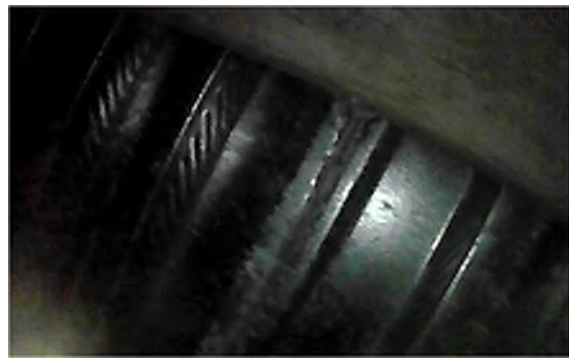
Figure 57: Stay-in-place Deck Forms at NAG14

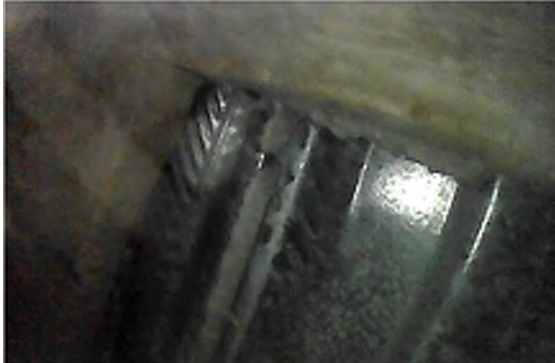
Figure 58: Stay-in-place Deck Forms at NAG15

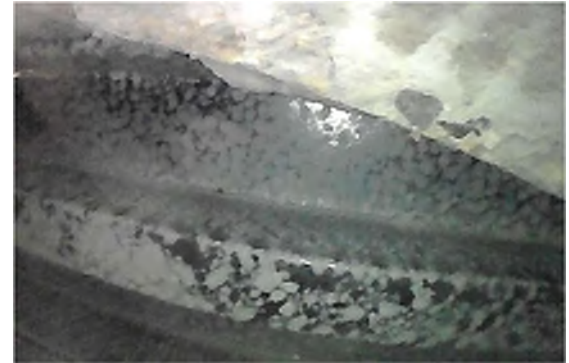
Figure 59: Stay-in-place Deck Forms at NAG16

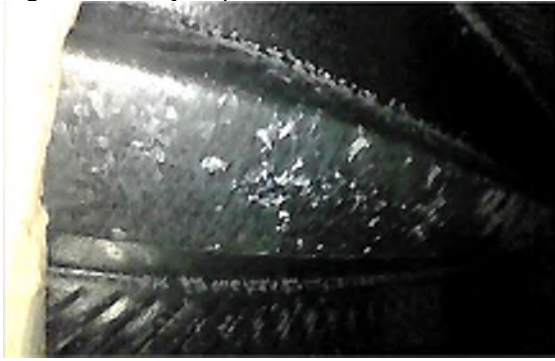
Figure 60: Stay-in-place Deck Forms at NAG17

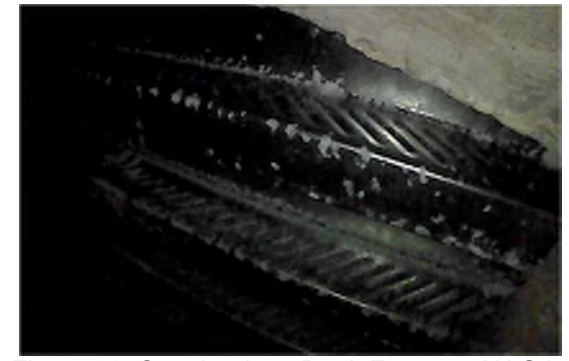
Figure 61: Stay-in-place Deck Forms at NAG18

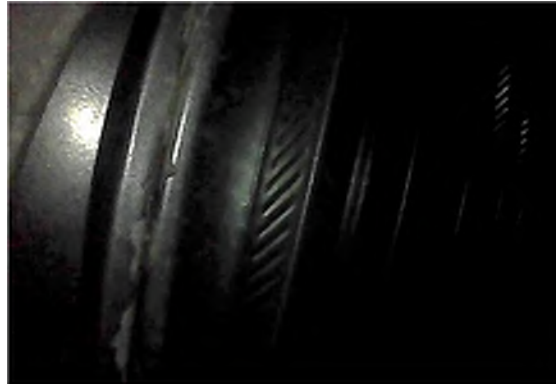
Figure 62: Stay-in-place Deck Forms at NAG19

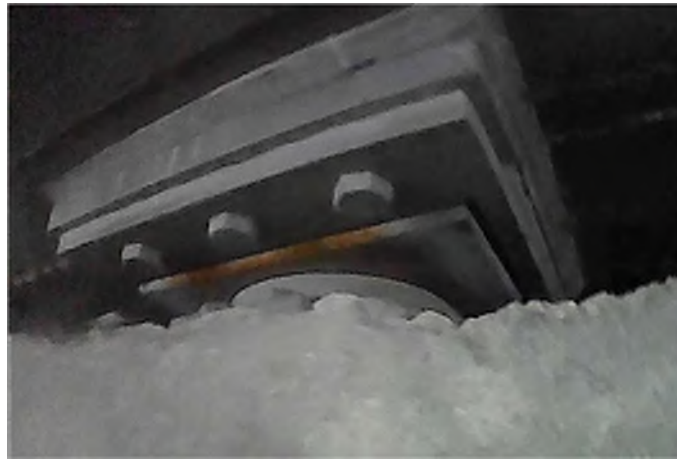
very dark, and it was not possible to analyze the condition of the girder ends. However, during the imaging of the girder ends, VCS noticed that there was some corrosion present at the bearing plate at the NAG15 location as shown in Figure 64.

Figure 64: NAG15 Bearing Plate

The stay-in-place deck forms at the inspected locations appear to be in good condition. While corrosion of the galvanizing was commonly observed as expected, there were no visible indications that the steel in the forms is corroding. Corrosion of the bearing plate was observed in one location at the north abutment.

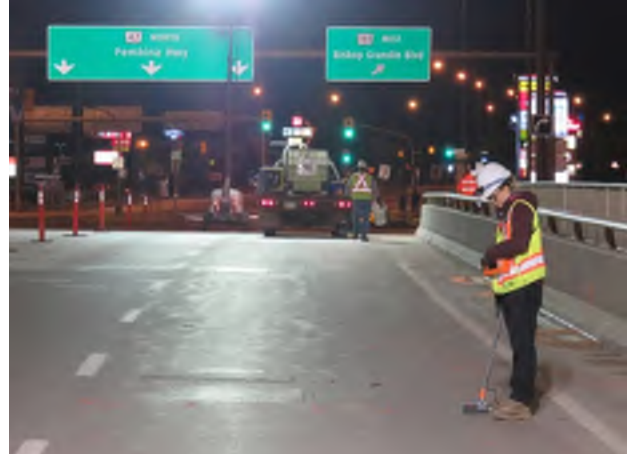
**Photo 1.2 – Cover Survey at Night**

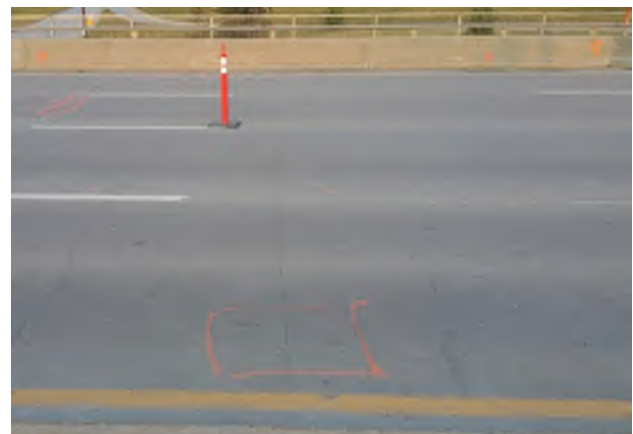
There is a higher concentration of transverse cracking, previously patched areas, and delamination in the tension zones over the piers. Transverse cracks are typically medium width (0.35 to 1mm), however wider cracks ranging from 1 to 2mm, with a maximum width of approximately 2.5mm, are common in the northbound lanes,

**Photo 2.1 – Delamination with Wide Crack in Northbound Lanes**

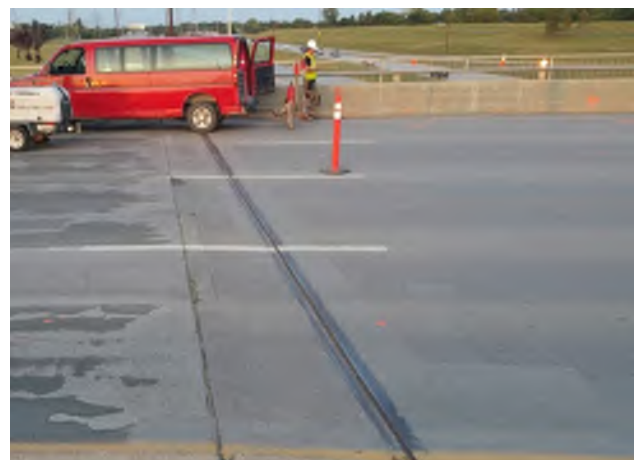
**Photo 2.2 – Previous Patch with Map Cracking at North Abutment**

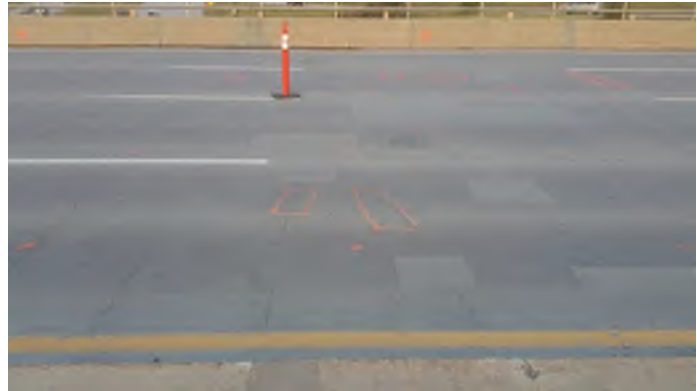
**Photo 2.3 – Typical High Concentration of Cracks, Patches and Delamination over Pier Area with Cracks through 2014 Repairs**

In some cases the transverse cracks have reappeared at the 2014 patch locations, and in other cases they have not. A smaller number of patches were also completed in 2010 and 2011 according to the City, and these patches are adjacent to the 2014 patches in most cases. The reappearance of the cracks in the patch areas suggests that they are in part related to live load, and that they may be deeper in some cases than the repair depth of 100mm. Previous concrete repairs to the median are noted to have occurred in 2006 according to the City's 2015 inspection report. In general the number of patches and delamination show an increasing rate of deterioration of the deck, however the overall deck condition also suggests that the deck is still at a stage where preventative maintenance will be beneficial and cost effective.

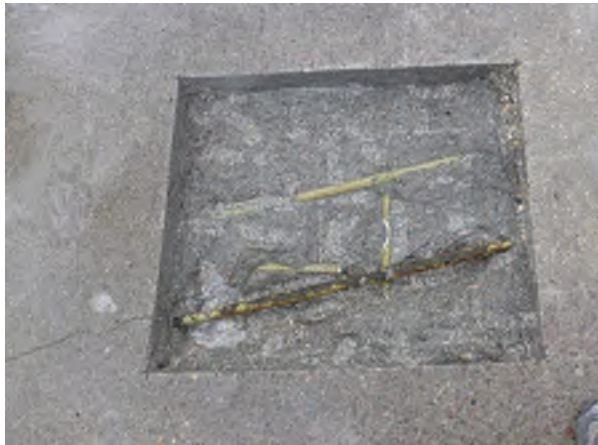
In order to verify the results of the deck testing, and to provide additional information prior to the 2018 maintenance program, three test patches were opened up on the northbound lanes. The test patches were approximately 450 mm by 600 mm and approximately 75 mm deep, or down to the reinforcing depth. The test patches were selected to be at wide crack locations. The concrete cover to reinforcing ranged from 60 to 75 mm, which was consistent with the cover survey. Within the test patches it was noted that the epoxy coated reinforcing had significant corrosion where cracks were located directly above the reinforcing, and that the cracks extended down to the reinforcing. The epoxy coating was intact on the reinforcing where cracks did not exist. It was also noted that there was shallow delamination, at approximately 20 to 30 mm depth, across one of the test patches, indicating that at least

**Photo 2.4 – Test Patch at Wide Crack with Failed Epoxy Coating and Corroded Reinforcing Directly Below Crack**

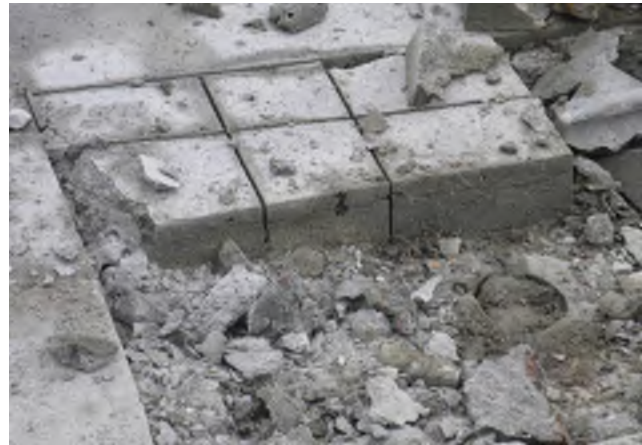
some of the areas noted in the delamination survey are at shallow depth, as opposed to at the reinforcing depth.

**Photo 2.5 – Test Patch with Shallow Delamination**

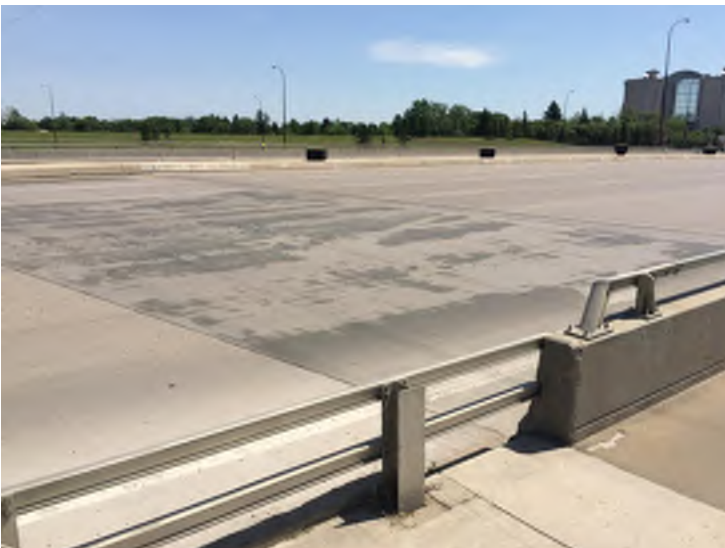
Photo 11  
North approach slab, southbound lane with delamination of epoxy-polymer overlay.

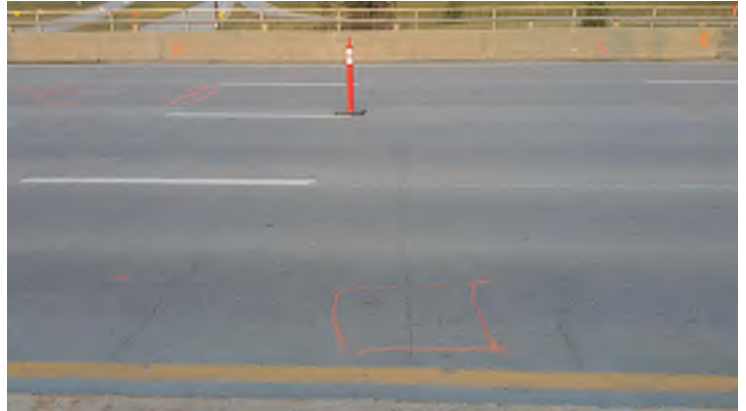
Photo 14  
Span 4, northbound lanes, wide crack through delamination.

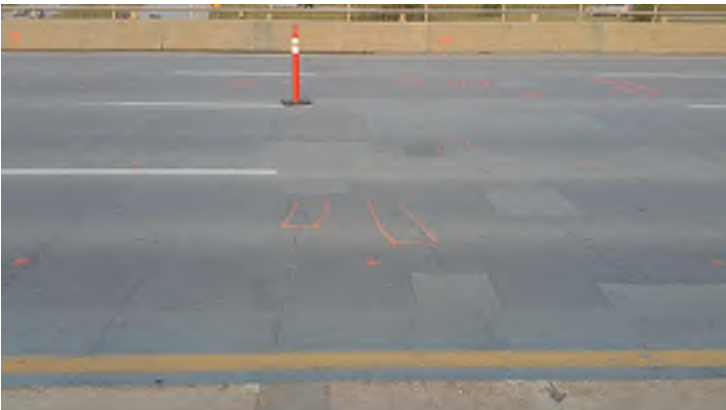
Photo 15  
Over pier 4, northbound lanes. 2011 and 2014 repairs, delaminations and wide cracks.

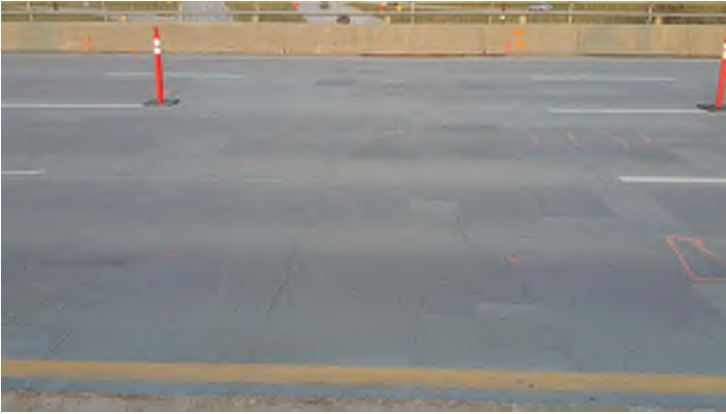
Photo 17  
Over pier 3, northbound lanes. 2011 and 2014 repairs,  
delaminations and wide cracks.

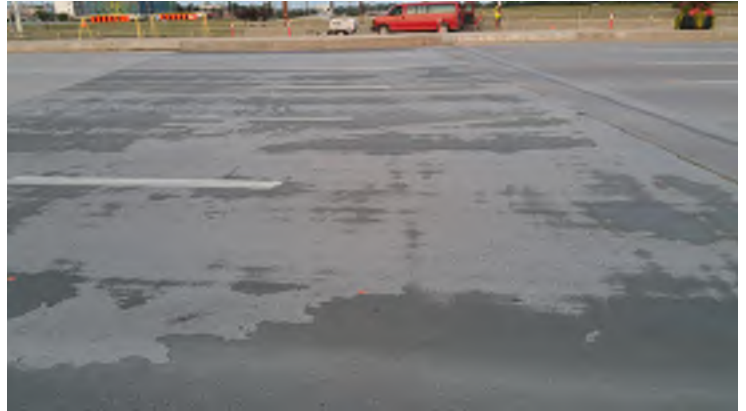
Photo 22  
North approach slab, southbound lanes, with delamination of  
epoxy-polymer overlay.

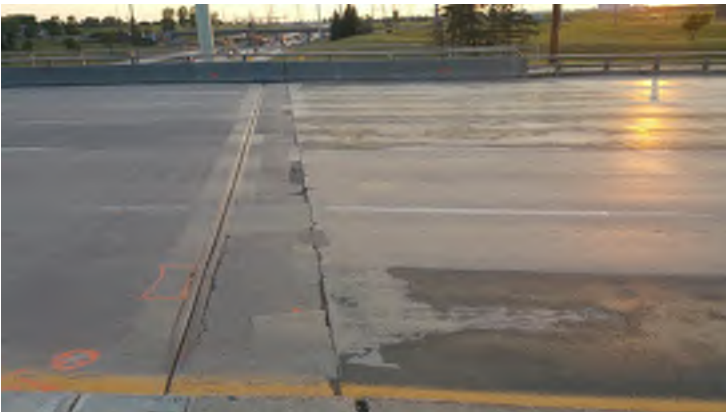
Photo 23  
Expansion joint between north approach slab and span 1,  
southbound lanes, very narrow gap.

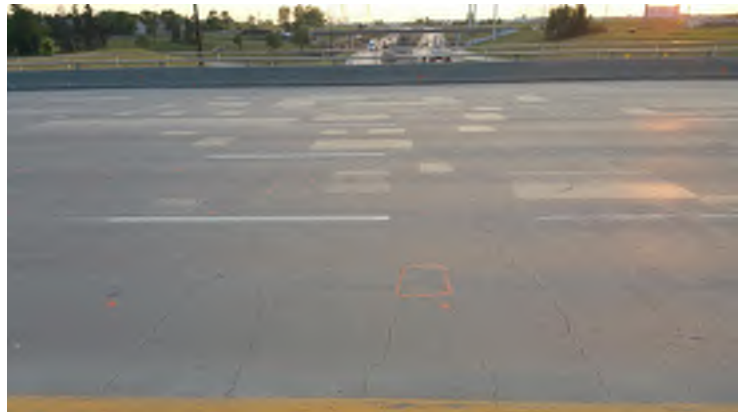
Photo 28  
Over pier 3, southbound lanes. Previous repairs,  
delaminations and cracks.

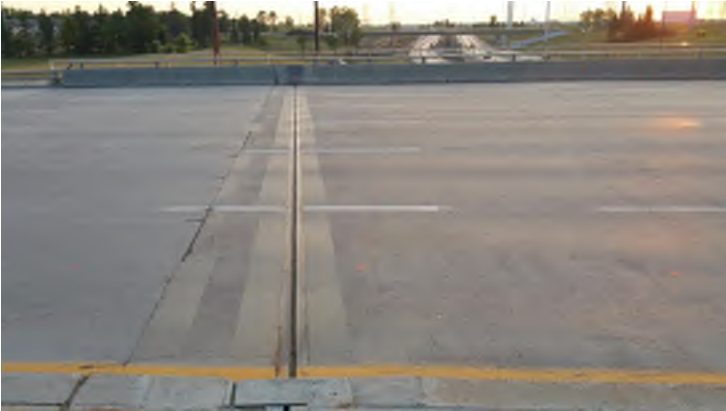
Photo 29  
Expansion joint between south approach and span 4,  
southbound lanes, very narrow gap.

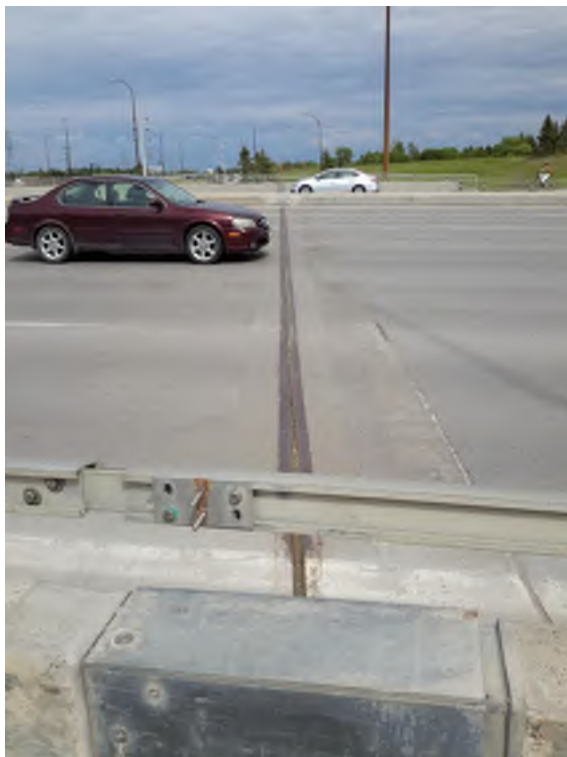
Photo 31  
South expansion joint, southbound lanes, very narrow gap.  
2017-08-23

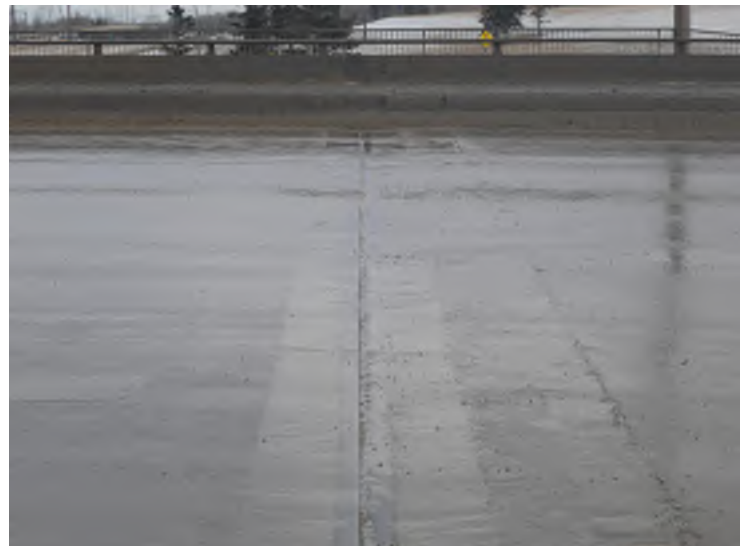
Photo 32  
South expansion joint, southbound lanes, narrow gap.  
2018-01-19

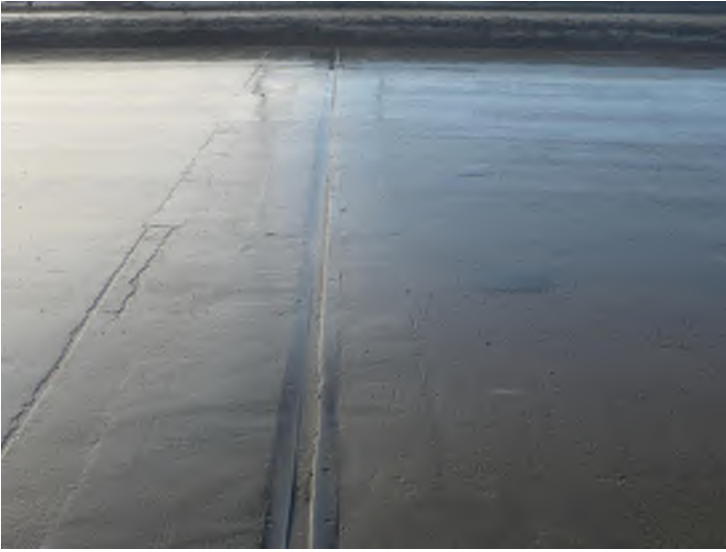
Photo 33  
North expansion joint, southbound lanes, very narrow gap.  
2018-01-19

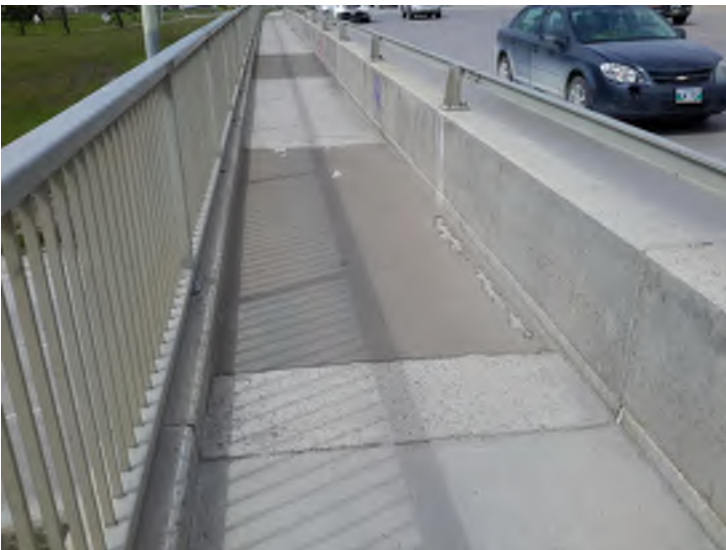
Photo 35  
West sidewalk looking north. Epoxy-polymer overlay visible.

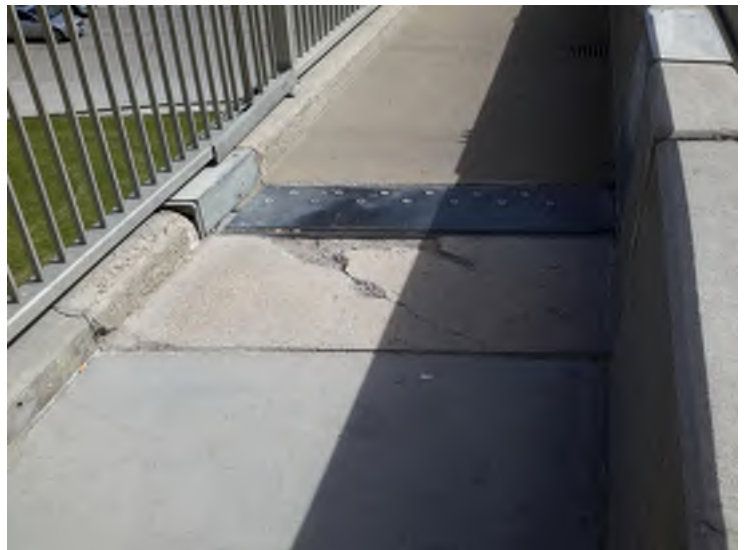
Photo 36  
East sidewalk spalling at north joint.

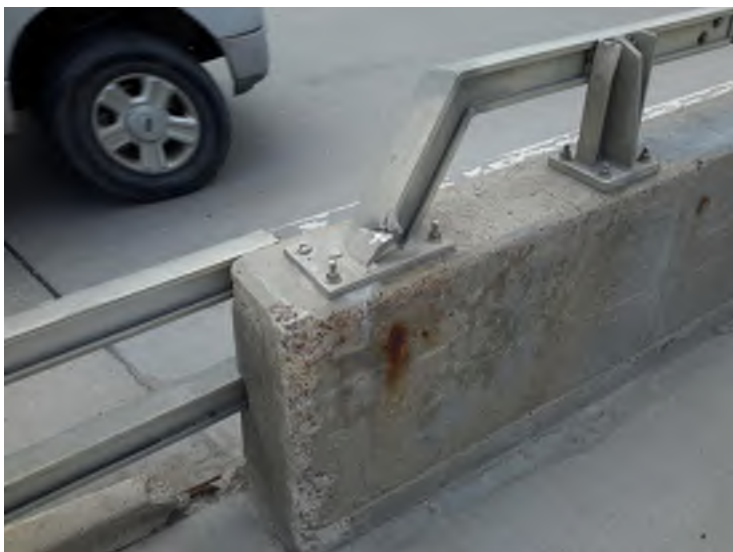
Photo 39  
Southeast traffic barrier, note impact damage to rail.

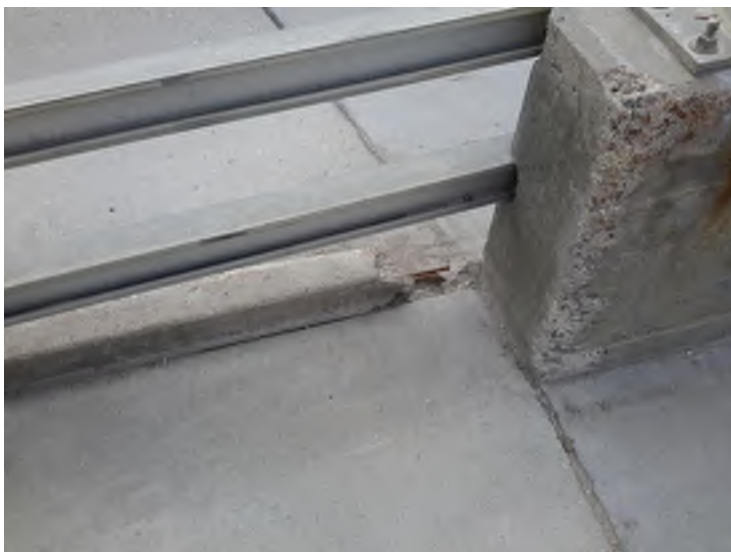
Photo 40  
Southeast corner, note missing concrete curb with exposed rebar.

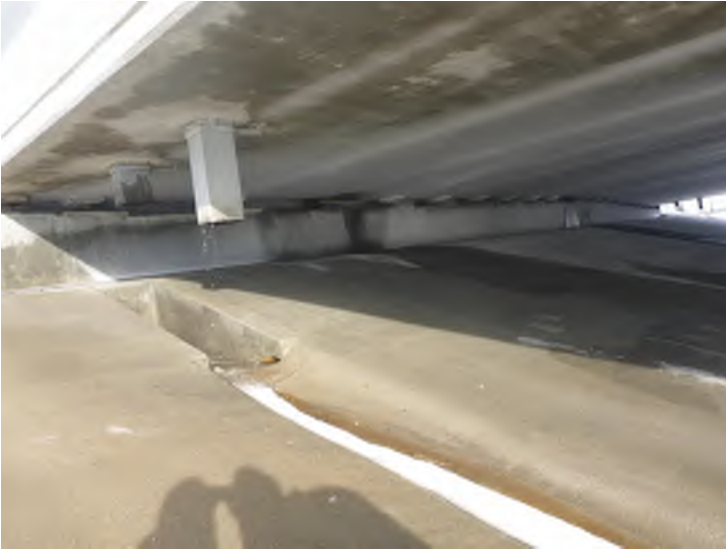
Photo 41  
Leakage at north abutment expansion joint, looking east.

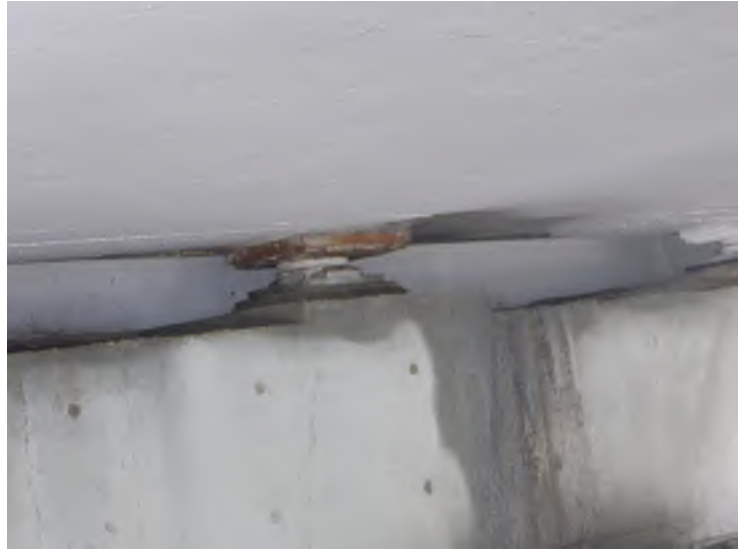
Photo 42  
Leakage at north abutment expansion joint, between 4th and 5th bearing from west.

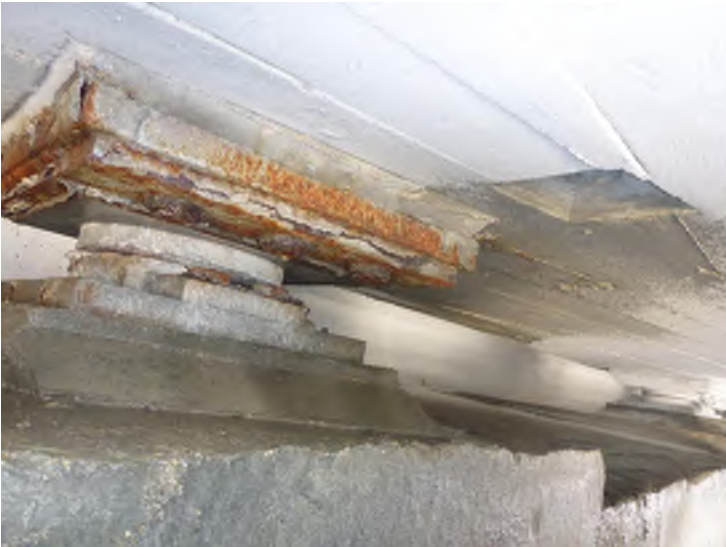
Photo 43  
North abutment, corrosion on 4th bearing from west. Drain not plugged, leakage from expansion joint.

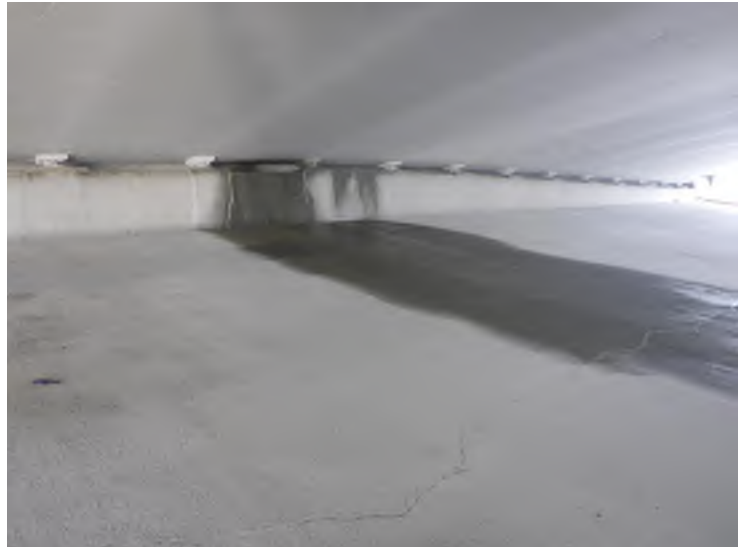
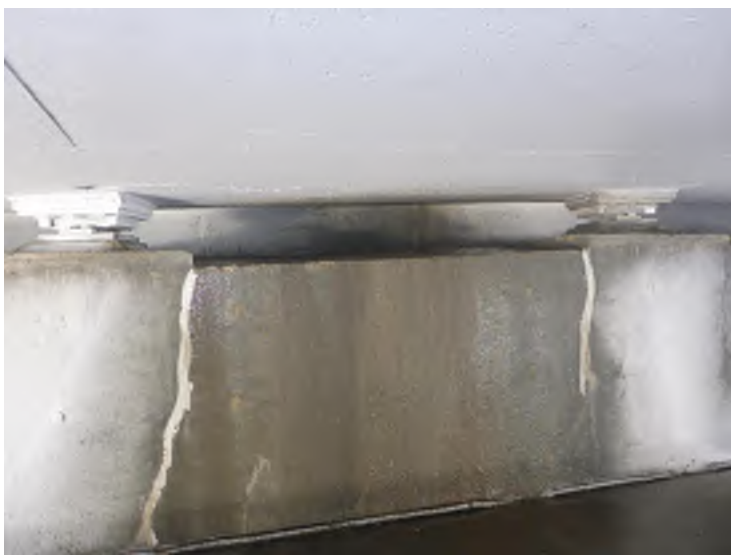
Photo 44  
Leakage at north abutment expansion joint, between 10th and 11th bearing from west.

Photo 45  
Leakage at north abutment expansion joint, between 10th and 11th bearing from west.

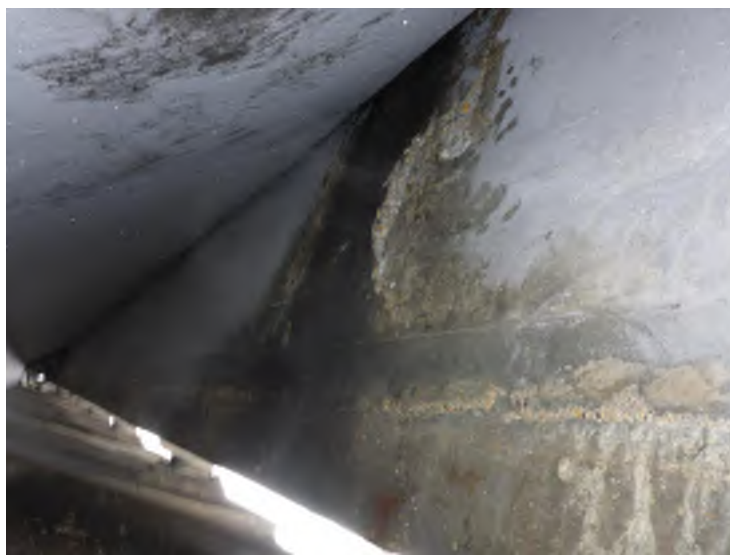
Photo 46  
Spall on girder ends at north abutment with leakage from expansion joint.
