### DETAILED BRIDGE CONDITION SURVEY

## Pembina Highway Bridge Over Abinojii Mikanah (Bishop Grandin)

(Site No. B-215)

November 22, 2024

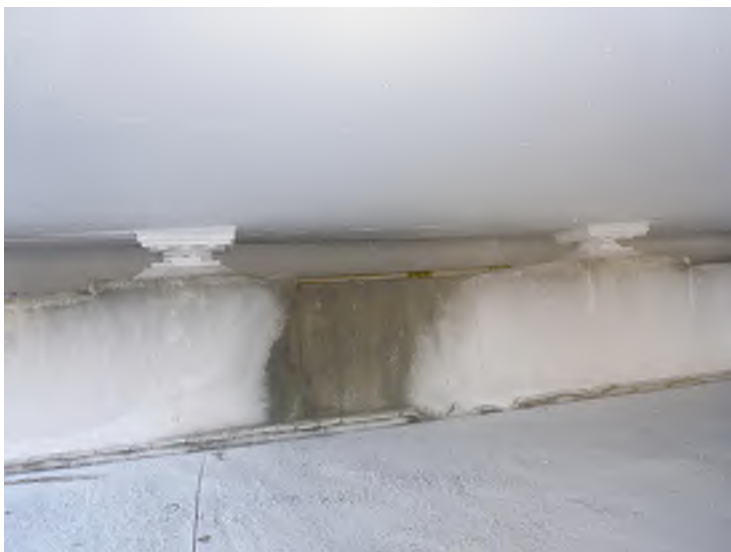
Photo 47  
Leakage at south abutment expansion joint, between 2nd and 3rd bearing from east.

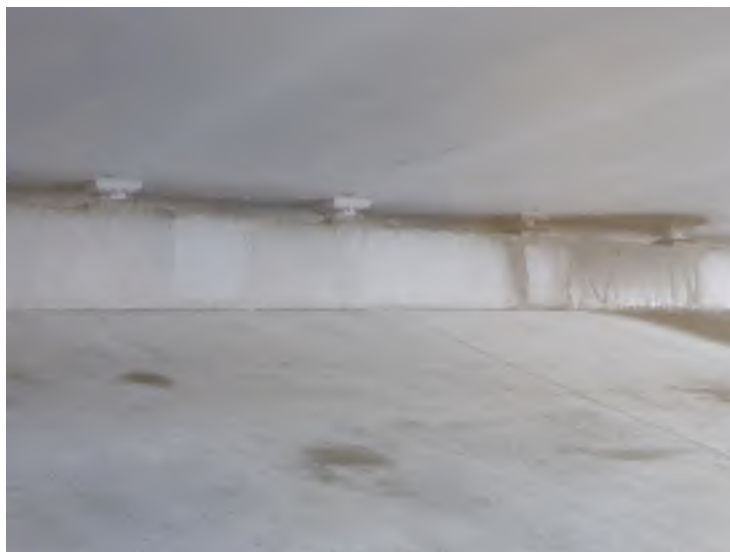
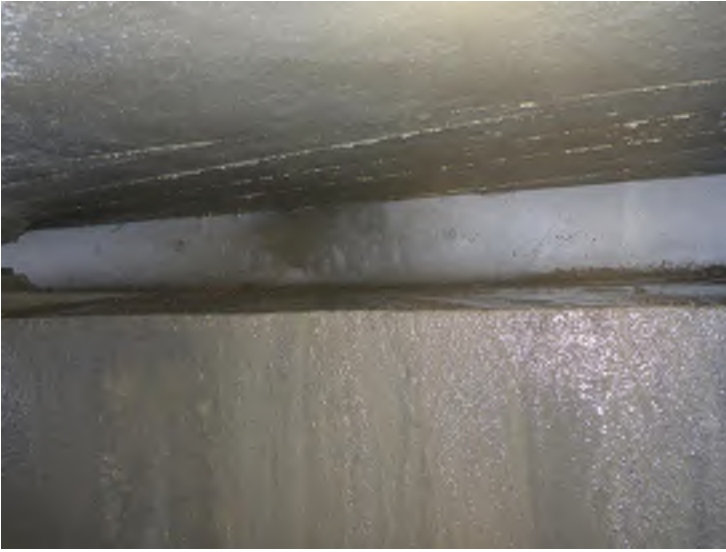
Photo 48  
Leakage at south abutment expansion joint, between 4th and 5th bearing from west.

Photo 49  
Leakage at south abutment expansion joint, between 4th and 5th bearing from west.

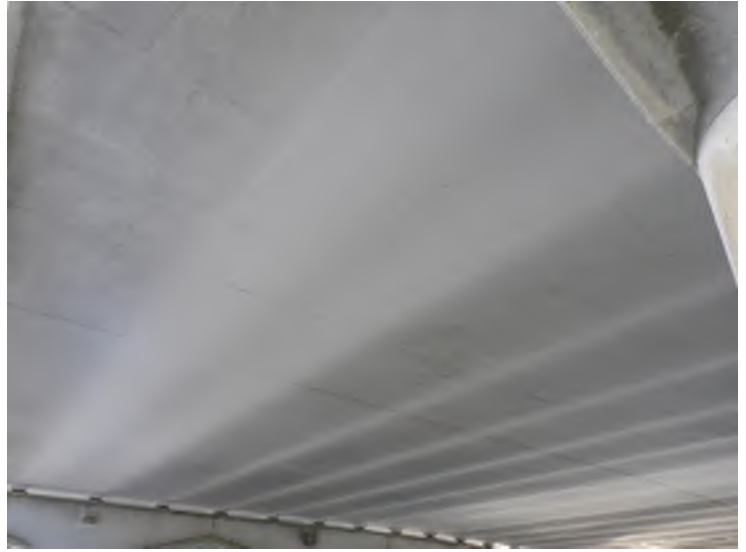
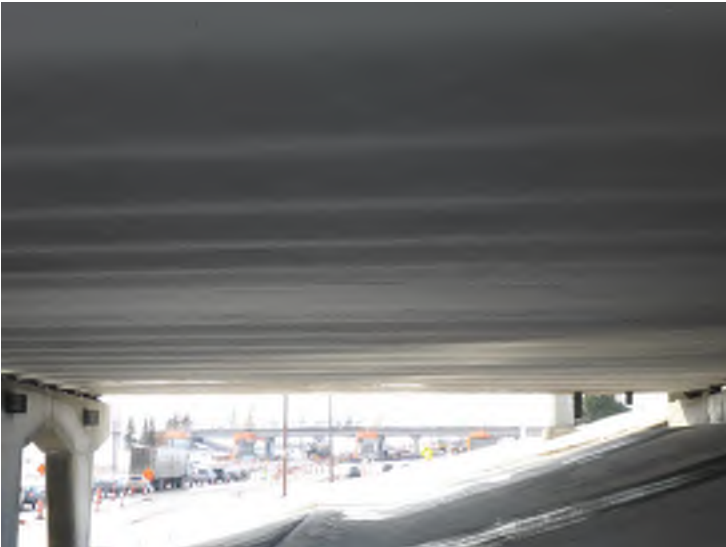
Photo 50  
Underside of the bridge deck, looking west. No signs of cracks, efflorescence or leakage. Frost at girder lines.

Photo 51  
Underside of the bridge deck, looking west. No signs of cracks, efflorescence or leakage. Frost at girder lines.

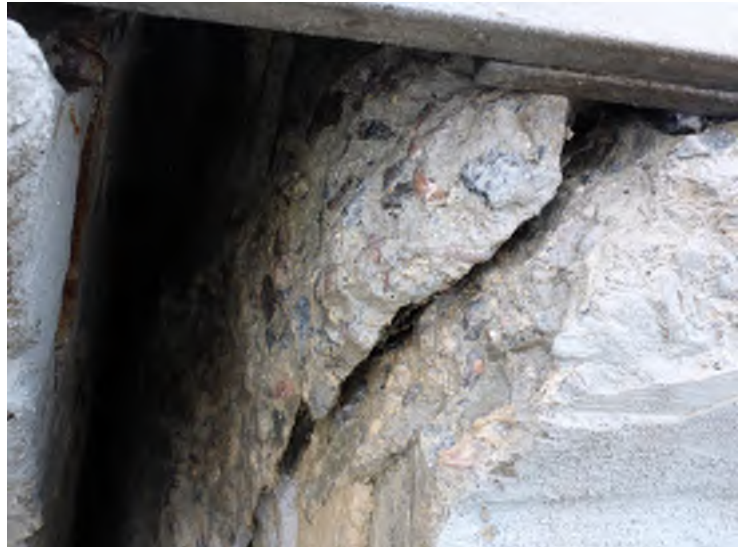
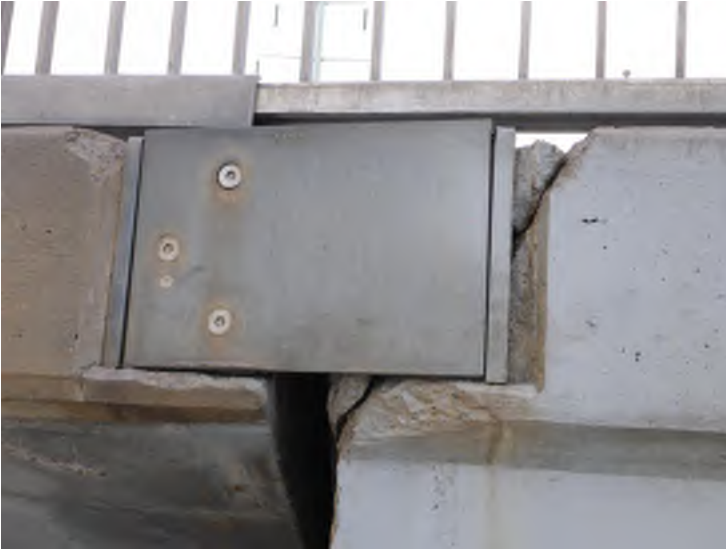
Photo 52  
Spalling at curb on east side wing wall of north abutment.

Photo 53  
Spalling at curb on east side wing wall of north abutment.

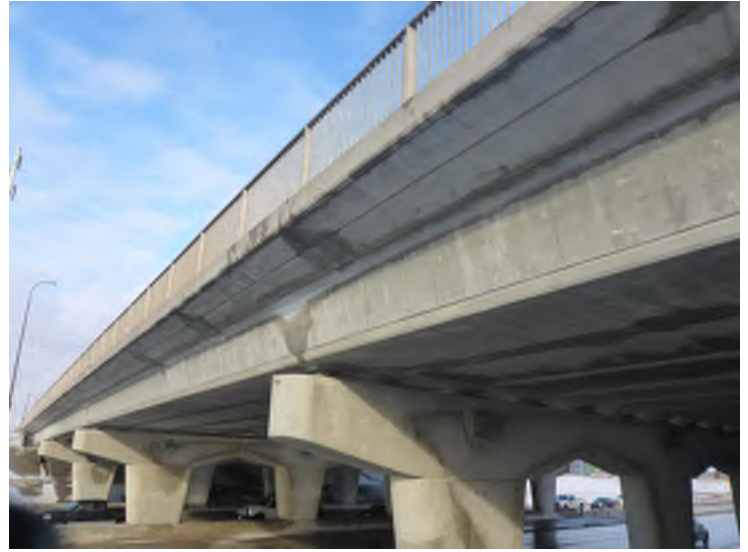
Photo 54  
West elevation, minimal signs of leakage at sidewalk construction joints.
